Lidia Bohun ¹, Eduard Pleshakov ², Sergiy Shvachko ³

FAILURE ANALYSIS OF A MOTOR VEHICLE SUSPENSION HELICAL SPRING

Abstract. The purpose of this work is to reveal the cause of the failure of the motor vehicle rear suspension barrel-shaped spring with the progressive elasticity characteristic and predict measures to increase the lifetime of springs of this type. The fracture of the spring occurred on the middle coil, which operates under conditions of more severe stress in comparison with other coils. The chemical composition of the spring material, determined by X-ray fluorescence spectral and microstructural analyzes, corresponded to chromium-silicon steel 54SiCr6. In terms of structure and mechanical properties, the spring material met the standards. No traces of decarburization were detected, and no crack initiation, caused by non-metallic inclusions, was found in the material of the fractured spring. Macroscopic examination of the spring surface did not reveal any cracks, scratches, dents, traces of blows with stones and marks of spring coiling tool. Instead, extensive areas of exfoliation of the protective coating were found. The metallographic analysis revealed selective co

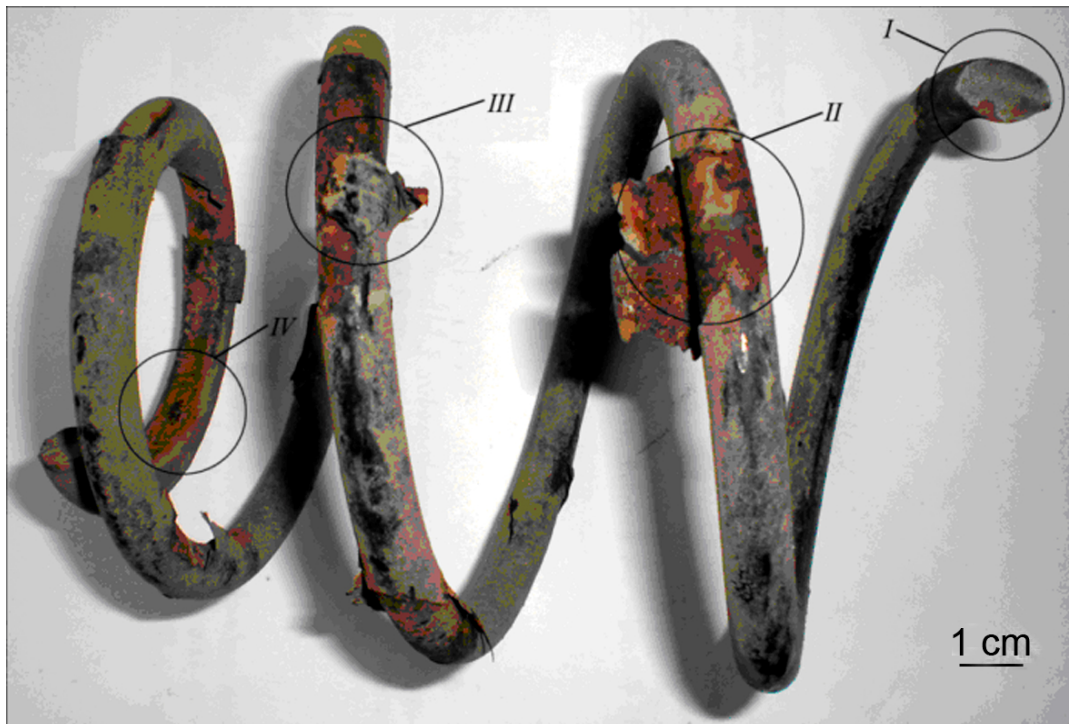
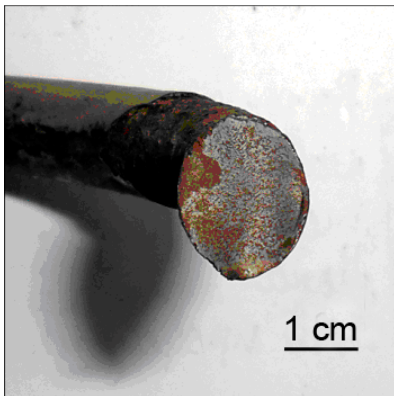
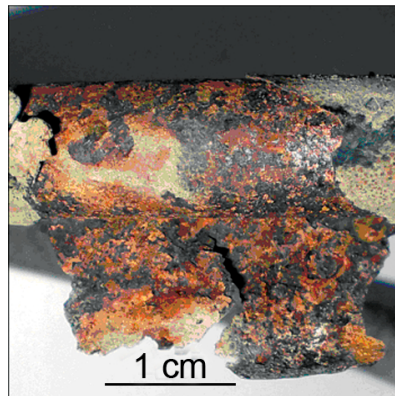
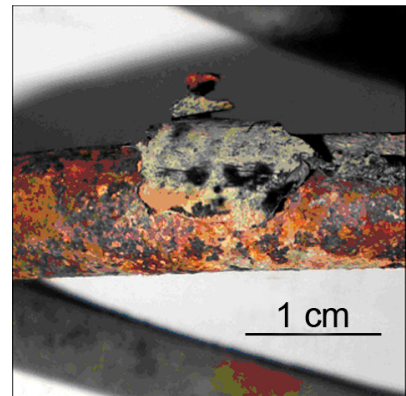
The fractured spring has the form of a barrel-shaped helix coiled to the right (Fig. 1, a). The outside maximum diameter of the spring is 108 mm, the minimum diameter is 76 mm, the total height of the unloaded spring is 336 mm. The total number of spring coils is 7 and the spring wire diameter is 10 mm. The spring weight is 1.25 kg. The fracture of the spring occurred on the middle coil having the largest diameter.

Fig. 1. The appearance of the spring of the rear suspension of the Ford Fiesta car: a – general view; b – fragment I; c – fragment II; d – fragment III

The quality of the spring was checked visually with a magnifying glass with 5 times magnification in accordance with DSTU 8429:2015 [15]. The appearance of the spring and the fracture was documented using a Casio Exilim 8.1 Mega Pixels camera (Fig. 1, *a, b*). During the inspection, no cracks, hairlines, rolled-in scales, electric burns, small dents, scratches, marks of spring coiling tool, and the remains of lubricants were observed on the surface of the spring. Instead, traces of rust and erosion of the protective coating were observed, which led to its exfoliation from the spring surface (Fig. 1, *c, d*).

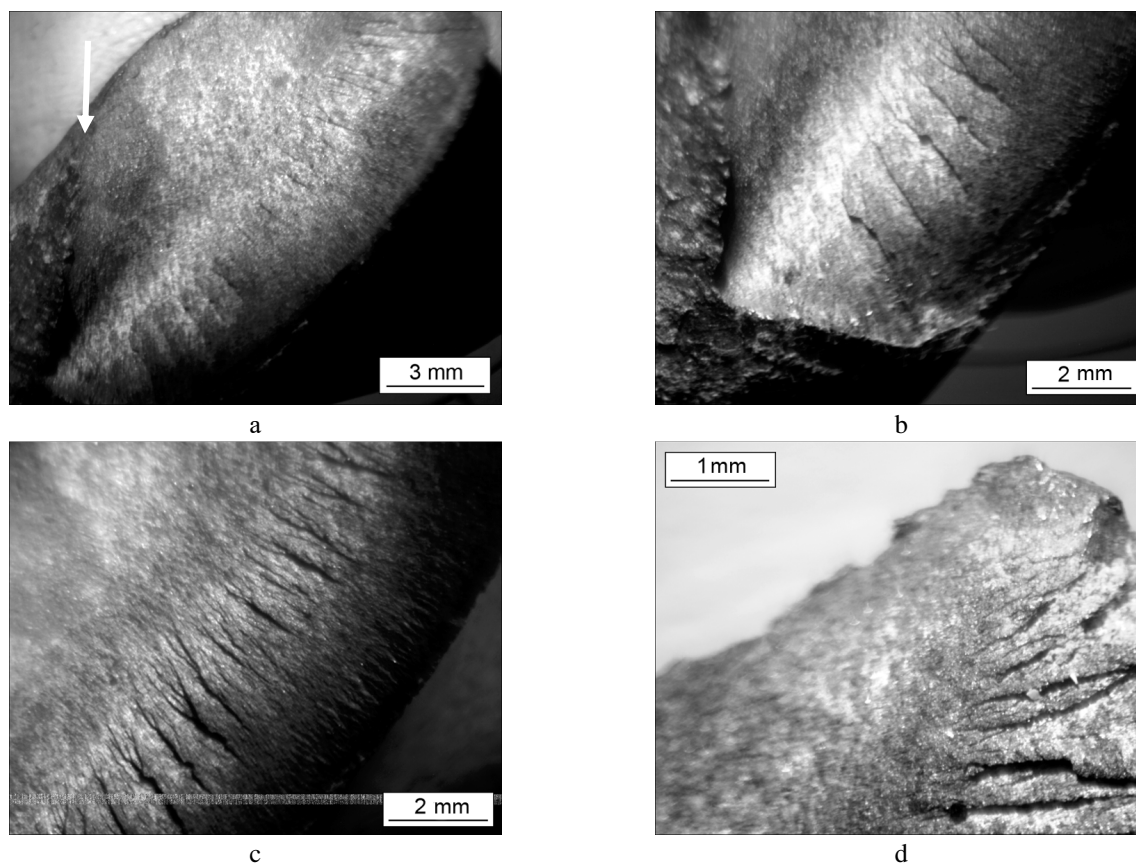
Macrofractographic studies of the fracture surface were performed using an MBS-9 microscope at magnifications of up to 7 times. The fatigue crack propagates from the fracture origin (Fig. 2, *a*, indicated by an arrow) with the reorientation of the crack plane along the spiral surface to the central axis of the coil wire (see Table 1, sample 1). The zone of the steady fatigue crack propagation is smoothed and identified by fatigue ridges – traces of movement of the crack front, which diverge concentrically from the crack initiation point (Fig. 2, *a*, *b*). After depletion of the safety margin, the spring broke down quickly. The fast fracture zone with a transverse size of about 6 mm contains steps of the river pattern formed due to the spiral reorientation of the fracture surface (Fig. 2, *c*, *d*).

Fig. 2. Macrostructures of the zones of the spring fracture surface: (a) the crack origin (indicated by an arrow); (b) transition from the fracture origin to the fatigue crack propagation zone; (c) the fatigue crack propagation zone; (d) the fast fracture zone

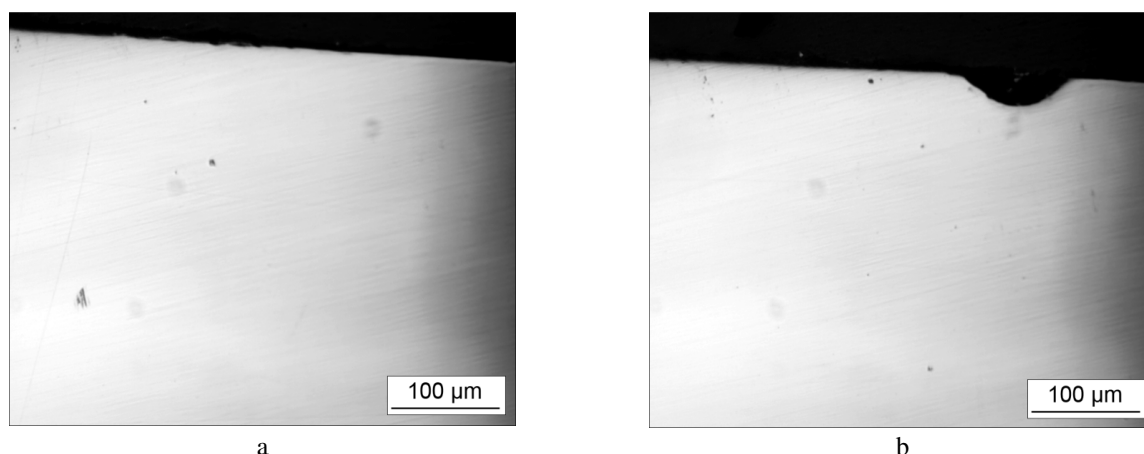
Evaluation of non-metallic inclusions in steel springs was performed according to DSTU ISO 4967:2017 (GOST 1778) [16]. A small number of dot particles of oxides (Fig. 3) and single elongated sulfides, which are usually double sulfides of iron and manganese, were found. Oxide and sulfide inclusions in their maximum size are twice smaller than the inclusions that correspond to the grade 1 of the reference scales, so they are evaluated by the grade 0.

Car springs are made of rolled products, for which dot inhomogeneity, central porosity, and liquation square should not exceed the grade 2 [15]. Therefore, the quality of spring rolling on non-metallic inclusions meets the requirements for the rolling for the manufacture of car springs.

Fig. 3. Microstructures of non-etched microsections (see Table 1, sample 1)

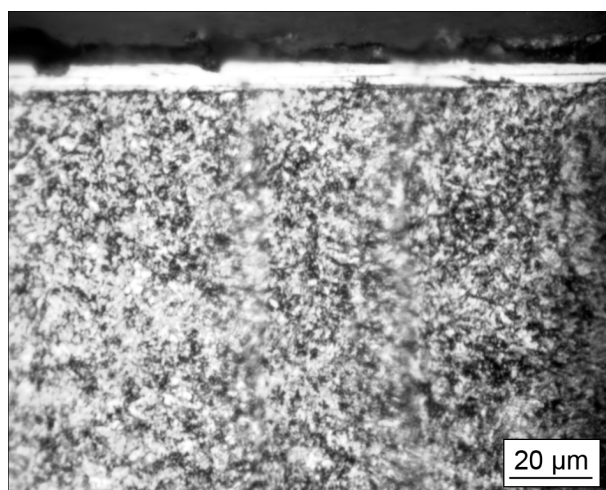
Microstructural study of the spring after operation, having a structure of troostite of tempering, found no traces of decarburization, even at the recommended allowable magnification of 500 times (Fig. 4).

Fig. 4. Microstructure of the spring of the Ford Fiesta car after heat treatment and application of a protective surface coating (after operation)

Microstructural studies of the spring showed that a protective coating was applied to its surface (Fig. 4). The thickness of the spring coating, which was determined by the results of three measurements, ranged from 6 to 7 μm .

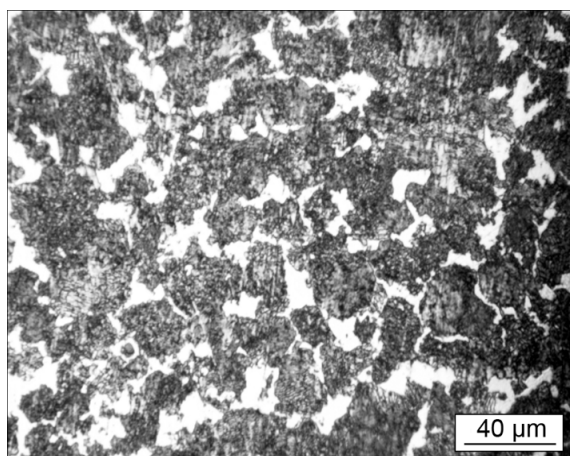
Since the device does not determine the content of light elements (up to atomic number $Z = 11$), the carbon content was determined metallographically by the structure in the annealed (equilibrium) state (Fig. 5). An approximate estimate of the carbon content in the spring steel was performed according to the standard DSTU 7175:2010 [22]. By comparing the equilibrium microstructure of the spring (Fig. 5) with scales of the standard, it is established that the microstructure corresponds to grades 3 – 4 on the scale 7. This indicates the content of pearlite in the structure of steel 70–80%, and ferrite – 30–20%. Thus, the approximate carbon content in the steel is 0.56 to 0.64%.

Fig. 5. Microstructure of the spring steel after annealing

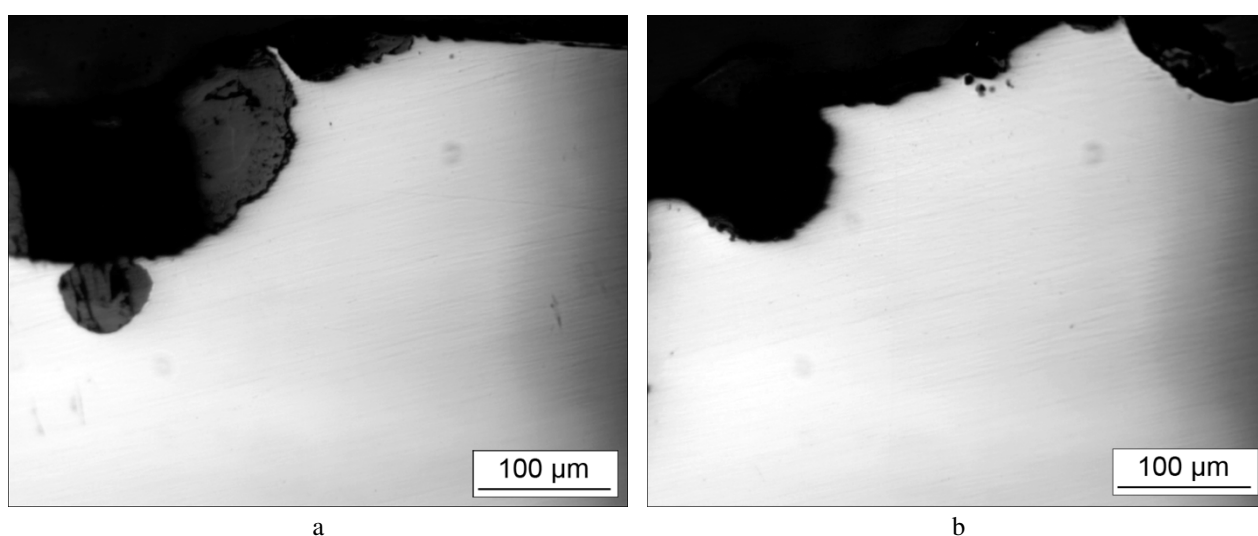
Visual assessment of the coating according to DSTU 3830-98 [27] and microstructural studies of the surface layer of the spring after operation revealed corrosion damage in places of exfoliation of the protective coating (Figs. 1 and 6). External inspection of the spring after operation showed that the coating was exfoliated on large surfaces (Fig. 1). The metallographic analysis revealed non-uniform selective corrosion, which causes exfoliation of the protective coating and spreads to the depth of the product in the form of pitting damage (Fig. 6). One of such deep pits became the initiation site of the main fatigue crack in the spring.

Fig. 6. Microstructure of corrosion damage to the spring surface in places of exfoliation of the protective coating

Instead, extensive exfoliation of the protective coating was found. Local corrosion damage in the form of deep pits, which formed in unprotected areas under the influence of operational factors, caused fatigue fracture of the middle coil of the barrel-shaped spring, which operates under conditions of more severe stress in comparison with other coils. The analysis of deformation fields performed in the work [28] confirms the fact that in progressive springs, the central coils are most deformed in contrast to linear cylindrical springs, in which the deformation of coils is the same.

Thus, the cause of the failure of the rear suspension spring of the car was the corrosion fatigue of the material due to the simultaneous action of the corrosive environment and cyclic alternate loading.

The research can be used to understand the importance of adhesive strength and wear resistance of protective coatings on the spring surface. Their local exfoliation causes subsequent corrosion damage to the spring, which stimulates its fatigue fracture.
