Analysis of Eddy-Current Testing and Metallographic Examinations for Corrosion Damages of Heat Exchanging Tubes in NPP Steam Generators

Tetiana Kovalenko, Stepan Lys*, Volodymyr Vostres

Lviv Polytechnic National University, 12 S. Bandera St., Lviv, 79013, Ukraine

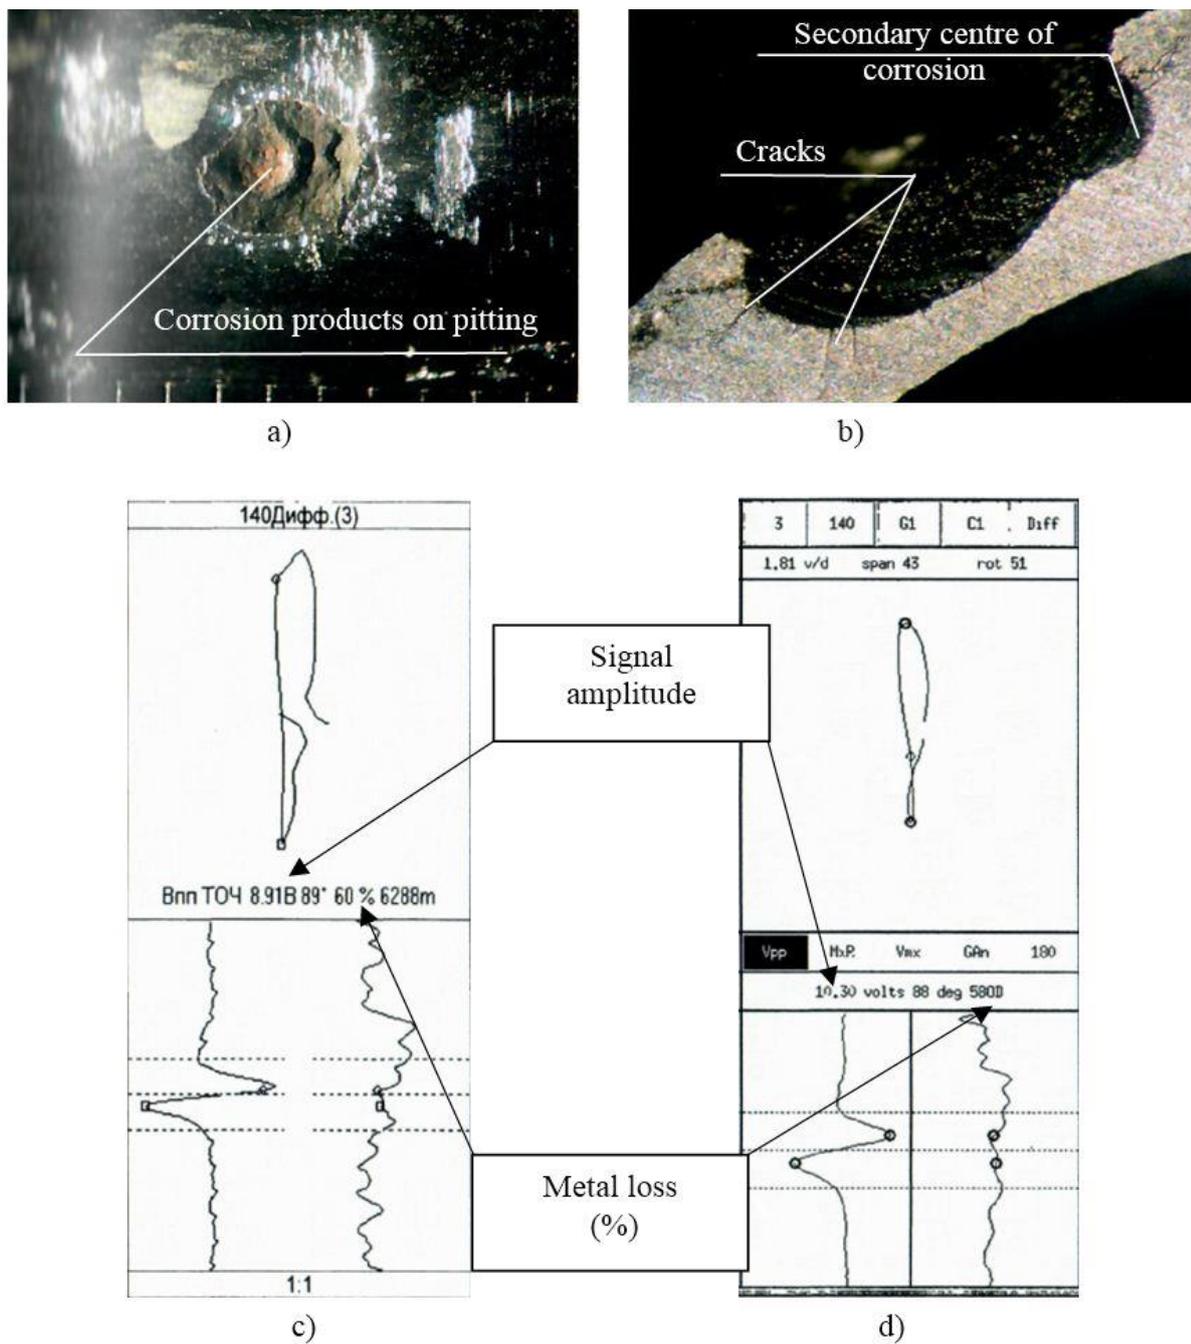
Fig.3. Critical round shape corrosion pitting:
 a) Defect appearance on the HET surface;
 b) Defect appearance on the metallographic section (metal damage depth up to 1.25 mm (83%);
 c) ECT results by "TEDDY-8" system;
 d) ECT results by "MIZ-30" system.

The metallographic section in cross section represents the corrosion pitting as a hollow in metal mainly an oval shape which begins on the tube surface. In all the cases the hollows are filled with corrosion sediment with typical layer structure. The cracks propagate into metal from large pitting. In pitting with cracking the framework structure of sediment is observed. Besides the metal cracks are perpendicular to the sediment layers (see Fig. 4, b). Some defects have almost regular oval shape. In the centre is situated the pitting nucleus, around which the layers of corrosion sediment are formed. Other corrosion pitting of the irregular shape as a result that corrosion centres have two or more nuclei. The crack emergence also deforms the pitting shape.

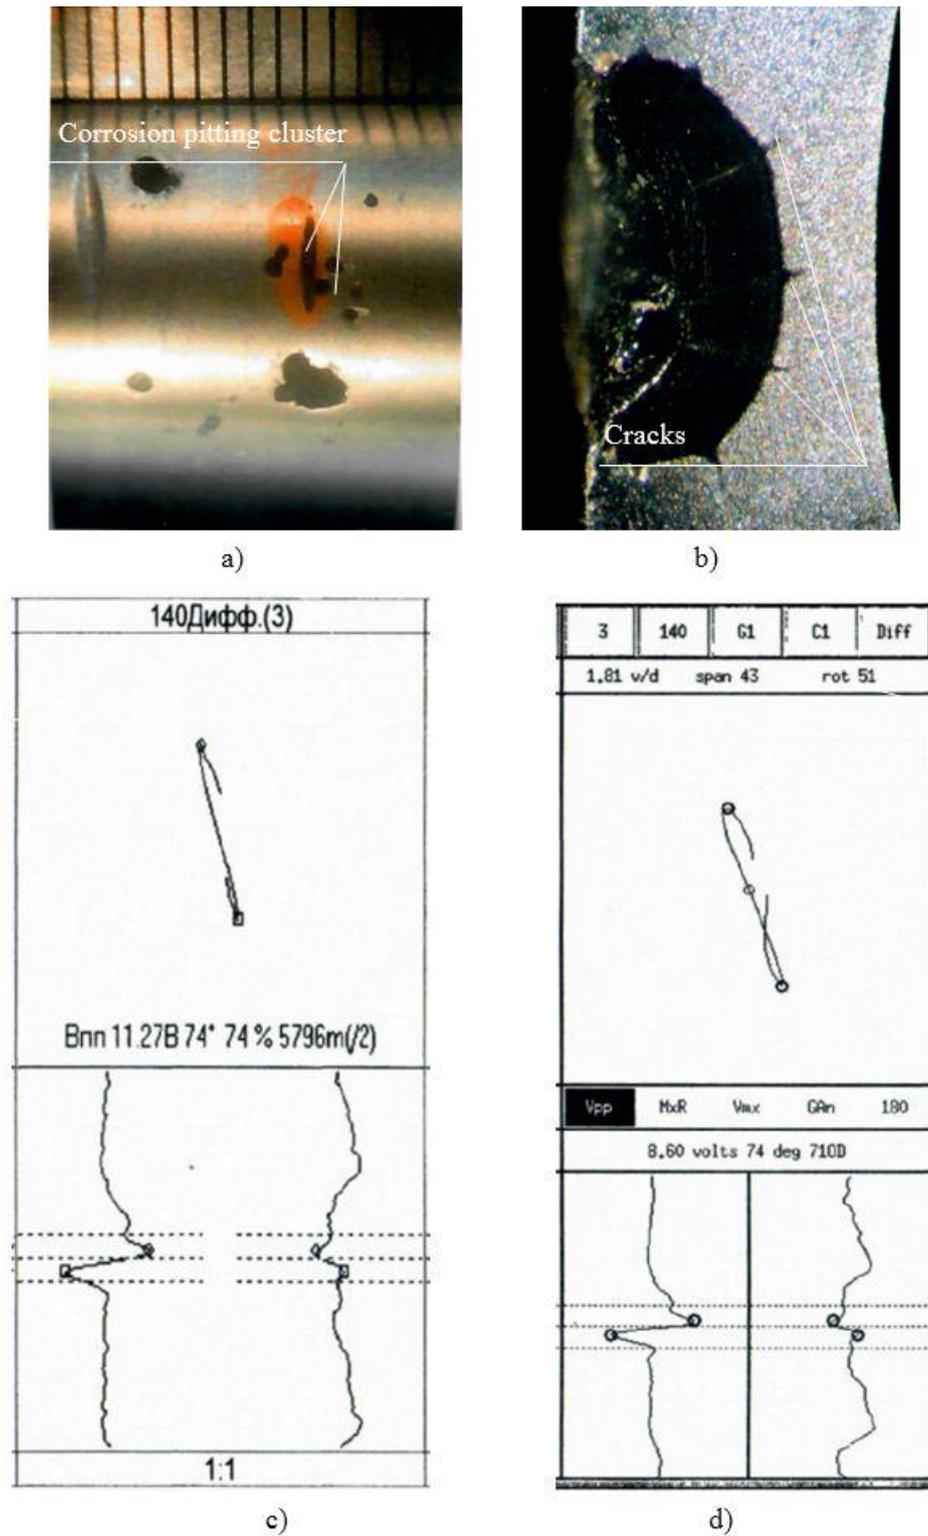
Fig. 4. Critical irregular shape corrosion pitting:

- a) Defect appearance on the HET surface;
- b) Defect appearance on the metallographic section (metal damage depth up to 1.2 mm (80%);
- c) ECT results by "TEDDY-8" system;
- d) ECT results by "MIZ-30" system.

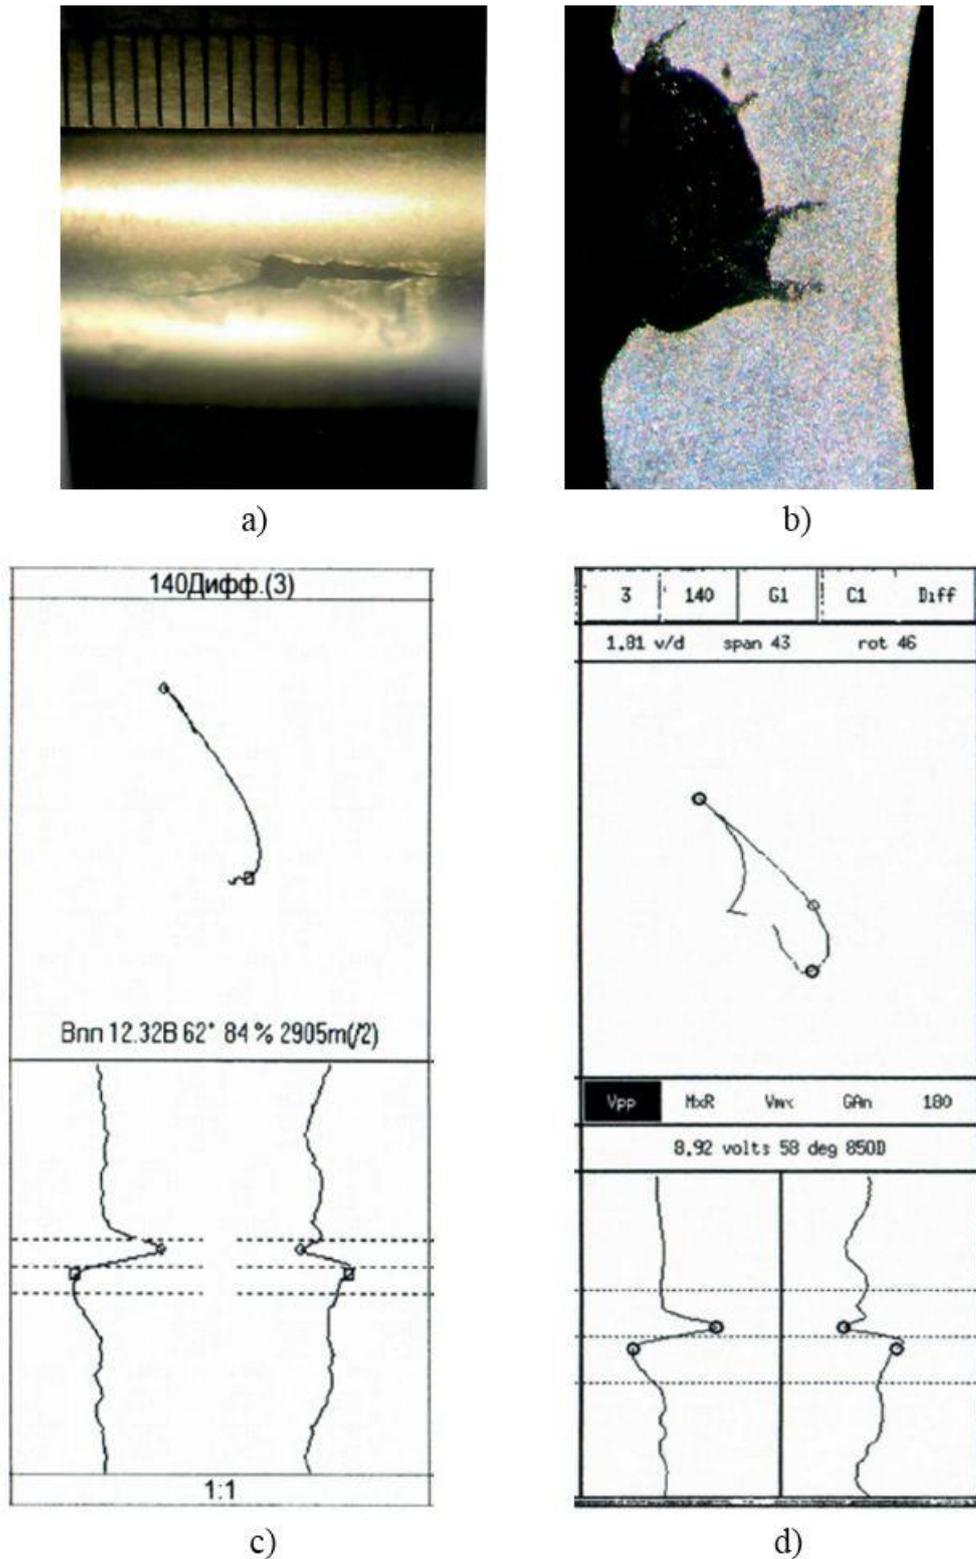
Fig. 5. Critical wedge-shaped corrosion pitting (the total length up to 20 mm):

Based on the results of the performed analyses, it was determined that corrosion pitting is the most frequent one to occur. The pitting corrosion is known as the most dangerous type of local corrosion. Corrosion pitting defects were conditionally distributed into critical and subcritical during the test performance. Critical defects are those which make a further HET operation dangerous. The tubes having such defects should be blanked off. From the standpoint of ECT, the critical corrosion pitting is characterized by a great percentage of metal loss (from 60 to 100%) at signal amplitude equal to 10...20 V (Fig. 3, 4 and 5). Characteristic properties of these defects from the metallography standpoint are as follows. In all the analyzed cases these are large corrosion pitting which have round, oval or elongated longwise shape of the tubes. The defects have the dimensions in 2...4 mm range on the tube metal surface. The corrosion products sediments have the intricate shape in the form of coaxial circles positioned around a central hollow – a pitting core. In most cases the cracks are propagated from corrosion pitting predominately longways the tube surface; the cracks may be up to 20 mm long (see Fig. 5, a).

- a) Defect appearance on the HET surface;
- b) Defect appearance on the metallographic section (metal damage depth up to 1.32 mm (88%);
- c) ECT results by "TEDDY-8" system;
- d) ECT results by "MIZ-30" system.
