EMERGENCY CONDITION OF LOGGIES IN BUILDINGS WITH SUPPORTING BRICK WALLS

A real example of such a problem in the existing 9-storey building with brick load-bearing walls, where the shortcomings of construction were manifested, namely the poor quality of masonry at the junction of loggias to the load-bearing walls of the building.

All these construction errors, individually or in combination, often lead to damage or destruction of the load-bearing structures of loggias, which, in turn, makes the building an emergency. An example of such a situation is the condition of loggias in an existing building with load-bearing brick walls on the street. Volodymyra Velykoho, 44 in the city of Lviv.

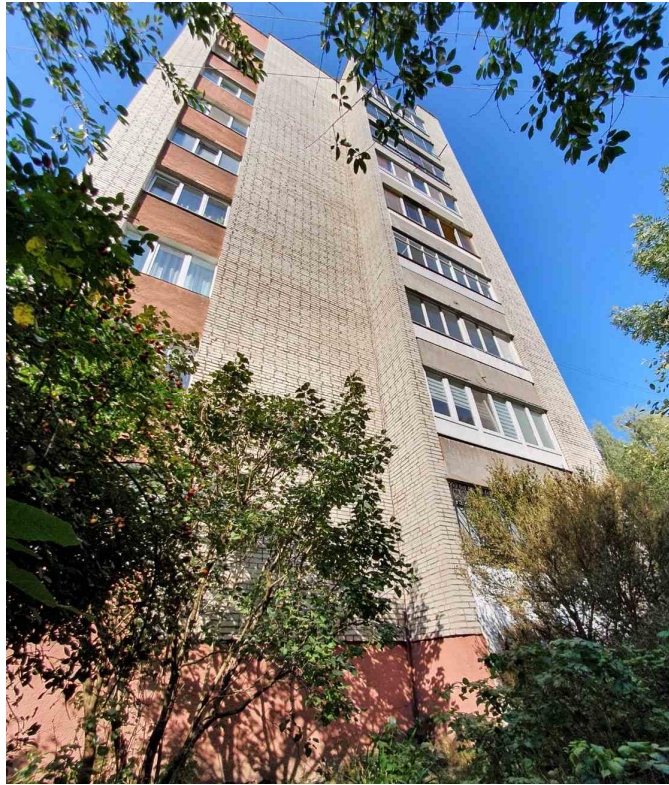
Fig. 1. Scheme of the building

Structural scheme of the building, part of which was inspected, with longitudinal and transverse brick load-bearing walls and horizontal overlapping disks. Residential building (Fig. 1).

The building has a stair and elevator unit. The height of the living floor from floor to ceiling is 2.5 m. The height of the building to the top of the parapet is 28.4 m.

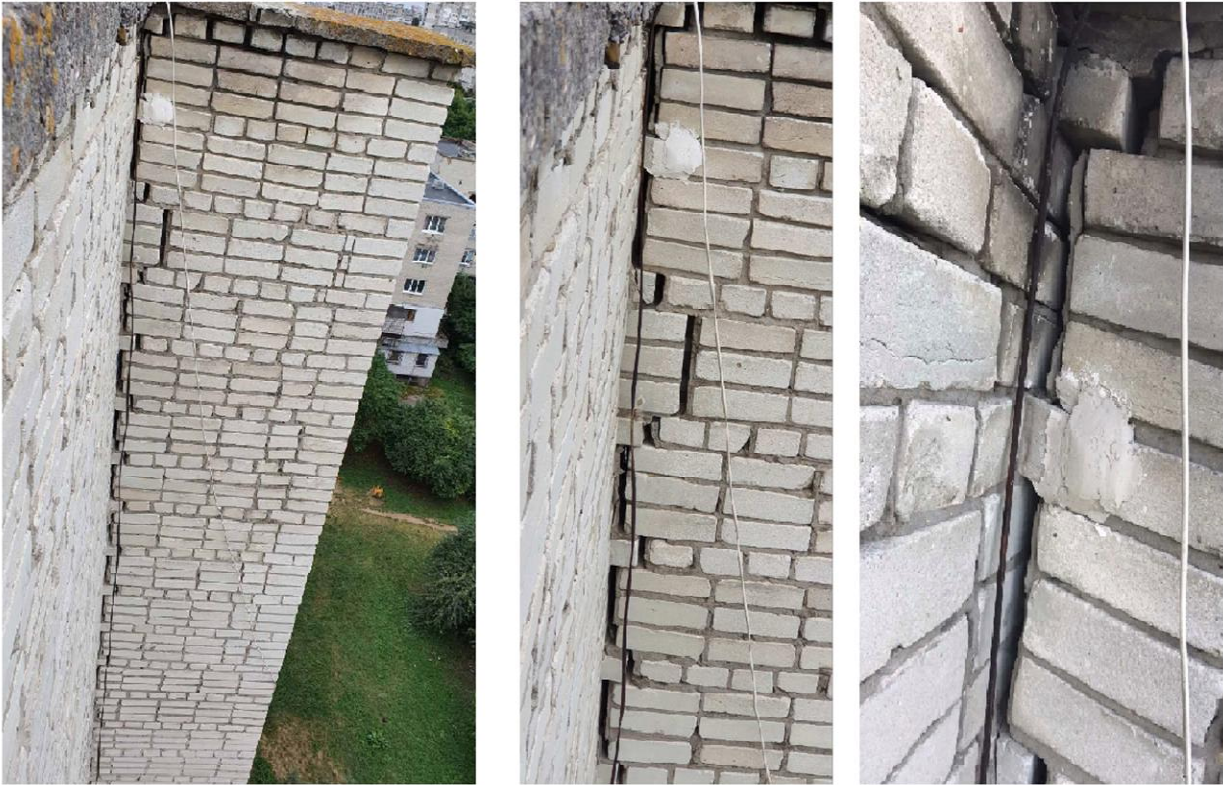
- vertical crack along the height of the building at the junction of the load-bearing walls of the loggia and the house with a width of up to 40 mm;
- poor-quality ligation of brickwork of the longitudinal load-bearing walls of the building with the transverse load-bearing walls of the loggia;
- deviation horizontally from the building of the load-bearing structures of the loggia;
- diagonal crack when making a load-bearing wall of a loggia with a difference of seams to 20 mm (Fig. 4).

In (Fig. 2) you can see a vertical crack in the height of the building, the width of which is greatest at the highest point of the building and reaches 40 mm. The crack is mainly in height between the rows of masonry, but there are also cracks in the body of the brick in a row, which serves as a link between the wall of the loggia and the load-bearing wall of the building.

The brickwork of the loggia is three-row with a bandage in one row, which connects the loggia with the perpendicular load-bearing wall of the house. Prefabricated ribbed reinforced concrete floor slabs rest on the end bearing load-bearing brick walls of the loggia and are not attached to the building. This means that the connection of the loggia with the house is solved by only one row of masonry, which is nested in height in three rows.

After the formation of a through crack at the height of the building, the loggia begins to work as a free-standing part, respectively, there is a danger of its destruction.

Fig. 2. Vertical crack at the junction of load-bearing walls and loggia

Based on a visual inspection of the visible part of the building structures and the results of calculations, it can be concluded that the cause of cracks is poor quality masonry load-bearing walls of the loggia and load-bearing walls of the building, which caused an emergency condition of the building.

This situation requires fencing of the area near the loggia, a ban on residents to go to the loggia and the urgent development of a project to strengthen building structures to eliminate the emergency situation.

Reinforcement of the considered building structures can be made of metal structures, namely clamps and straps, which should connect the structure of the loggia with the load-bearing wall of the

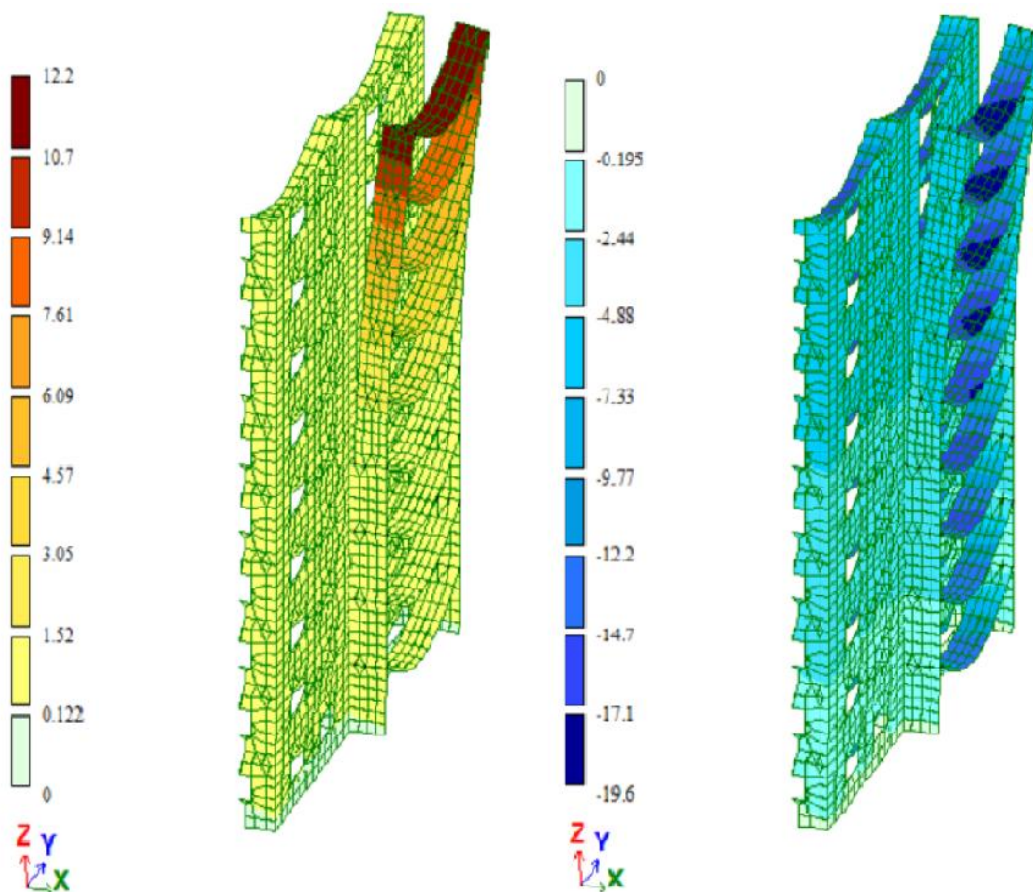
Fig. 3. Isopolies of loggia displacements along X (horizontal component, mm) and Z (vertical component, mm)

To better understand the operation of the structure after the formation of cracks and taking into account its structural scheme and white loading, a calculated finite element model was created in the PC "LIRA-CAD" and the movement of the loggia was obtained (Fig. 3).

The structure of the loggia is designed so that the loads are unevenly distributed, namely on the outside (from the side of the facade) enclosing reinforced concrete panels and glazing create a running load, which causes skew of the loggia structure, because it is not attached to the building properly.

To obtain a more accurate reproduction of the existing structure of the loggia, after the formation of through cracks, in the calculation scheme between the outer load-bearing wall of the building and the 5 upper floors was modeled deformation seam (at this height visually visible crack opening).

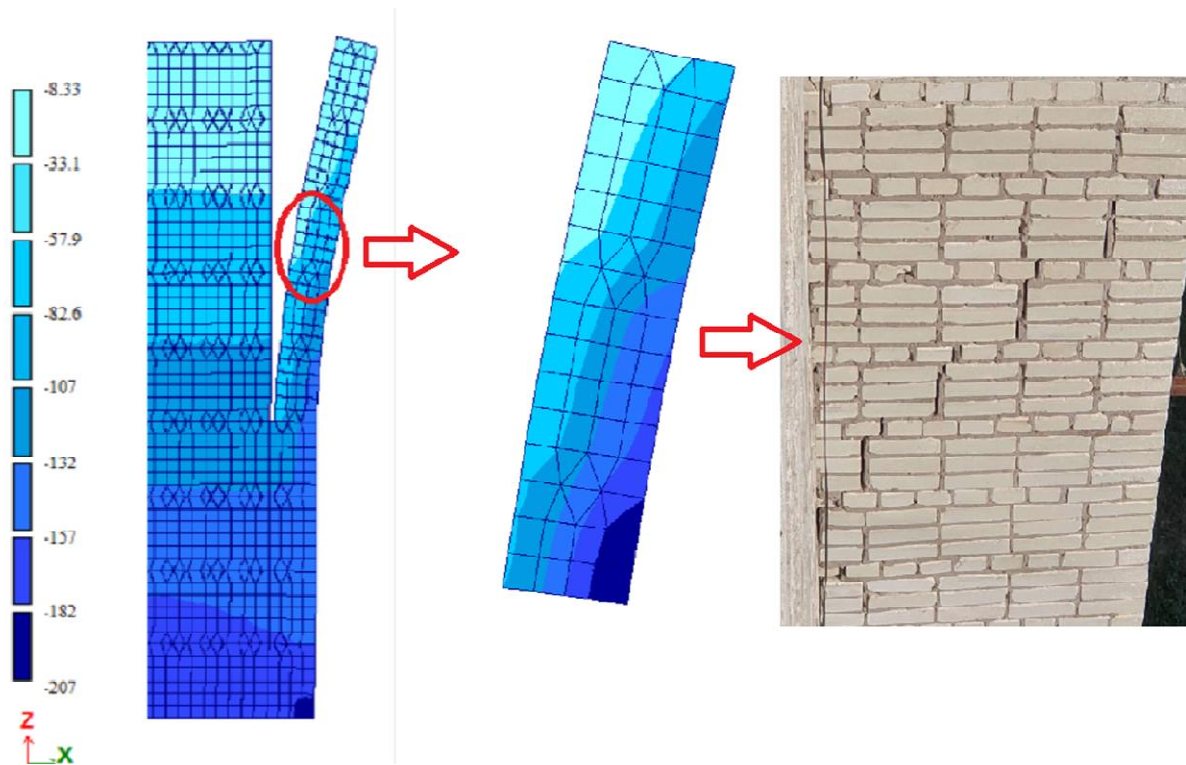
A diagonal crack, which is located at the level of the 6th floor, is also fixed in the end bearing wall of the loggia (Fig. 4). The reason for this crack is that after the connection between the walls of the loggia and the walls of the house collapsed, the loggia began to deviate from the building, due to the fact that the facade of the loggia has constant running loads from reinforcing concrete wall panels and glazing.

(Fig. 4) shows the distribution of vertical stresses N_y , as well as the diagonal crack that cuts the brickwork at the seams.

External loads are applied to the facade of the loggia, which, in turn, due to the occurrence of a through vertical crack, leads to uneven stress distribution.

Fig. 4. Comparison of stress distribution N_y with a diagonal crack

According to the comparison, the nature of the stress distribution corresponds to the nature of the development of the diagonal crack.
