APPLICATION OF CFD FOR INTERIOR FLOW ANALYSIS INFLUENCED BY EXTERIOR CONDITIONS

The aim of the paper is the presentation of application CFD analysis for interior flows in chimneys and flats in a building. It is a summary of a case study of fatal intoxication by carbon monoxide coming from a gas heater of flowing water at a bathroom. That kind of accidents mostly happens due to problems with ventilation and very popular old construction gas water heaters. Closed, airtight windows are the main causes of the production of carbon monoxide but sometimes wrong construction of the chimney outlets versus the roof shape causes the backdraught of combustion products. The paper deals with an accident which took place in one of Polish cities. Gas heater of flowing water installed in a bathroom at the first floor was connected to the vent pipe with a low outlet. During windy weather conditions, at the end of October, so in a cold season, one of the inhabitants of the apartment died in bathroom due to carbon monoxide intoxication.

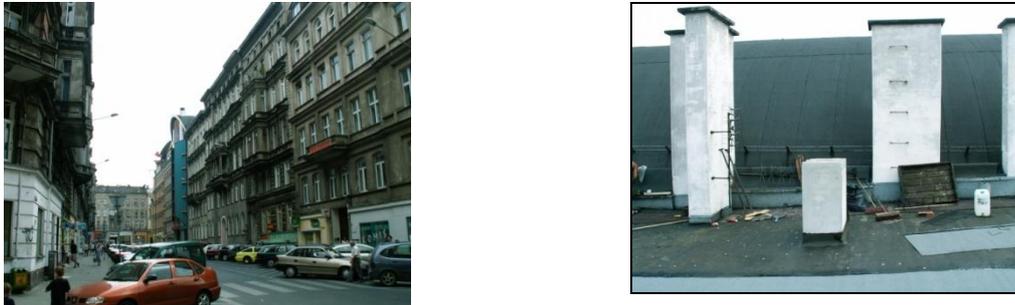
Fig. 1. The view of the new building from the street and of the outlets after adjustments

Other outlets' heights have not been changed because they were located further than 10 m from the top of the roof, thus they were outside the distance given in the Standard. One of the outlets remaining at its primary height was originally an outlet of the ventilation duct and to this vent duct a flowing water gas heater was connected in an apartment at the second floor. Consequently, the outlet's function was changed to an exhaust duct outlet. However, the construction of the chimney remained untouched, the chimney had two side wall outlets left as designed for a ventilation duct outlet.

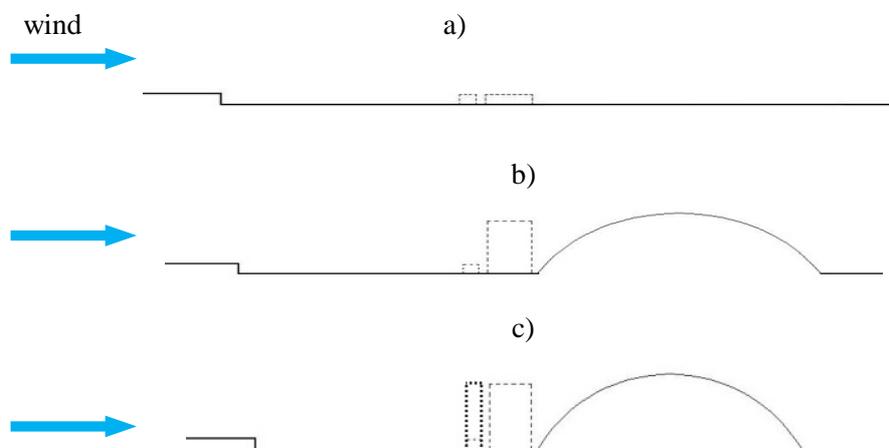
The new roof has changed the aerodynamic characteristics of the neighboring buildings, especially around the chimney outlets of the ventilation and exhaust ducts. Some of the chimneys' heights have been changed to fulfill the requirements of the Polish Standard (PN-89/B-10425).

Fig. 2. A cross-section of the roofs: a – before the construction of the arched roof; b – after the construction and c – the height of a chimney as recommended. Wind direction is marked

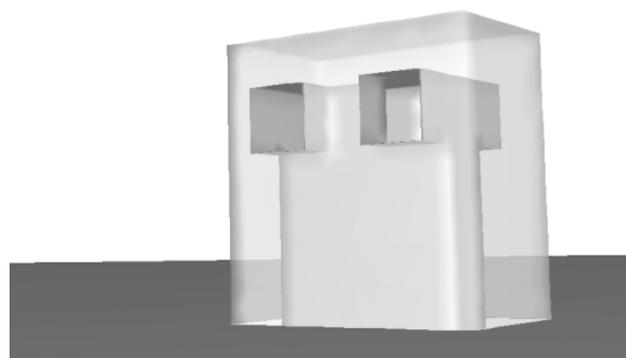
Fig. 4. The view of the outlet of the chimney during the accident. Wind direction was parallel to the walls with the outlets

The chimney protruded over the roof surface by about 0.6 m, the centers of the two outlets were at 0.4 m above the roof surface.

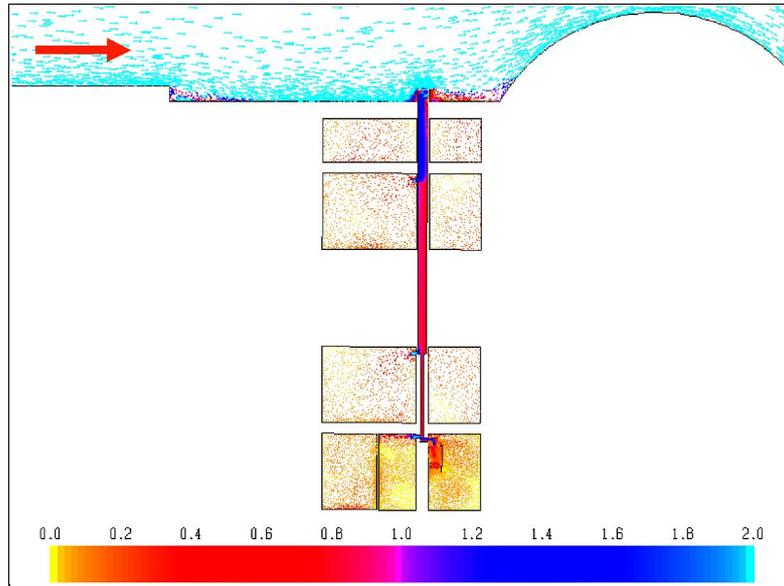
Fig. 7. Exhaust chimney duct and the connected rooms

The discharge of fumes was blocked by the cold air from the outside in the long chimney duct. The flow in the chimney was reversed due to the influence of the wind. Higher chimneys that served for the ventilation of the same apartment had outlets in the area of higher wind speed because the outlets were higher and closer to the arched roof.

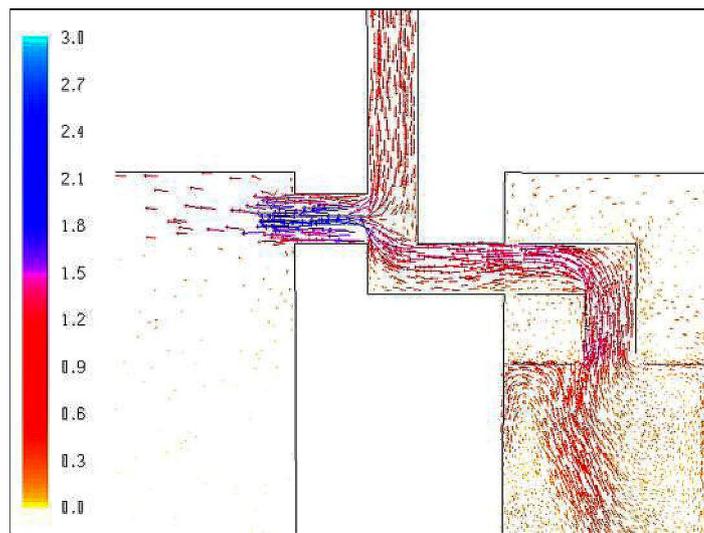
Results. After conducting the analysis the following conclusions were reached. First of all, resulting from the existing construction, features of the chimney; as well as the external conditions during the accident, in the initial phase of the water heater operation the products of combustion were not discharged upwards through the chimney but returned into the bathroom through the small fan outlet of the former ventilation duct above the place where the exhaust pipe was connected to the ventilation duct (Fig. 8).

The calculations assumed that the small fan did not function at the time. If the side wall outlet fan was removed from the model, still a similar effect of discharge of exhaust into the bathroom occurred, only the fumes would flow through the inside of the heater.

Fig. 8. Wind speed vectors in the cross-section of the chimney near the connection of the gas heater

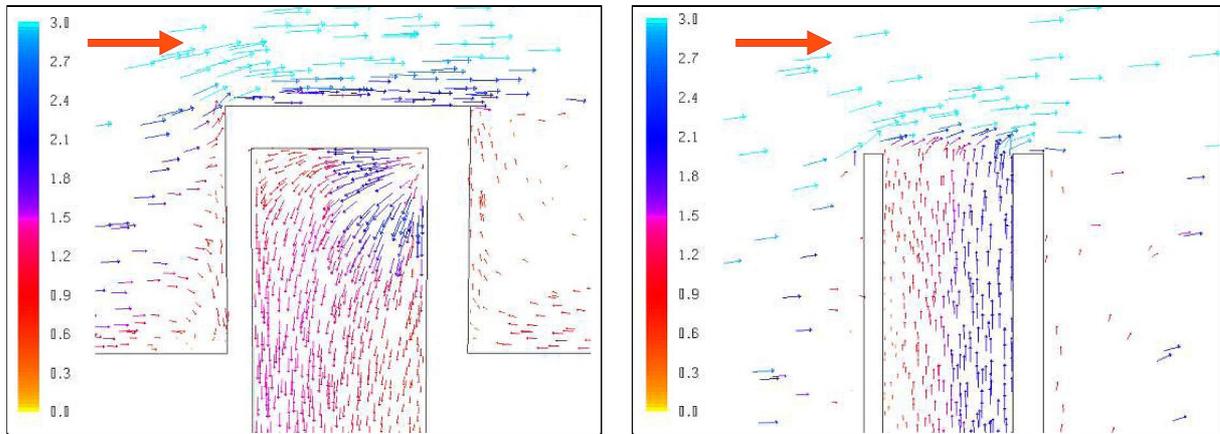
Fig. 9. Wind speed vectors in the cross-section of the chimney near the chimney outlet. Left: the existing construction; right: the recommended construction of the chimney. Wind direction is marked by an arrow

The problem of the cold air influx from the outside to the chimney can be eliminated by increasing its height to the similar height of all the other chimneys, as well as moving the outlet of the duct to the top of the chimney from the side walls (Fig. 9). The last improvement has been implemented in compliance with the Polish Standard (PN-89/B-10425).
