CONSERVATION OF ARCHITECTURAL AND ARTISTIC HERITAGE

**CAUSES OF DESTRUCTION  
OF ARCHITECTURAL DETAILS MADE OF ALABASTER STONE.  
(FOR EXAMPLE, THE GOTHIC CHURCH IN DROHOBYCH)**

**The aim of this study is** to define the reasons and the consequences of the deterioration of the gothic alabaster portal of the parish church of St. Bartholomew in Drohobych.

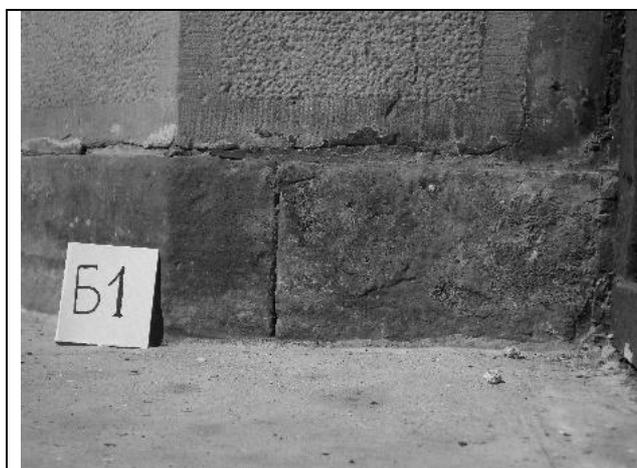
#### Block No. 1

Four stone rectangular planes, which follow the angle of the portal, are made of sandstone. The surface finish of the stone looks like a bush-hammered plane with fluted arrises. The block was hewn of sandstone.

**State:** stable

**Losses:** 90 % of the face finish is lost

**Deterioration:** weathering, small splits

**Cracks:** two deep cracks, which can lead to chipping off the substantial part of the block

**Contamination:** black patina, yellow and white spots, which can cause dampness of the stone

**Additions:** joints between the blocks and the wall filled with cement mortar. One of the block planes is inserted as a separate slab, which can be a result of the previous restoration work

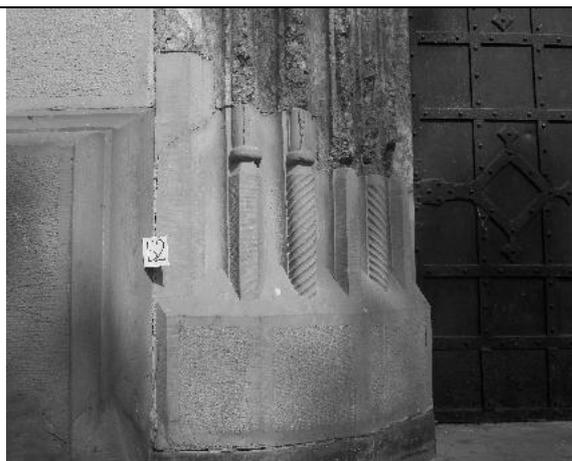
**Block No. 2**

**Result of the restoration work:** Block №2 looks like four square planes with a transition to the corrugated body of the portal. Molding profile of the ribs resemble an astragal. There are six ribs. The bead moldings have a prismatic and curved form. The square planes of the block have a bush-hammered decoration with fluted arrises. The block is hewn from sandstone.

**State:** satisfactory

**Losses:** not detected

**Deterioration:** stone weathering, small splits and cuts

**Cracks:** one large crack in the stone, which can lead to chipping off the substantial part of the block. The crack follows to the lower part of the block, jointed with cement mortar. Between the cement mortar additions and the stone small cracks appeared, one of which was jointed with cement over again.

**Contamination:** spots of black and red paint, little orange pots like spots of rust, white smudges

**Additions:** a gap between the block and the entrance door filled with cement mortar and partly painted in green colour.

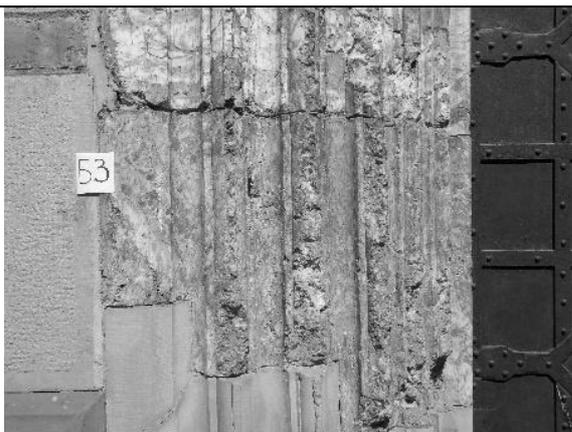
**Block No. 3**

Alabaster molding block, consists of five ribs.

**State:** unsatisfactory

**Losses:** lower part of the 1, 2, 3 ribs of the portal

**Deterioration:** on the most part of the stone's surface (80%) erosion caused by wind, water erosion, temperature change can be observed, which resulted into the formation of numerous cuts, cavities, splits, minor and large cracks. Marks of mechanical cleaning of the stone: deep even furrows all over the plane.

**Cracks:** minor, small, large

**Contamination:** yellow, red, white spots; spots of black and red paint

**Additions:** a gap between the block and the entrance door filled with cement mortar and partly painted in green colour. The joints between the blocks and the wall are filled with cement mortar.

**Panels:** jamb of the portal of yellow alabaster with grey veins

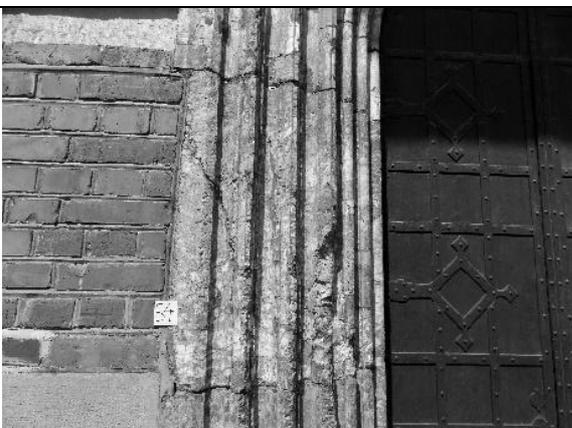
**Block No. 4**

Alabaster molding block, consists of five ribs.

**State:** unsatisfactory

**Losses:** significant part of portal ribs lost its initial form. A part of the third rib is completely lost.

**Deterioration:** on the most part of the stone's surface (80 %) erosion caused by wind, water erosion, temperature change can be observed, which resulted into the formation of numerous cuts, cavities, splits, minor and large cracks. Marks of mechanical cleaning of the stone: deep even furrows all over the plane.

**Cracks:** two deep cracks, which can lead to chipping off the substantial part of the block; numerous small and internal cracks

**Contamination:** there are splashes of black and red paint on the internal side of the portal; green cement addition, black patina

**Additions:** 11 panels of yellow and grey alabaster. The state of panels is stable. Between the block and the entrance door there is a gap all over the height of the block filled with cement mortar

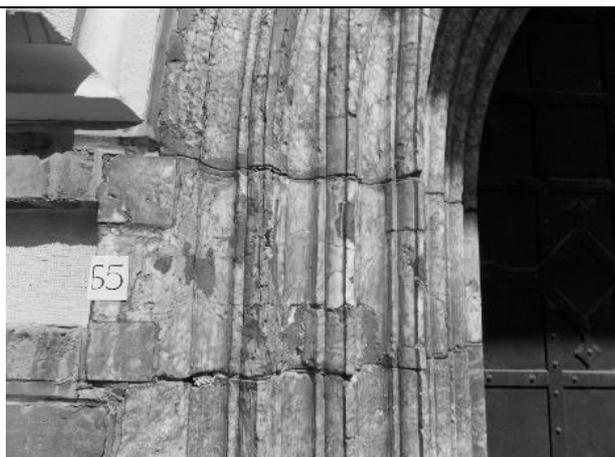
**Block No. 5**

Alabaster molding block, consists of five ribs.

**State:** unsatisfactory

**Losses:** a part of the yellow alabaster panel chipped off

**Deterioration:** erosion on the surface of the stone; the surface is uneven and rough, entirely covered with cavities, furrows; there are marks of coarse sandpapering of stone

**Cracks:** seven large deep cracks, which can lead to chipping off the substantial part of the block. Numerous minor, small and internal cracks.

**Contamination:** there are spots of black and red paint on the internal side of the portal; green cement addition, black patina

**Additions:** Six cement mortar additions. Between the block and the entrance door there are a gap, joints, cracks, cavities filled with cement mortar

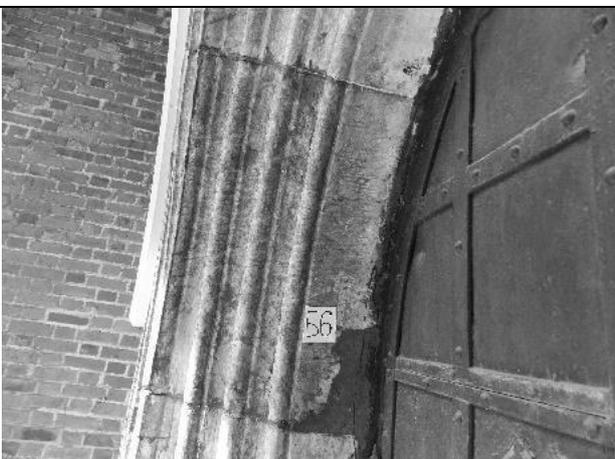
**Block No. 6**

Alabaster molding block, consists of five ribs and intersecting crossings to the next block.

**State:** unsatisfactory

**Losses:** part of the fifth molding

**Deterioration:** erosion of the surface of the stone, numerous cavities, cracks, furrows, and the surface is uneven and rough. There are flat horizontal furrows on the jamb of the portal. They are supposedly the marks of the tool, which remained after the stone dressing.

**Contamination:** there are spots of black and red paint on the internal side of the portal; green cement addition; black patina; yellow, white and orange spots; on the jamb surface of the portal lime or gypsum mortar was detected.

**Additions:** Between the block and the entrance door there are a gap, joints, cracks, cavities filled with cement mortar. Cement additions are also on the ribs of the portal.

**Panels:** five alabaster panels

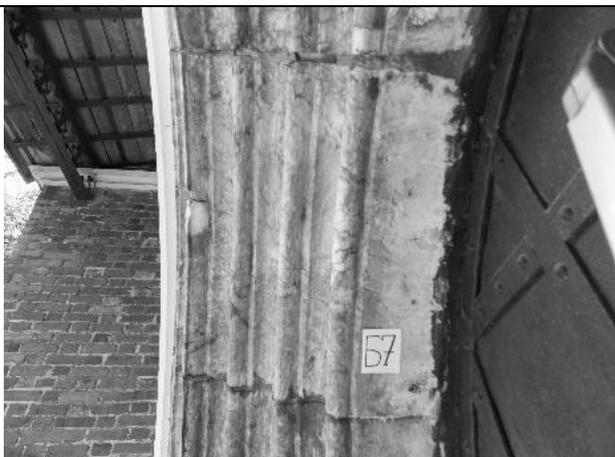
**Block No. 7**

Rounded block consists of seven ribs. Profile of the ribs has a bead molding shape.

**State:** unsatisfactory

**Losses:** not detected

**Deterioration:** mechanical deterioration – splits, erosion of the surface of the stone, numerous cavities, cracks, furrows

**Cracks:** three large cracks, which can lead to chipping off elements of the block

**Contamination:** most of the surface of the stone is covered with yellow spots, splashes of cement mortar; jamb of the block is rubbed with gypsum mortar

**Panels:** six alabaster panels of different colour

**Additions:** there is an addition of gypsum and cement mortar on the fourth rib. The crack on the third rib is filled with cement. Between the block and the entrance door there is a gap all over the height of the block, joints

<p>between the blocks are filled with cement mortar. There is a sample of two kinds of cement mortar with different content of impurities between the seventh and the eighth blocks, which can be a result of the restoration work in different periods</p>
--	---

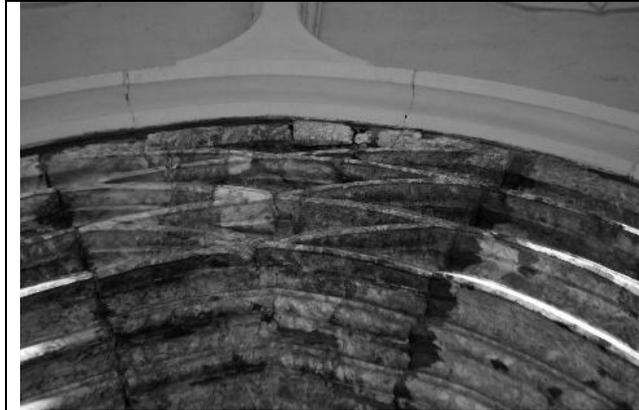
**Block No. 8**

Keystone of the portal with intersecting ribs, which create a diamond pattern.

**State:** unsatisfactory

**Losses:** part of the ribs at the intersection of the fourth row of ribs

**Deterioration:** mechanical deterioration – splits, erosion of the surface of the stone, numerous cavities, cracks, furrows; the stone is uneven and rough. There are deep furrows, which can be a result of the mechanical cleaning with metal brushes

**Cracks:** deep cracks between the alabaster panels and the authentic stone, deep crack on the second rib, which can lead to chipping off most of the block, numerous small cracks.

**Contamination:** splashes of cement mortar, yellow spots, black patina. Part of the cement additions between the block and the entrance door is in black, red and green paint.

**Panels:** ten alabaster panels of different colour – yellow, white, grey – fixed on the cement mortar. There is an inserted wood peg between the fifth and the sixth rib, polished as a profile shape.

**Additions:** cracks, joints between the blocks, a gap between the block and the entrance door filled with cement mortar

The fourth reason is mechanical loading, which results into the formation of deep and large cracks. The biggest loading falls on the upper keystone part of the portal, which is now in the critical condition.

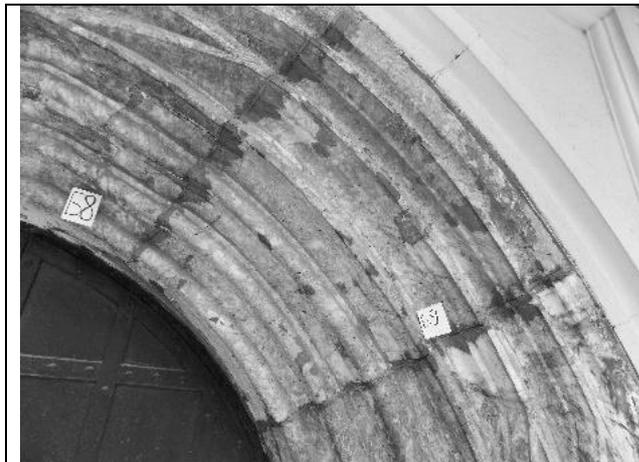
**Block No. 9**

Rounded block consists of seven ribs. Profile of the ribs has a bead molding shape.

**State:** stable

**Losses:** small piece of the sixth block is lost

**Deterioration:** deep flat furrows are cut horizontally on the jamb of the block in a chaotic order; there are also numerous furrows on the surface of the stone, which can be a consequence of the mechanical cleaning with metal brushes. Erosion of the surface of the stone, numerous cavities, cracks, furrows, and the stone is uneven and rough. The jamb of the block is far whiter than the natural colour of the stone, the reason of such state of the stone is unknown.

**Cracks:** four deep cracks, numerous minor and small cracks. There are also cracks in the cement addition between the block and the entrance door.

**Contamination:** yellow spots, black patina. A part of the cement additions between the block and the entrance door is in black, red and green colour.

**Panels:** three alabaster panels

**Additions:** numerous minor additions of cement mortar on the ribs of the block; also, on the entire surface near

the junction of the eighth and the ninth block, between the jamb of the portal and the entrance door a gap is filled with cement mortar
--	---

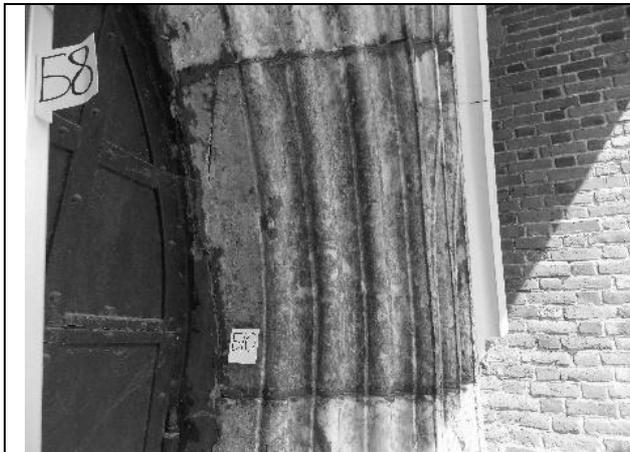
**Block No. 10**

Alabaster molding block, consists of five ribs and intersecting crossings to the next block.

**State:** stable

**Losses:** not detected

**Deterioration:** deep flat furrows are cut horizontally on the jamb of the block in a chaotic order; there are also numerous furrows on the surface of the stone, which can be a consequence of the mechanical cleaning with metal brushes. Erosion of the surface of the stone, numerous cavities, cracks, furrows

**Cracks:** seven large deep cracks (the biggest cracks are on the jamb of the block all over its height, as well as between the first and the second ribs over the block's height), numerous small and big cracks, which can lead to destruction and chipping off part of the block.

**Contamination:** yellow spots, black patina, a part of the cement additions between the block the entrance door is in black, red and green colour

**Panels:** four alabaster panels of different colour – yellow, green, white

**Additions:** cement additions on the ribs of the block near the junction of the eleventh and the tenth blocks over its breadth; all ribs in the lower part are supplemented with cement mortar, also a gap between the entrance door and the block; grouted joints and cracks. Cement additions fissure and come off the stone, cracks in the cement are filled with cement mortar again. There are as well cement mortars with different content of impurities

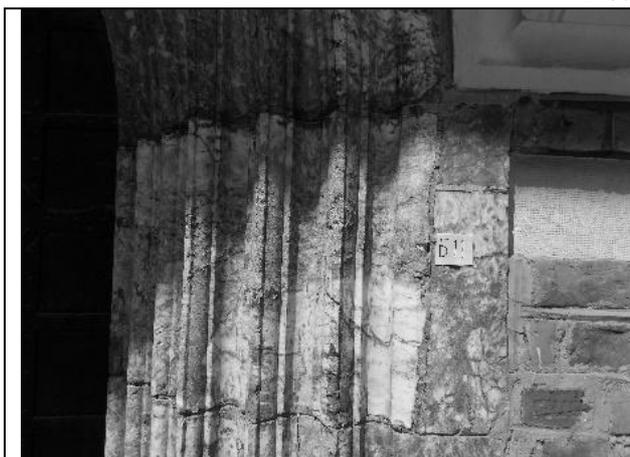
**Block No. 11**

Alabaster molding block, consists of five ribs

**State:** unsatisfactory

**Losses:** not detected

**Deterioration:** stone stratification, mechanical damages, numerous splits, deep flat furrows are cut horizontally on the jamb of the block in a chaotic order, there are also numerous furrows on the surface of the stone, which can be a consequence of the mechanical cleaning with metal brushes. Erosion of the surface of the stone, numerous cavities, cracks, furrows

**Cracks:** six large deep cracks, which can lead to chipping off considerable part of the block. Numerous minor and small cracks.

**Contamination:** yellow spots, black patina, a part of the cement additions between the block the entrance door is in black, red and green colour

**Panels:** five alabaster panels of different colour – white, grey

**Additions:** three small cement additions on the ribs of the block, as well as between the entrance door and the

block; grouted joints and cracks. Cement additions fissure and come off the stone, cracks in the cement are filled with cement mortar again. There are as well cement mortars with different content of impurities
--	--

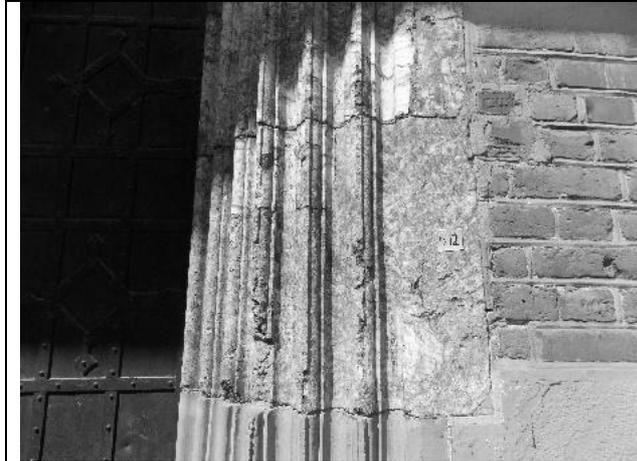
**Block No. 12**

Alabaster molding block, consists of five ribs

**State:** unsatisfactory

**Losses:** considerable part of the fourth rib of the block is lost. A part of the ruined block (the fourth one) was supplemented with the alabaster panel, which is lost as well. There are preserved marks of panel mounting: four hewn rectangular chamfers and cement mortar on which the panel was fixed. A little fragment of the third block is lost too.

**Deterioration:** stone stratification, mechanical damages, numerous splits, deep flat furrows are cut horizontally on the jamb of the block in a chaotic order, there are also numerous furrows on the surface of the stone, which can be a consequence of the mechanical cleaning with metal brushes. Erosion of the surface of the stone, numerous cavities, cracks, furrows

**Cracks:** four deep cracks, the biggest one is on the jamb of the block and follows all over its height

**Contamination:** yellow spots, splashes of green and red paint, a part of the cement additions between the block and the entrance door is in red, green and black colour.

**Panels:** four alabaster panels of different colour – grey and white

**Additions:** a gap between the entrance door and the block, joints between the blocks, cracks and splits are filled with cement mortar

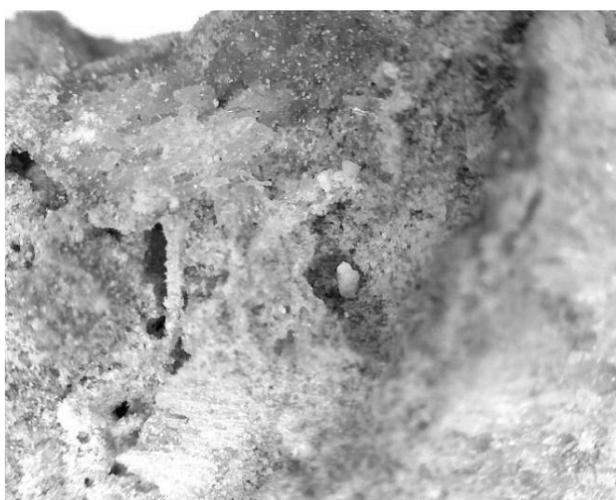
**Fig. 5.** Block 11. Sample XV. Clearly outlined structure of the alabaster crystals. Finely crystalline structure. Small content of clay impurities and veins of fibrous selenite

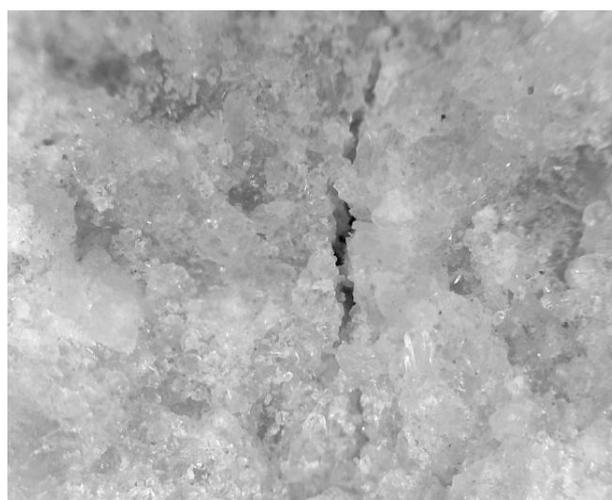
**Fig. 6.** Block 7. Sample XI. The process of water erosion and void formation was observed, which caused the cracks in the stone

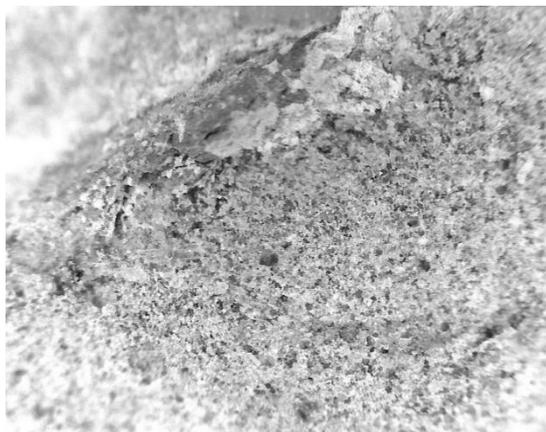
**Fig. 7.** Block 6. Sample IX. Lime and sand content is bigger than cement content. Mortar structure is porish

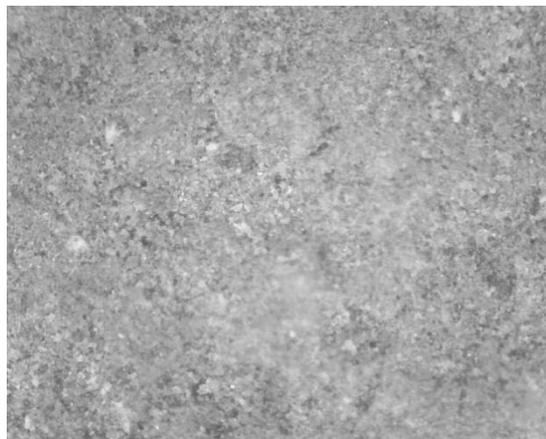
**Fig. 8.** Block 1–2. Sample XIX. Impurities of brick powder and lime
