Bohdan Demchyna¹, Leonid Vozniuk², Mykhaylo Surmai¹

CONDITIONS OF EXISTING RESIDENTIAL BUILDINGS 50–60 YEARS AND MISTAKES OF THEIR CONSTRUCTION

Lviv Polytechnic National University,

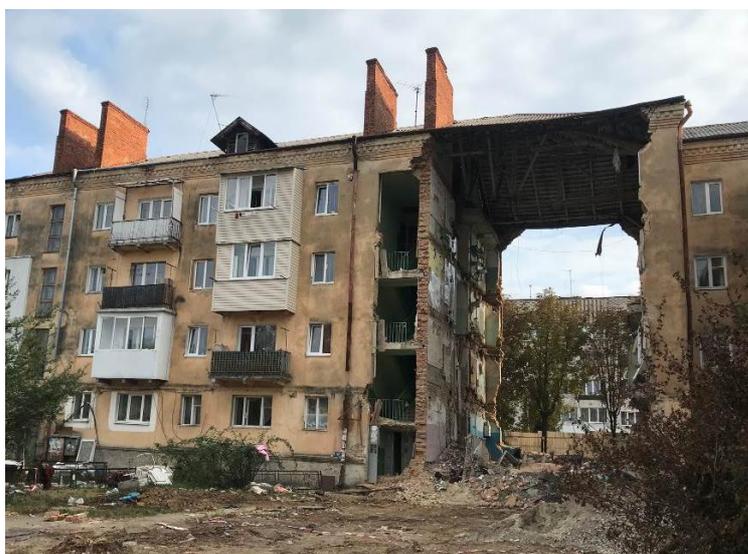
- collapse of building structures of a part of a building of all 4 floors (Fig. 2);
- basement walls and basement walls, no waterproofing;
- visible loss of stability of the middle bearing wall of the basement, vertical cracks in the wall with opening up to 10 mm in height of the bearing brick wall with the destruction of the masonry (Fig. 3). No brickwork of the basement walls. Wrapping of walls, vysolyas, fungus damage, destruction of bricks, as well as weathering and loss of strength of seam solution;

Fig. 2. The collapse of part of the building

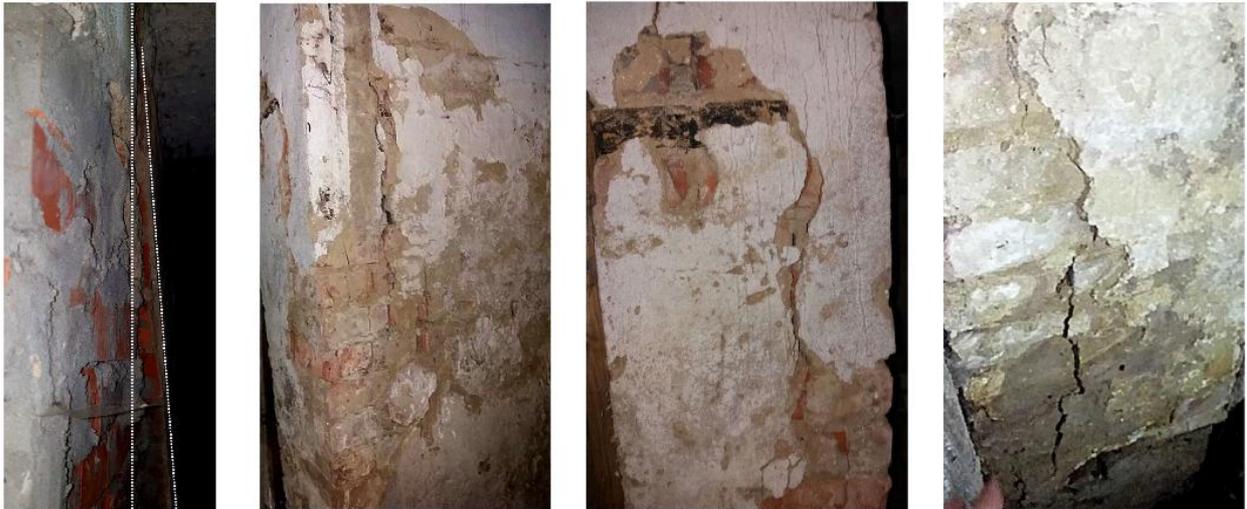
Fig. 3. Visible loss of resistance, as well as vertical and horizontal cracks in the middle bearing wall on axis B in axes 6–8

- low grade of brick and mortar, which is confirmed by laboratory tests.

As can be seen from the calculations – the compression stresses that occur in the walls of the middle bearing wall of the right side of the building, along the axis B in the axes 6–8, significantly exceed the bearing capacity of the brickwork. This phenomenon is also confirmed by the results of the survey of the building where the emergency walls were identified (Fig. 3).

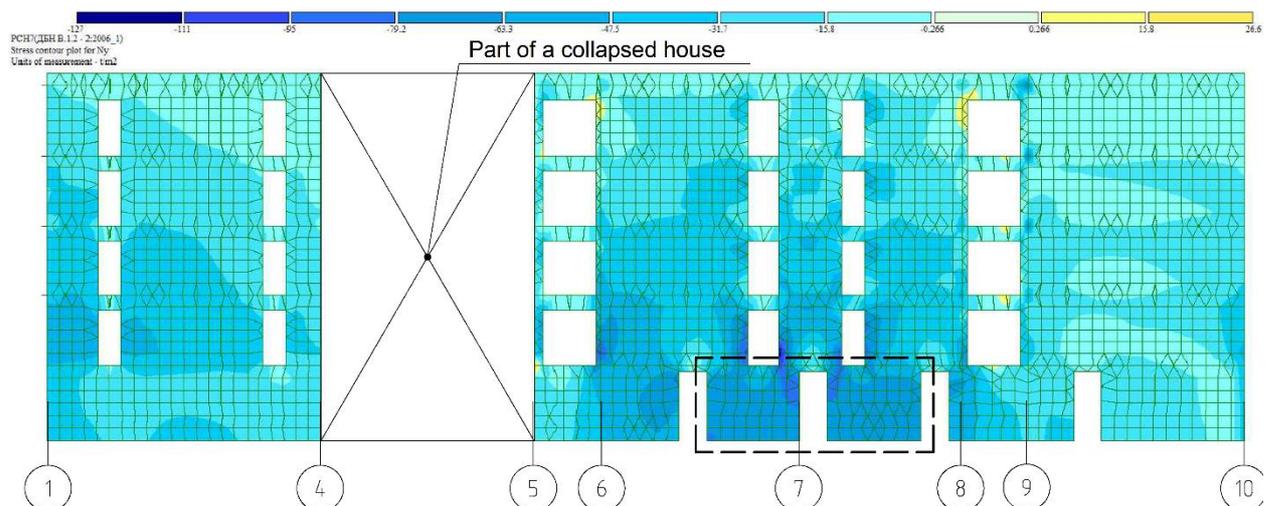
The design models of the right and left parts of the building were created, on the basis of which the distribution of stresses in the middle bearing and the most loaded walls of the right part, along axis B, in axes 1–10 (Fig. 4) was obtained.

Fig. 4. The distribution of stresses in the middle bearing walls along the axis B, in the axes 1–10, after the collapse

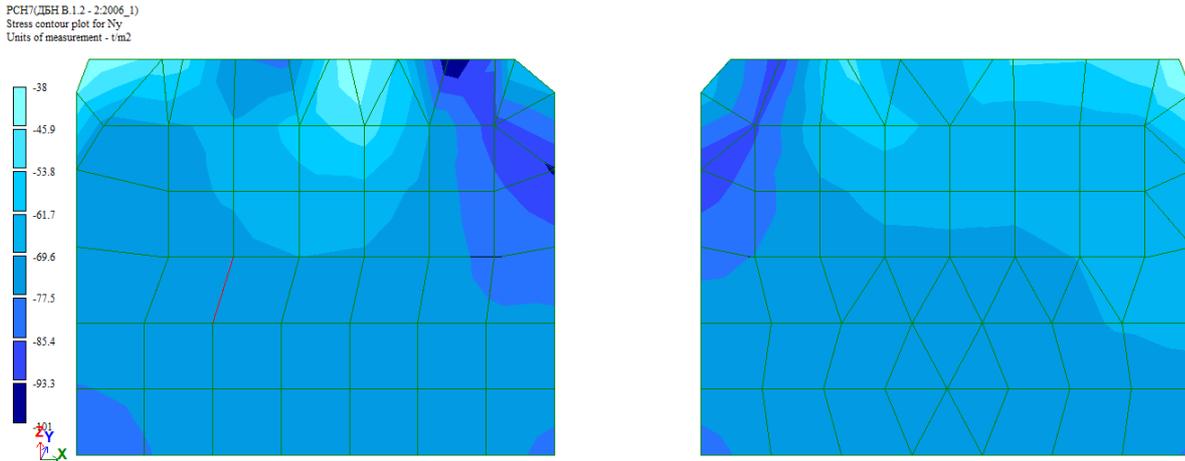
Fig. 5. Distribution of stresses in the basement walls of the right part of the building along axis B, in axes 6–7 and 7–8

The maximum stresses in the basement walls along axis B, in the axes 6–7, 7–8 exceed the allowable values of compressive strength of masonry $R = 29,56 \text{ t/m}^2$.

$$N_y = -38 \dots -101 \text{ t/m}^2 > R = 29.56 \text{ t/m}^2.$$

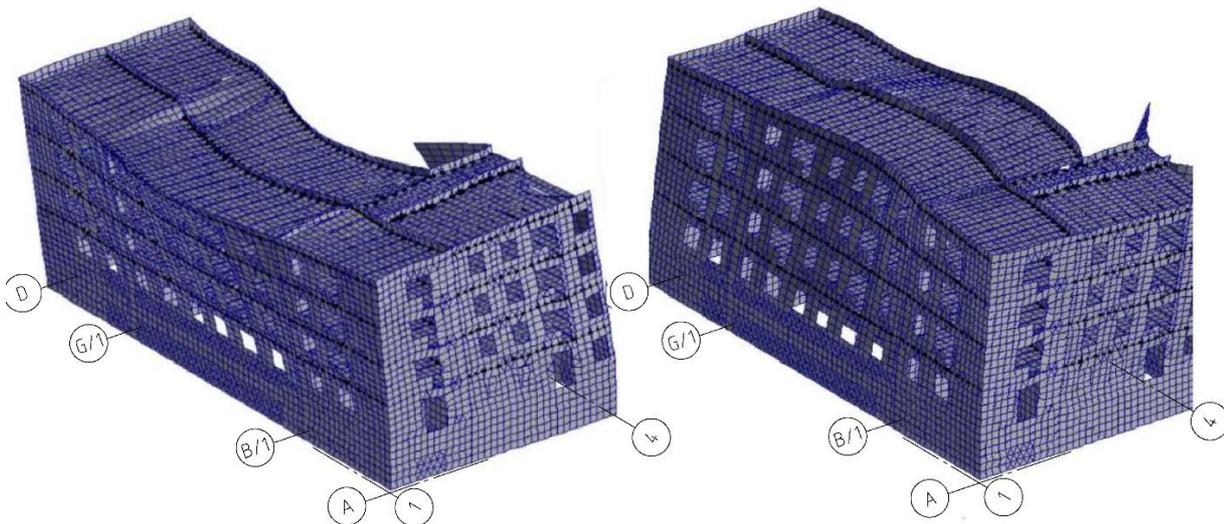
To analyze the possible impact of the collapse on a part of the building, in axes 1–3, AD, a dynamic calculation was made of the possible impulse that caused the collapse, which allowed to obtain the character of the movement of the building structures from fluctuations, in particular in Fig. 6 shows the nature of the movement from the 2nd translational form of oscillations.

Fig. 6. The nature of the movement of building structures of the left part of the house after the collapse of the 2nd translational oscillation

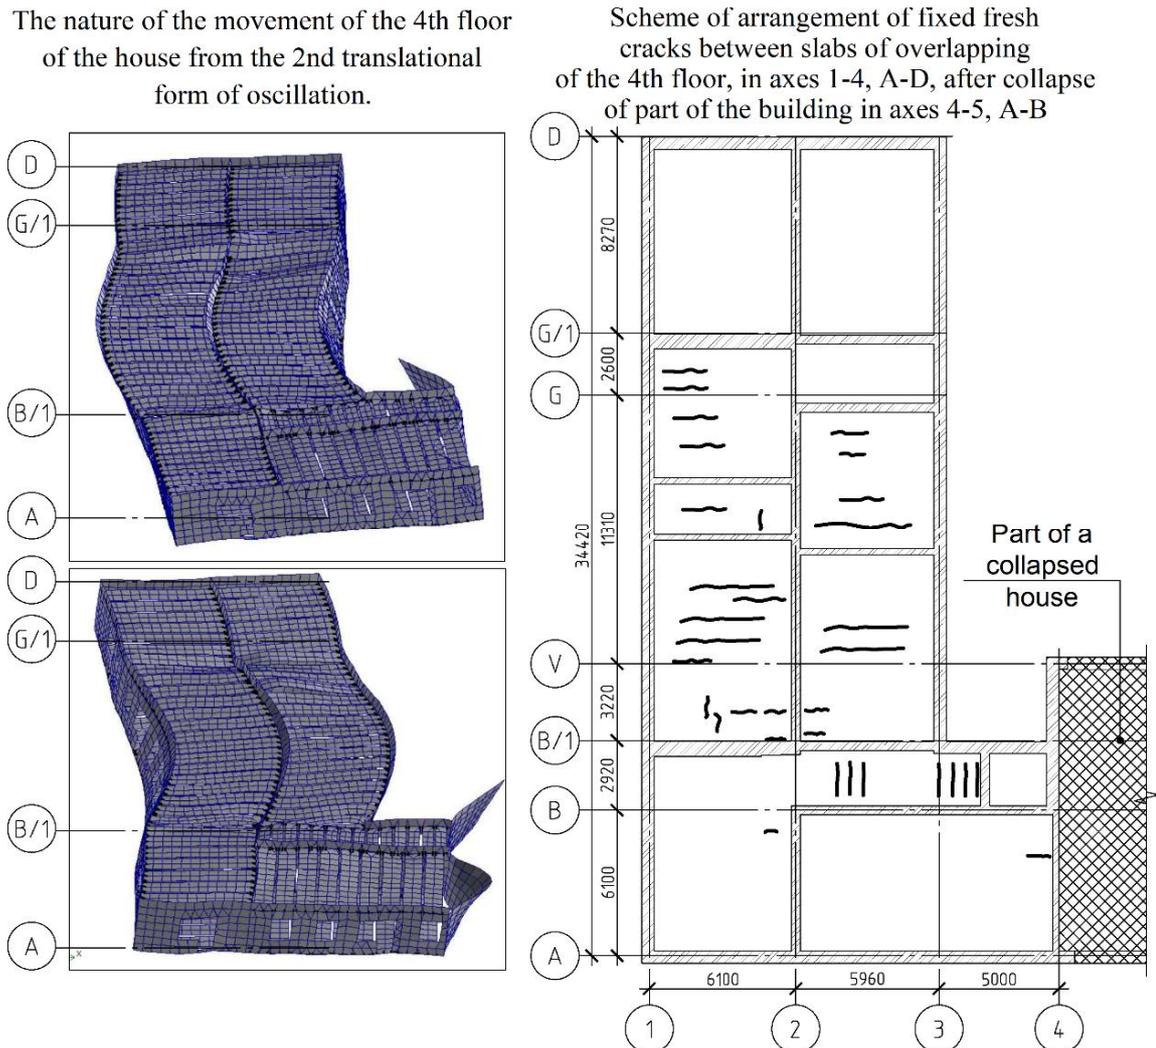
Such character of displacements is confirmed by the results of the survey presented on the scheme of location of defects with fixed fresh cracks between slabs of overlapping and at the top of partitions at the junction with the overlapping disk of the 4th floor of the left part of the building (Fig. 7).

Fig. 7. Comparison of the nature of the movement of the building structures of the left part of the house after the collapse from the 2nd translational oscillation with the actual placement of fresh cracks formed after the collapse of part of the building

Throughout the building, there are cracks under the floor slabs in the ceiling, as well as fresh cracks between the seams of the floor slabs, indicating the movement and disturbance of the flooring discs due to the impact caused by the collapse of the structures in axes 4–5, AB. These defects were further confirmed by the results of the dynamic calculation, using the finite element method in the PC “Monomakh-SAPR”, which allowed to obtain a similar nature of the movement of the overlapping disks of the building.
