¹Esmeralda Paupério, ²António Arêde, ³Rui Silva, ⁴Susana Moreira
CONSTRUCT-LESE, Faculty of Engineering, University of Porto, Porto, Portugal

CROSS-BORDER FORTRESSES IN PORTUGAL; INSPECTION AND DIAGNOSIS

Keywords: *Structural inspection, structures, defensive walls, forts.*

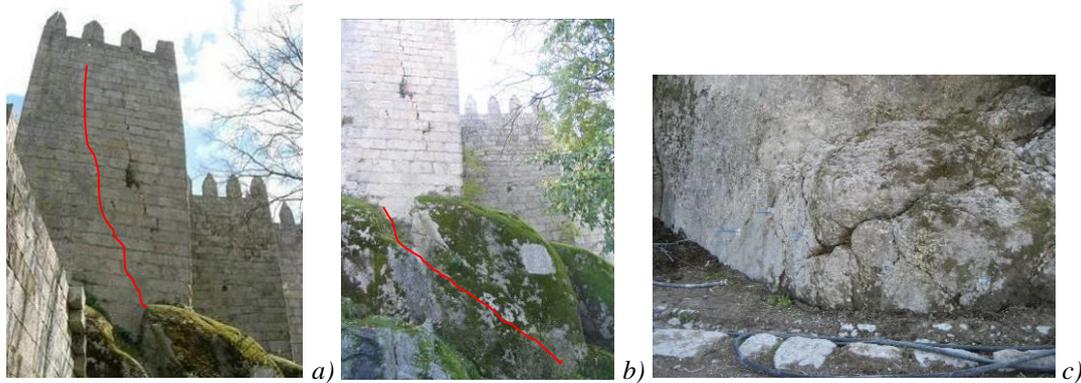
Fig. 9. a) Corner detachment; b) fracture of the support massif; c) severe degradation of the base support of the rock massif.

After the inspection, the constructive elements considered most affected were the T1 tower and the A fortress wall, for which urgent intervention was recommended. Particularly for the T1 tower, which presented joint openings with a V-shaped development (with apex at the corner base) and corner detachment by rotation, further studies were carried out. On the north face of the same tower, simultaneously with the joint opening, localized fracture of some ashlar stones was also observed, probably due to stones' compression crushing

caused by the stress increase resulting from the corner rotation. As causes of these damages, alterations to the rock mass outcrop were pointed out, since both the T1 tower and the other towers and walls of the Guimarães Castle are founded thereon, Fig. 9. This rock mass, which is almost 3.5m high in the support area of the T1 tower corner, presents an apparent joint/fracture and severe degradation at the base. The fracture positioning in the rock mass is in line with the direction of the joint opening observed in the North facing, where it is more pronounced.

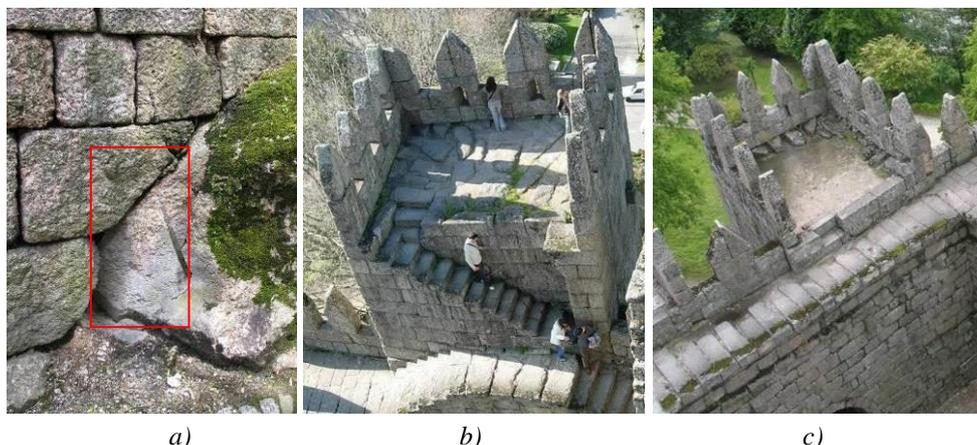
Fig. 10 (a) Mark of rock cutting with a dynamite stick; (b) Tower T1; (c) Tower T2

A closer look at the rock masses supporting the castle structures revealed that these were vertically cut, apparently by using dynamite, as suggested by the visible marks. These cuts, carried out within the scope of the urban arrangement of the castle surroundings in the mid-1940s, weakened the rock masses, in some cases leaving them supportless. In addition to the changes in the support conditions of the structures, the rock masses became even more vulnerable to erosion effects due to changes in the conditions of rainwater drainage. Therefore, it is considered that these cuts were responsible for some of the damage observed in the towers and walls, namely the detachment of the corner of the T1 tower. Fig. 10 a) shows a hole in a rock mass that might have been done to introduce a dynamite stick, as often used for thinning and cutting rock masses. Fig. 10 b) and c) presents images of the T1 and T2 towers that allow the visualization of the type of structure of the towers. During the inspection, and because it was considered to be an indispensable element, a survey of the dimensions of the T1 to T8 towers was carried out. Due to lack of knowledge on the construction process inside the towers, it was necessary to make a specific survey in the T1 tower (Arêde an others, 2017) in order to determine the face type and thickness of the wall, as well as the constitution of the interior filling; the location of the survey is indicated in Fig. 11 a). It is worth mentioning that part of this tower development height wise was rebuilt during interventions carried out by the former historic heritage institution called “National Monuments” in the mid-1930s/40s.

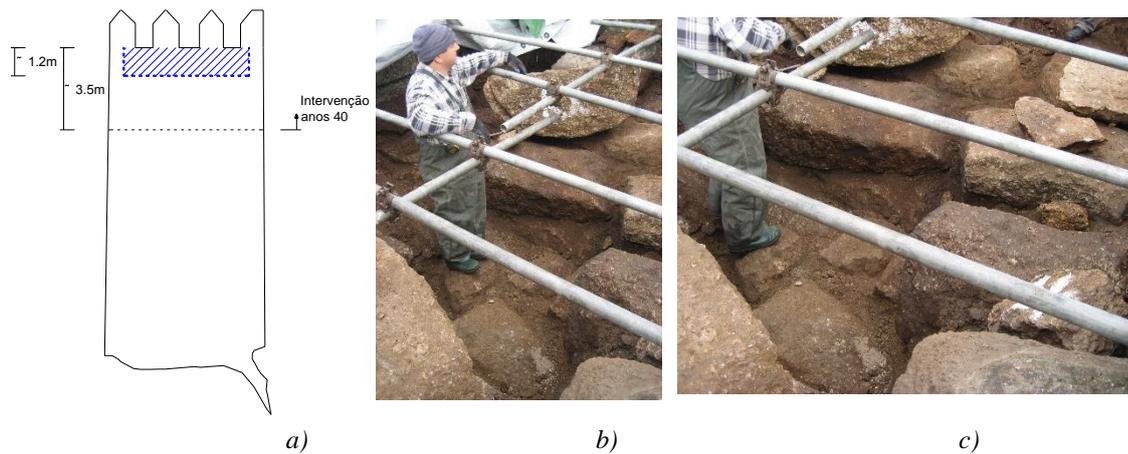
Fig. 11. Surveys on the top of Tower T1

The survey carried out at the top of the tower, Fig. 11 b) and c), allowed to verify that the constructive process of the tower's facades is carried out in rows of granite stonework of about 50 cm, made of stones of approximately 50 x 60/65 cm² and with variable length between 100 cm and 140 cm. The stones' positioning in the wall face alternates between the stone placed in a row and the stone to bond faces. The infill of the tower is completed with smaller granite stone and apparently black earth.

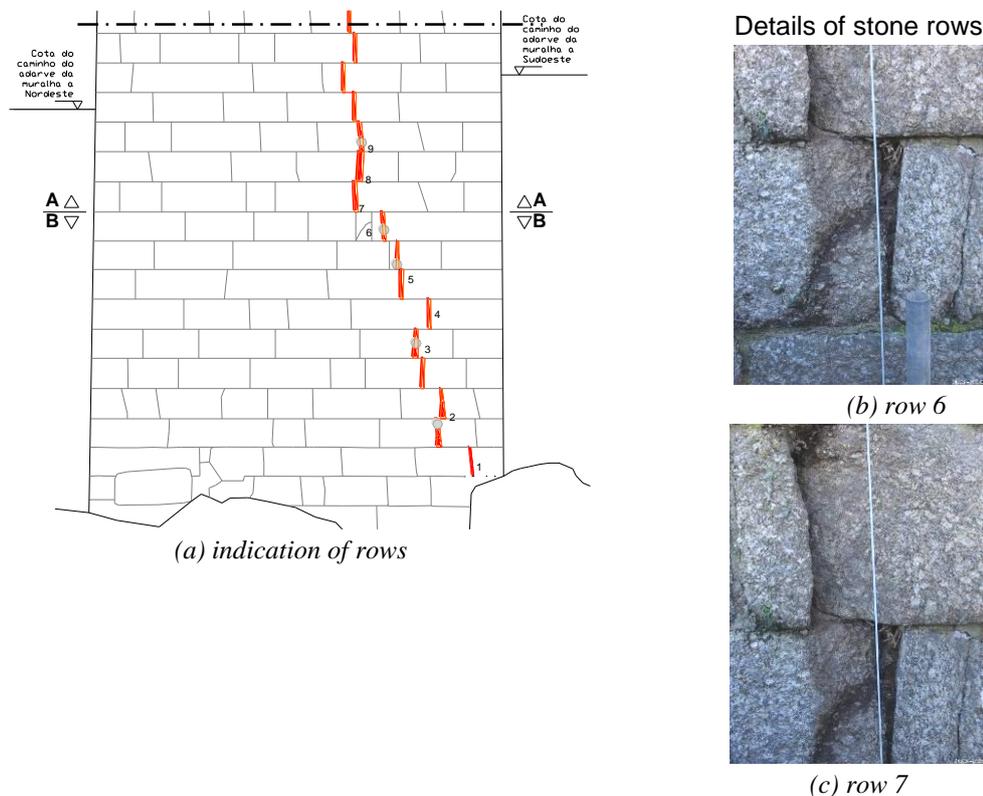
Fig. 12. Geometrical survey of the cracks of the North façade of tower T1

In the walls' faces and in the weakest area of the North façade, a survey of the joint openings and the observed cracking was carried out. In this survey, performed by stonework rows that were numbered from the base to the top, the wall thickness was also assessed, whenever possible. The introduction of a rod in the joints, allowed to see that, in some places, it entered about 2.0 m into the tower interior.

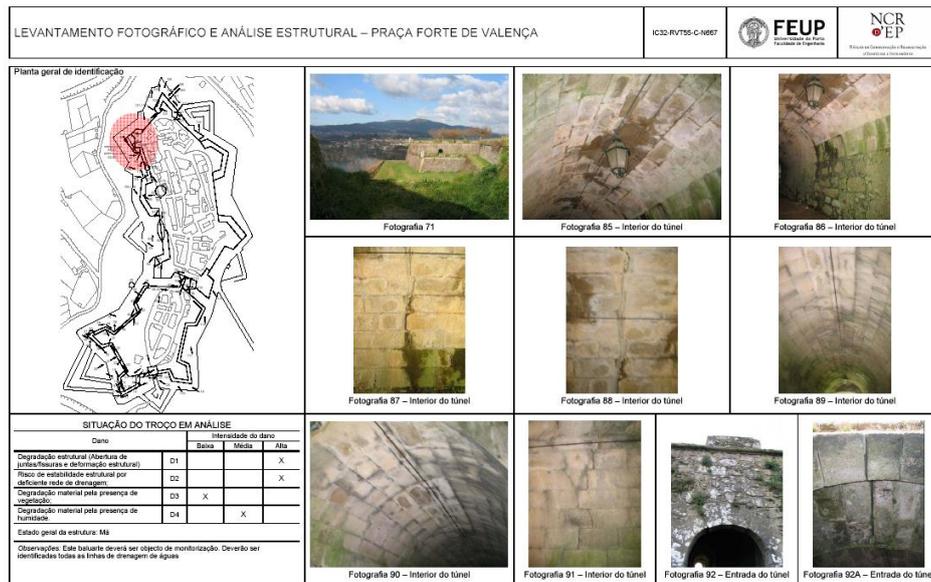
Fig. 14. Example of a photographic survey and structural analysis.

For larger structures, whether with high wall sections and/or at various levels, a photographic survey and a structural analysis were carried out by sections, Fig. 14. For each section under study, identified in a plan, in these forms it is shown a photographic record and a summary table that relates the damage recorded in the structure and its intensity of occurrence (low, medium, or high). In this way, in addition to the damage forms, a much more intuitive relationship is obtained between the damage, its intensity, and the place of occurrence, allowing for a more effective general identification of the state of conservation of the structure and the determination of critical points. It is noteworthy that, currently, the external slopes are not considered as an integral part of the structure and therefore, generally present a very poor maintenance. This situation is exacerbated by the indiscriminate cuts, resulting from the opening of streets or the execution of nearby constructions, this being a factor that enhances structural instability.

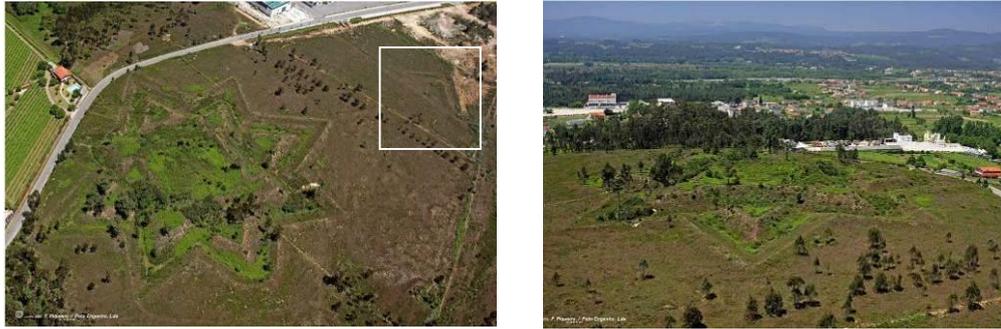
Fig. 15. Views of the Gandra Fort.

Thus, ingeniously, the well-worked and compacted soil materials were transformed into important defense and attack strongholds, with self-supporting slopes that, later, if the situation so required, could be lined with granite stonework. Of these forts, reference is made to the fort of Gandra, already identified in Figure 5 and shown again in Fig. 15, where, in addition to the well-defined star and with a point already cut by a road, it can still be seen what may have been a trench in an advanced line, this being the only trace that this fort would have dimensions much larger than what is presently seen. In an oblique photograph and taking the construction on the right side of the road as the scale, it can be assessed the dimension of the slopes of these structures.

Associating the war theories with the material that was at hand, an effective construction technique was achieved: the mixing and crushing of the “torrão”, eventually with some watering of the final layer, which translates into a material with good consistency and with a waterproofing protective layer that prevents its breakdown. Any intervention carried out in these forts will have to go through the preservation of the construction material and the filling of the existing holes with the original material, and not the uprooting of vegetation that favors the disaggregation of this material.

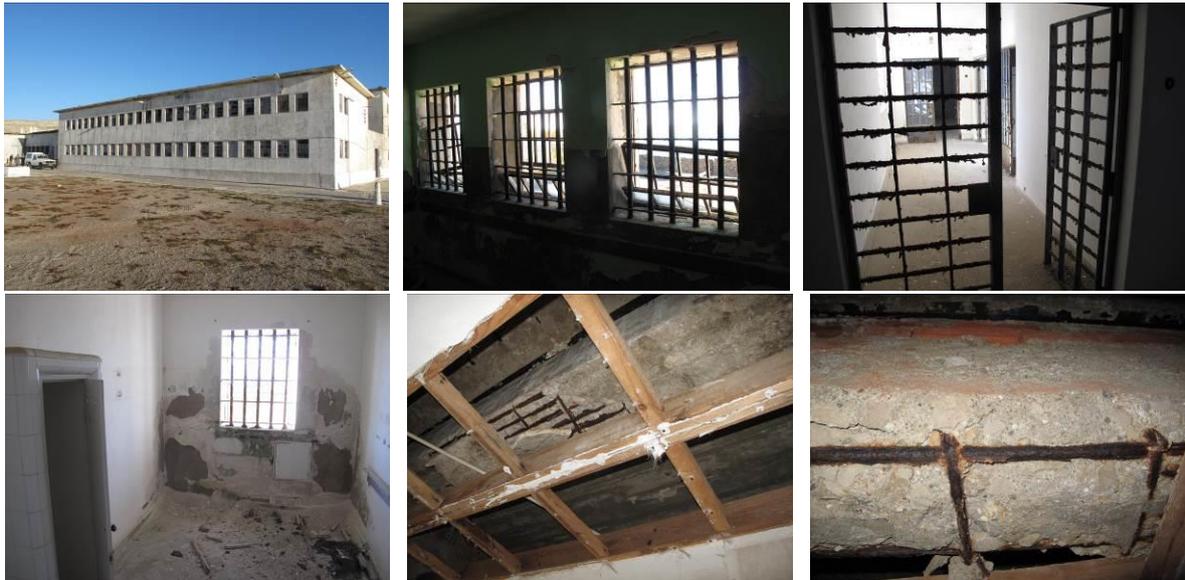
Fig. 20 – Former political prison buildings and their material/structural degradation
