REPRODUCTION OF THE LOST MONASTIC COMPLEXES OF OSBM

Abstract. The degree of the Basilian monastic complexes preservation in general and each object in particular is being investigated and the possibilities of their reproduction with adaptation to the original function are determined in the article.

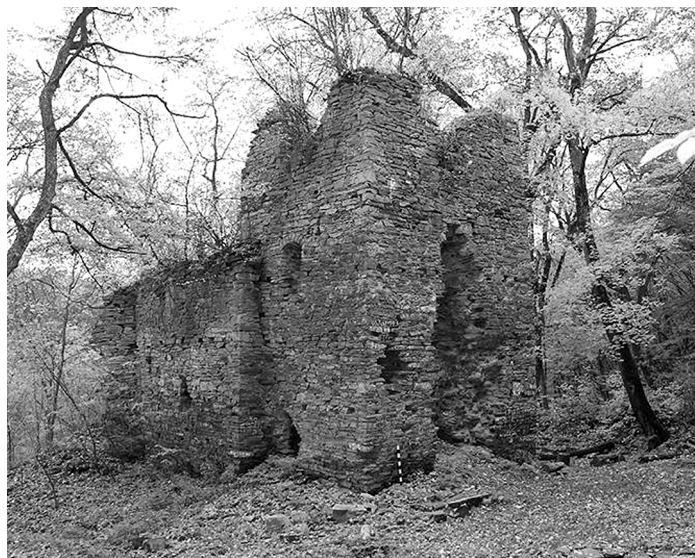
Fig. 3. The church's ruins in the tract Monastirok.
Photo 2014

The monastic church in the tract Monastirok, which is 2 km to the south of Buchach, is located on a rocky hill on the right bank of the Stripa River, has also survived to this day only in ruins (Fig. 3,4). The massive walls with the thickness of 1,7–1,8 m testifies of their defensive character. The temple is three konh with a rectangular porch and a high tower-bell tower over it. The height of the walls of nave and konh reaches 9

meters. The eastern part of the temple was completed by the apse conch, the two smaller conches emerged from the southern and northern walls of the church. The width of the apse is approximately equal to the nave width. Two narrow, high windows with semicircular jumper cut through the southern wall and one round window cut through the southern konh. The apse and the northern wall of Navi and the northern conch are without windows. Such construction of the northern facade was apparently due to the defensive needs – the northern wall of the church was turned towards the monastery gate, from where the enemy was expected to attack. The western facade of the temple completed a square in the plan tower-bell. The main defensive function was performed by a tower, approximately 15 m high, in the western wall of which was the entrance of the temple. Above the entrance there were two battle tiers, with one loophole on each side of the tower. A staircase, arranged in the thickness of the stone wall of the tower provided the connection between the tiers. Till now, only the church has gone to ruins. Such type of monuments is one of extremely rare in Ukraine. This monastery temple is of historical and artistic value and prompts the need for restoration measures to preserve it.

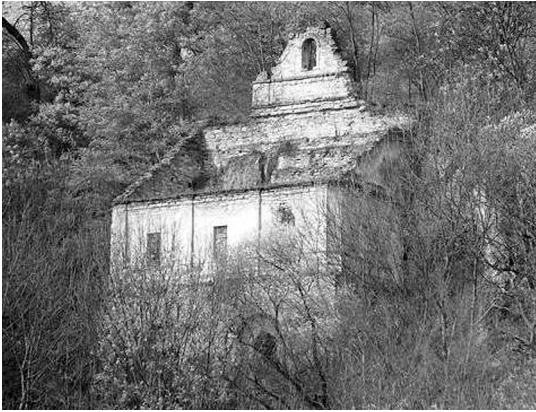
Fig. 5. Ruins of the monastery cave churches in Ulashkivtsi. Photo 2014

The new masonry monastery complex was built somewhat higher on a plain natural terrace in 1898 [7]. The ruins of the monastery cave church and the cell under it have survived to this day (Fig. 5, 6). To get to the monastic cave cells one has to climb the steep slopes. The monastery was located on the two levels. On the first tier of the caves there is a small cell with a window where the monks lived, overlooking the river Seret and the surrounding villages. The only entrance is covered due to the collapse. The church of Ivan the Baptist is added to the cliff. The cell located on the second tier, was really hard to get, as one need go down six meters deep into the cave with the help of the chain built by the local inhabitants. The cave monastery is belonged to those unique monuments which require an urgent systematic survey of open monastic objects, instrumental cave surveys and archaeological research, hence, any restoration measures for the preservation and restoration of the monuments have to be based on these investigations. We propose the following measures:

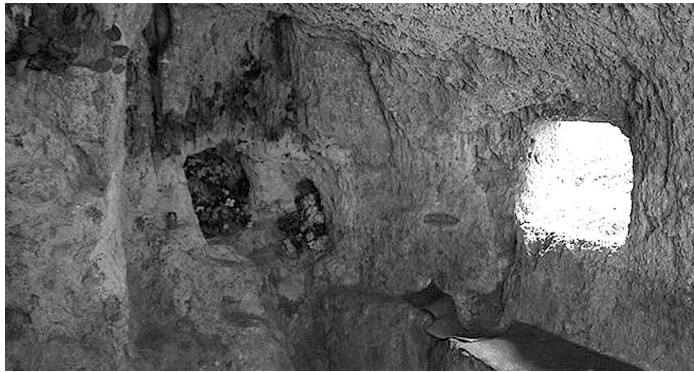
Fig. 6. Ruins of the monastery cave-cell churches in Ulashkivtsi. Photo 2014
