THE THEORY AND HISTORY OF ARCHITECTURE

Mykola Bevz

PAINTING DECORATIONS ON THE OUTSIDE WALLS OF THE CASTLES IN POMORIANY AND IN YAZLIVETS

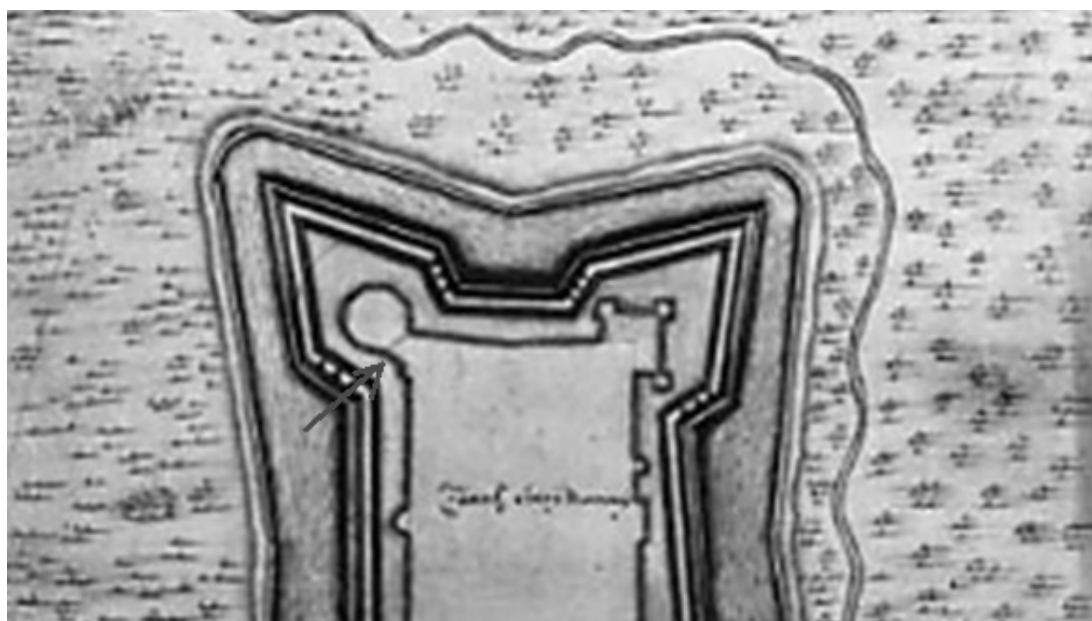
Fig. 2. Drawings of the fortifications of the Pomoryany castle taken from the work of Alexander Cholovsky.

In the northeast corner, a round tower with facets is marked. The western wall we are exploring is a preserved part of the “neck” to this tower. This wall is marked by an arrow

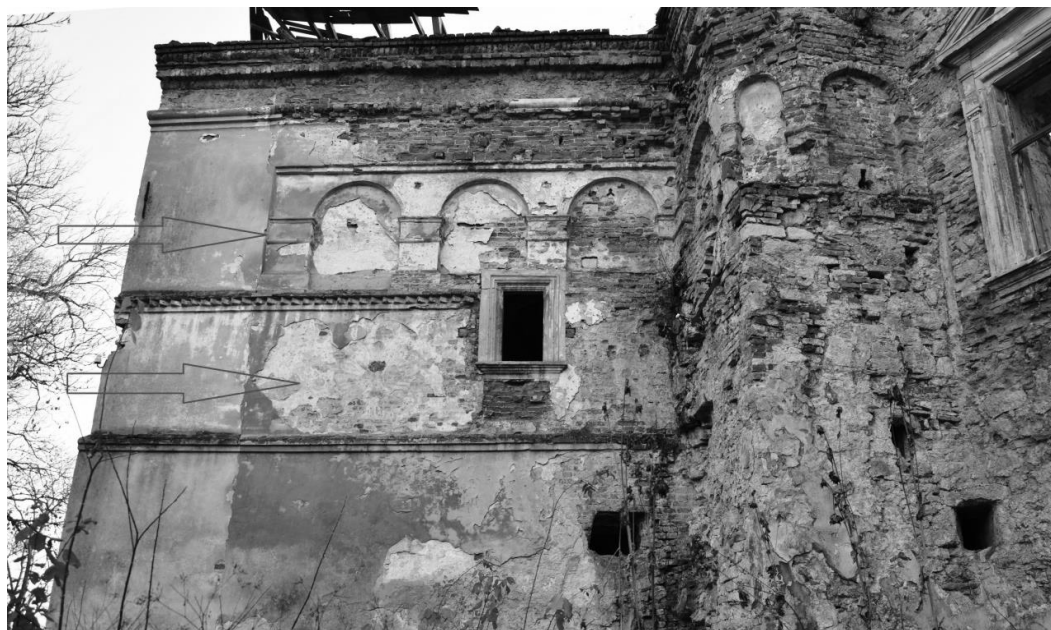
Fig. 4. The north wall of the corner tower of the Pomoryany castle.
The places where the polychrome paintings preserved are indicated with arrows

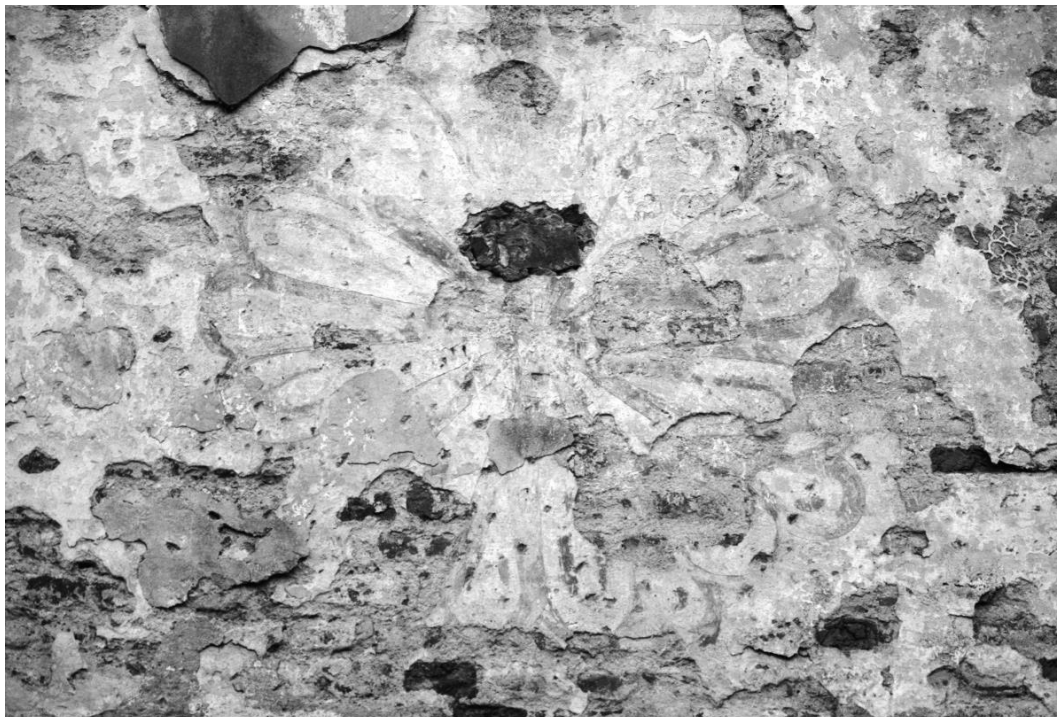
Fig. 5. A large rosette drawn on the 2nd tier of the outer wall of the corner tower of the Pomoryany castle

Red, grey and blue colours dominate in the paintings. The murals are in the state of an emergency. Most of them are lost, although preserved fragments can be used to reconstruct an integral image. The second tier of the tower was painted with rosettes almost two meters in size (Fig. 2), among which were drawn some geometric figures (Fig. 3).

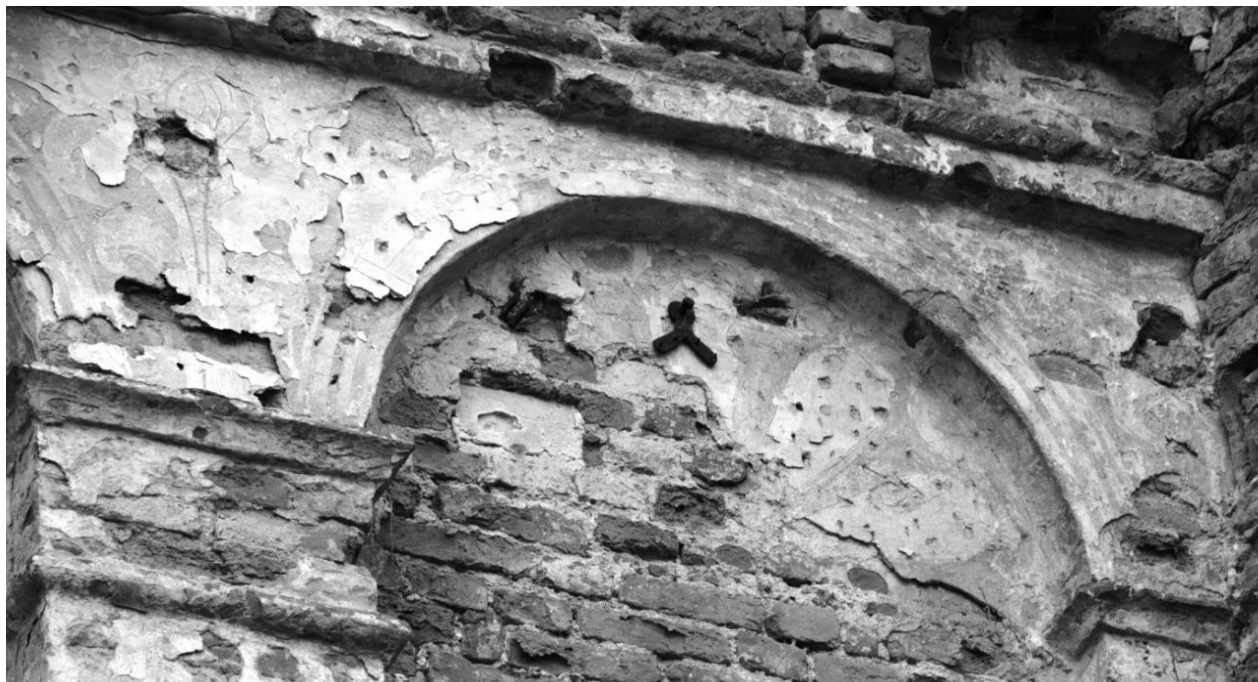
Fig. 7. Hand-drawn archivolts and half-rosettes in the arch belt on the 3rd tier of the outer wall of the tower. On the left side to the arch are fragments of a rose with branches

The third tier of the tower, which was built with a blind arcade, was also decorated with polychrome paintings. Their pattern corresponded to the arcade profiling of the wall. Under the arches were painted half-rosettes similar in style to those found on the 2nd tier (Fig. 4). The pilasters had hand-drawn fluting. Their traces are still barely readable. Above the arches, striped archivolts (at 7 belts) were drawn in detail. The triangular fields between arches above the pilasters are the most interesting: there is a large rose with symmetric branches. 30

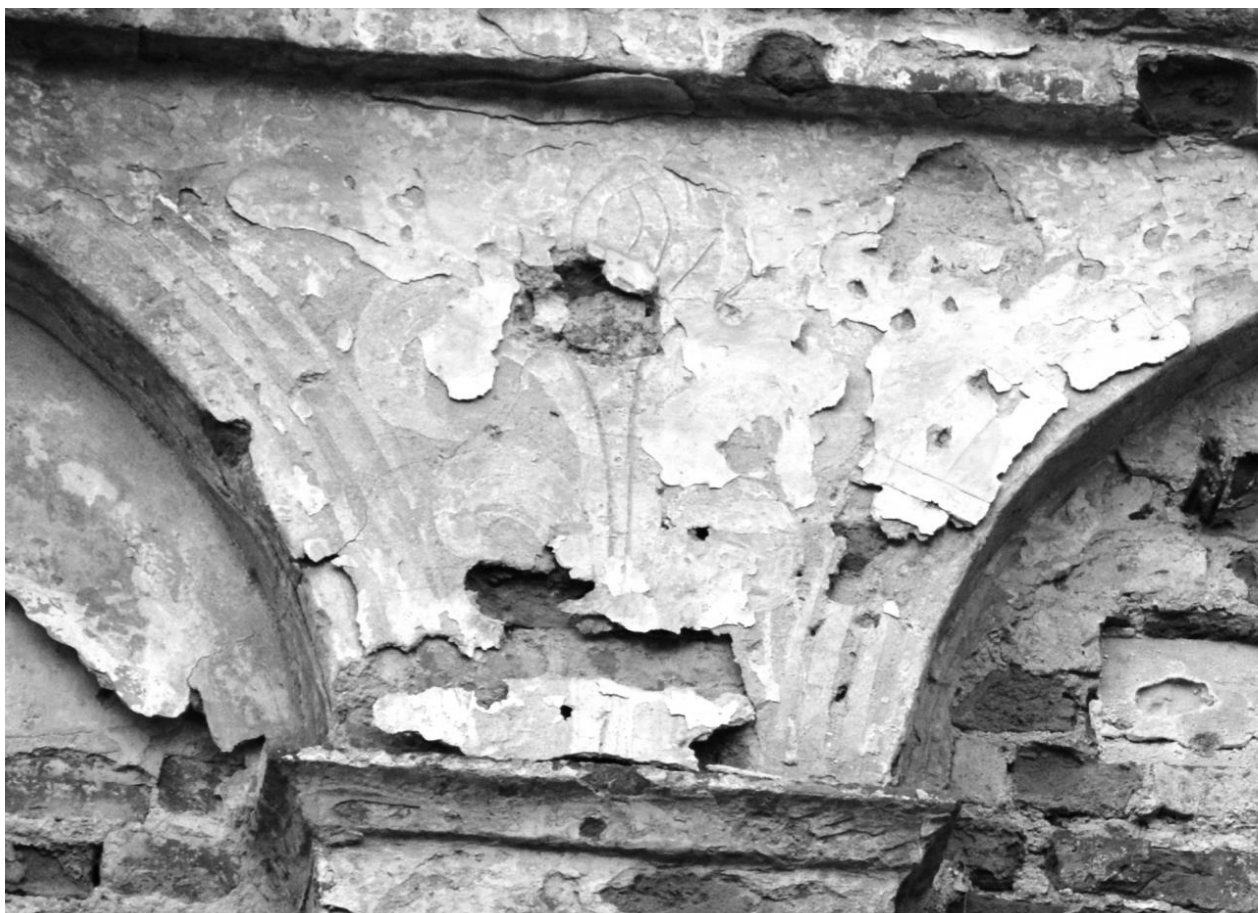
Fig. 8. Hand-drawn rose with branches on the 3rd tier of the outer wall of the tower

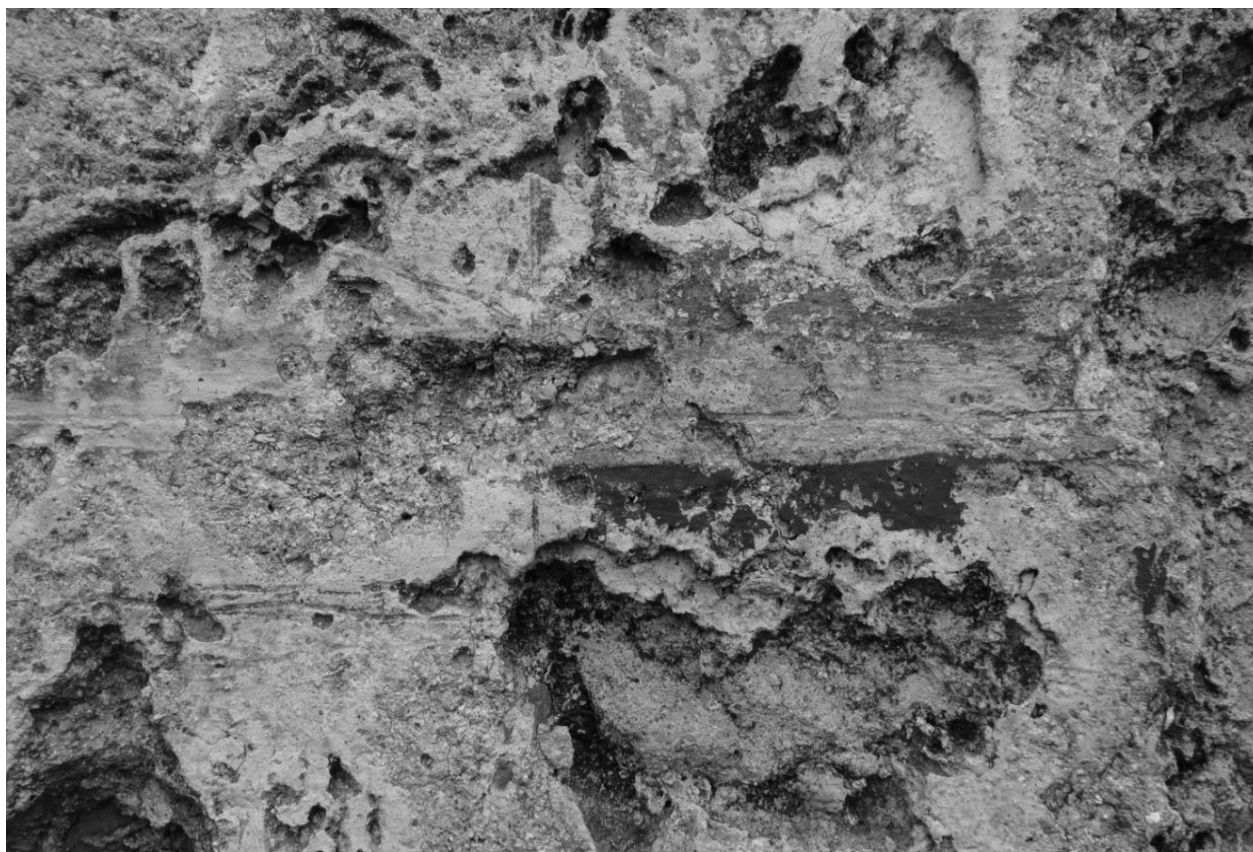
Fig. 11. Fragments of paintings at the outer wall of the castle in Yazlivets.

Unfortunately, only small fragments of polychrome survived, so it is unlikely to reconstruct the decoration. However, all fragments of the preserved plastering of the castle are worth examining in detail to determine the remains of polychrome. The preserved fragment shows a geometric pattern (Fig. 7) in several colours (red, grey, blue, white and ochre). It looks like it was an orthogonal grid of colourful lines that was combined with some other elements of the plant or figurative nature.
