ASSESSMENT OF ENVIRONMENTAL CONDITIONS WITHIN THE LIMIT OF THE RIPARIAN WATER PROTECTION STRIPS USING THE WEBGIS TECHNOLOGY

Abstract. The purpose of this research is the assessing of the current conditions of water protection strips in their role as an effective buffer that prevents water bodies from deteriorating due to the soil erosion and pollution. In the base of this study, the action plan is developing to improve the conditions of the water protection strips for the lakes. The approach is focused on the idea of an empirical study (based on observations and field measurements) of the environmental quality. An integral analysis of the territory of the protection strips is proposed, as well the processes and phenomena which are taking place within them, in order to obtain a clear picture of the state of the environment. In order to administrate, and to assure the visualization and transparency of this study the project blog on the "blogspot.com" platform was created with properly configured geographic interest patterns. Cartographic data were published on Google Maps and were integrated in blog. Thus, by accessing the blog, the views of the lake, the points of interest, with th

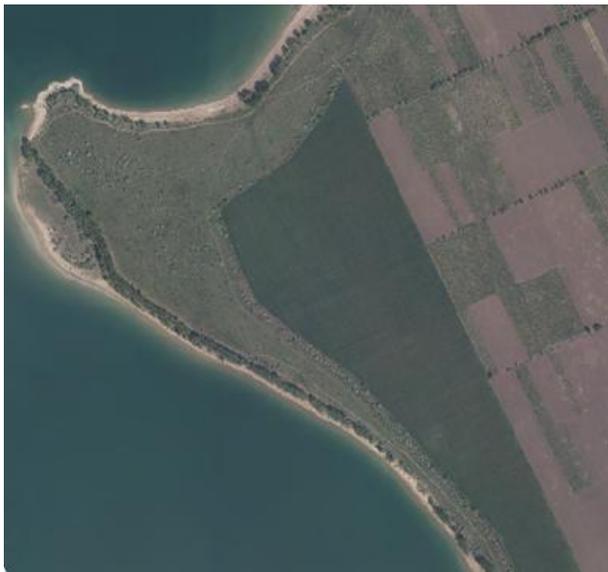
As a result of the site review of existing riparian protection strip, the length of about 11.5 km is located on the territory of Duruitoarea Nouă and Dumeni commune. The strip was created with the creation of the Costești-Stâncă reservoir and is currently discontinuous in its length (Fig. 6). The species that constitute the protection strip are the Euro-American poplar, the willow and the sail. The willow have regenerated naturally over time. Natural grassland regenerations are also found in the meadows in the immediate vicinity of the coastal protection strip.

Fig. 6. Protected coastline in the Duruitoarea Noua village

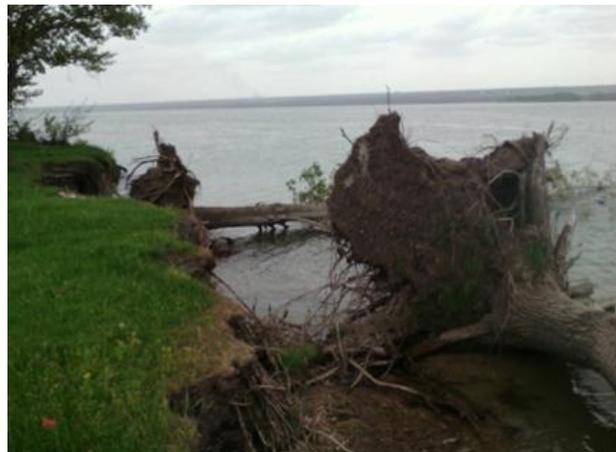
The age of Euro-American poplar is advanced in comparison with the age of technical exploitation. Thus, interventions are needed to regenerate coastal protection strips. The acceleration of the regeneration works of the riparian protection strip is also due to the shores of the banks due to the erosion caused by the waves and the weight of the trees (Fig. 8).

Fig. 8. Degradation of shores due to wave erosion and tree weight

Describing the coastal protection strip as it is currently being constructed, there is a lack of consolidation band. Here it is necessary to intervene with bank consolidation works and, if necessary, to create the consolidation band.

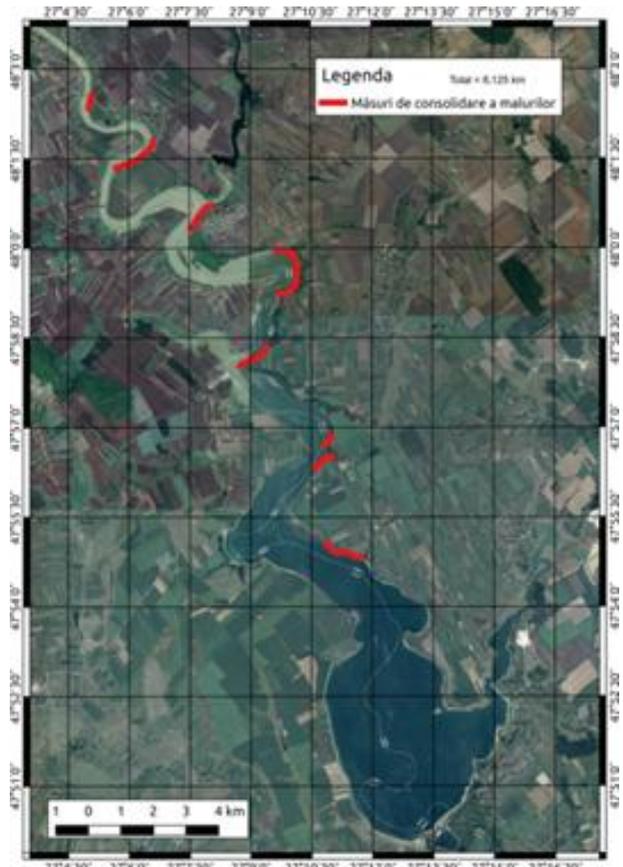
Fig. 10. Localization of measures to strengthen the shores of reservoir

Using the GIS mapping [References of Law number,..., 2016; Geoportal NSDI of Moldova, http://www.indes.gov.md/geoportal_inds] the localization of the actions on rehabilitation creation of protection strips was made (Fig. 9, Fig. 10) and location of solid waste landfills requiring action (Fig. 11).

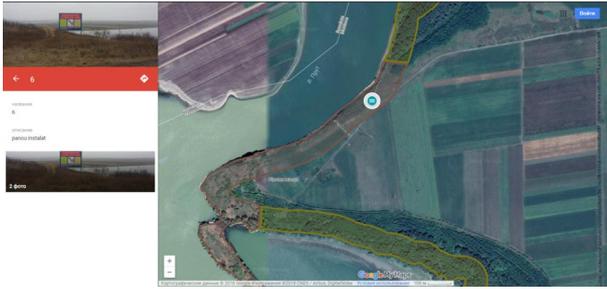
Figure 12 shows the location and picture (photos) of the information panel on the protection zone of Lake Costesti-Stinca.

Fig. 12. Viewing the information panel for the protection zone of Lake Costesti-Stinca
