**CONSERVATION OF MEMORIAL MONUMENTS  
AT HISTORICAL CEMETERIES – CHALLENGES  
AND PERSPECTIVES**

**Abstract.** The article analyzes the main restoration problems facing the restorer when working with memorial monuments at the historical cemetery. The method of solving these problems is offered on the example of diploma works of students of the specialty “Stone art works conservation” of the Architecture and Conservation Department of “Lviv Polytechnic”. NU.

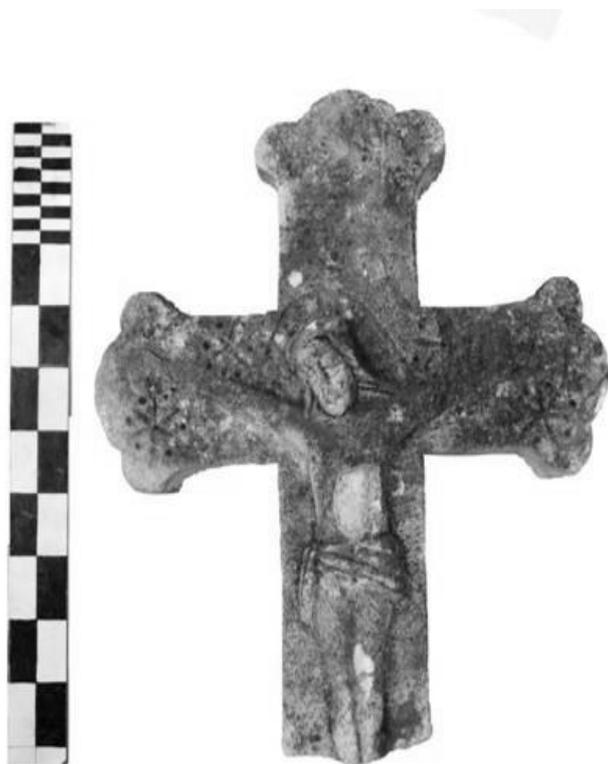
**Fig. 1.** Object at the time of receipt for conservation

The Museum of Sacred Art possesses a large collection of stone sacral monuments, and in 2016 and 2017 it transfers to the Architecture and Restoration Department a number of monuments that originate from the village of Nemirov, Yavoriv district. It is a white stone cross with a crucifix with the lost lower part of the cross and the face of Jesus. When entering the conservation, the cross was in a contaminated state with a layer of dust, earth, limestone, patina and a large number of different kinds of biodeterioration. The restoration of this object was performed by student Yankiv Nastya. In the process of restoration, the cross with a crucifix was cleaned of surface contaminants, patinas and biodeterioration. Supplemented lower part of the cross that was lost. Created texture like a natural stone. The stone is strengthened. One more tombstone monument in the form of crucifix with the forthcoming was restored by student Makaruk Marina in 2017. When entering the conservation, the cross was in a satisfactory condition. The main parts of the monument are preserved. There was an insignificant loss on the drapery of the tissue coming. The monument is covered with dust and dirt, biodeterioration. and patina. The monument was thoroughly cleared from the dirt, patina and biodeteriorations, an addition was made.

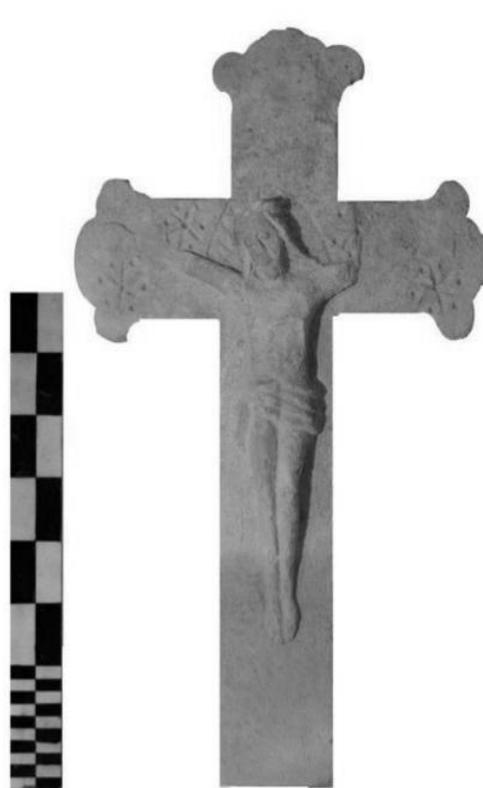
**Fig. 2.** Object after performing of conservation work

Speaking of the memorial monuments conservation at the historical cemetery come out that the history has developed in such a way that many of these cemeteries were partially or completely ruined and destroyed. The memorial monuments of such cemeteries often becomes part of museum collections, lapidary, sometimes private collections, and so on. Such facilities usually require restoration. So in 2016 a section of the cross with a crucifixion from the tombstone was transferred to the Department of Architecture and Conservation by the Museum of Sacral Art named after Anton Petrushevich, Lviv diocese of the UGCC for restoration works. A memorial was found at the cemetery in the village Nemyriv Yavoriv district, Lviv region. This work was performed and defended in the same year by the student Hanchevska Olena. Material and technique of execution indicated that the cross belongs to the Brusno masonry school. (Lew, S., 1967, c 193). The monument was created at the last 19-th – early 20-th century. Material – limestone, technique of execution – carving in a stone. The crucifix was broken down below the knees of Jesus. Stars are placed around the head of the Cross (solar signs); It is assumed that this cross was with two settlers that are lost. When entering the conservation, the condition of the object was unsatisfactory (Fig. 1). The lower part of the cross with the legs of Jesus is lost, and both arms from the elbow to the wrists are lost, and the upper part of the cross is opaque. The object was in a contaminated state with a layer of dust, dirt and cement mortar and biodeterioration. During the restoration, the cross was cleaned of dirt, cement mortar, patina, biodeterioration, and salinity of the monument was eliminated. The addition of the lost part of the cross was made of artificial stone. The reinforcement was use. Lost pieces were modeled and supplemented in artificial stone. The invoice has been executed, and the monument has been strengthened (Fig. 2). The monument is kept in the museum of Sacral Art named after Anton Petrushevich.

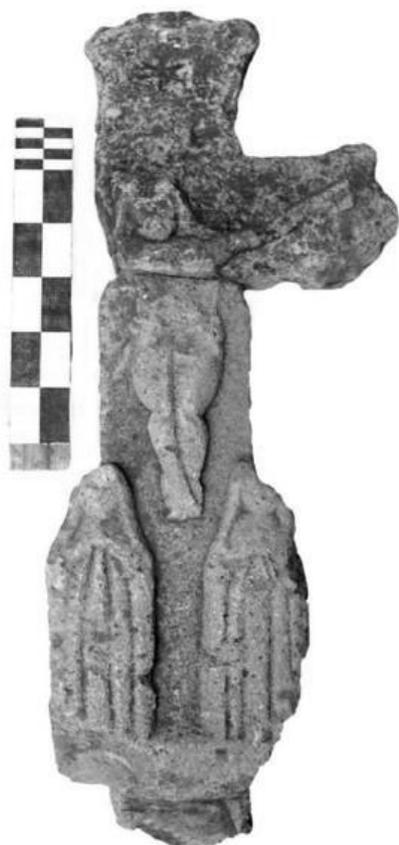
**Fig. 3.** Object at the time of receipt for conservation

The next gravestone monument in the form of a cross with the coming, which entered the conservation in 2018, was damaged already much more seriously (Fig. 3). At the time of receipt for conservation the cross was broken into two parts, there was no left arm, the body of Jesus, the drapery, the wreath on the head of Jesus, the heads of the coming were damaged. The monument was covered with dust and dirt, mosses. The monument was thoroughly cleared of pollution and mosses. All parts were glued and armed. The losses have been supplemented – the left arm of the cross, the end of the right arm, the body of Jesus, the heads of the coming (Fig. 4).

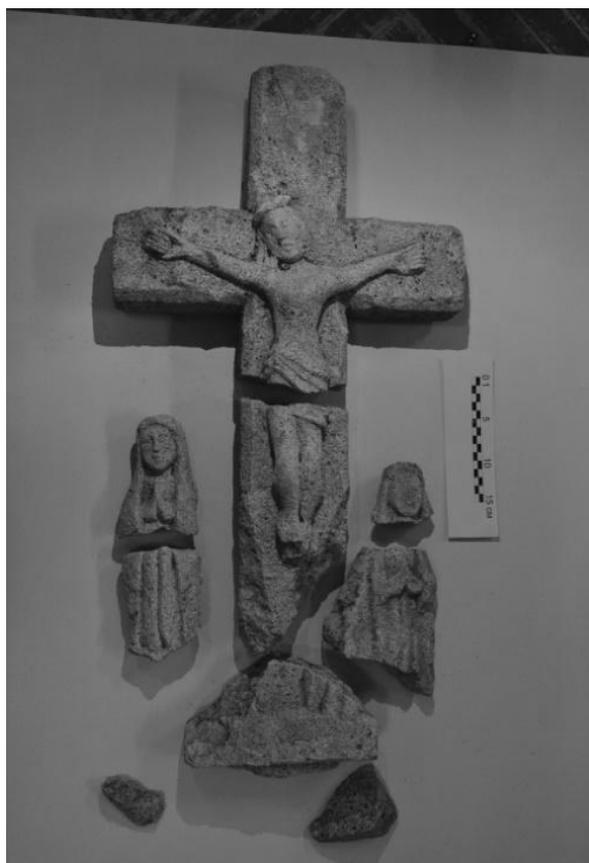
**Fig. 5.** Object at the time of receipt for conservation

Most seriously damaged monument in the form of a cross with the Crucifixion and coming receipt for conservation in 2017. The cross comes from the non-existent Ukrainian village of Sukha Volya, which is currently located in the Podkarpackie Voivodship of the Republic of Poland. At the time of receipt for conservation, the condition of the object was critical. Crucifixion was broken into nine separate parts (Fig. 5). The crucifix itself was broken into two part, the right figure from the cross was broken into two, the left – for three parts. Two more parts were repulsed from the corners of the cross, from the upper and lower. Probably the stone cross broke down when falling. For a long time, the monument was underground so the time of receipt for the conservation it was very dirty. Pores contain a large number of different types of biodeteriorations. The conservation was carried out by student Vlasyuk Julia. According to the technique of execution and the origin of the monument was attributed to the Brusno stonemasonry school. During the conservation, the cross was cleared of surface contaminants and biodeteriorations that were found in limestone pores. After complete cleaning, connection and gluing of parts of the stone cross, as well as addition of lost elements were carried out. The object was strengthened and colore unification was carried out (Fig. 6).

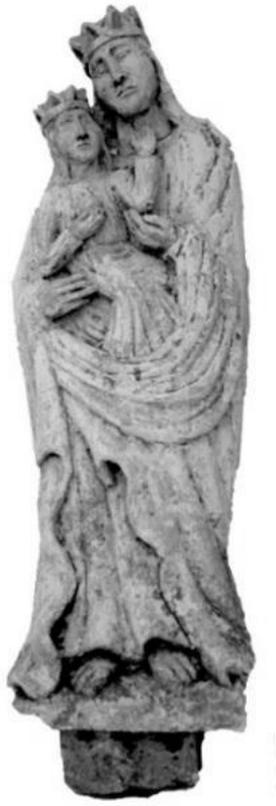
Fig. 7. Object at the time of receipt for conservation

In addition to crosses with crucifixes and forthcoming as memorial monuments in our historical cemeteries, there are also so-called “figures”. This is a different size of round sculptures, most often the Virgin Mary with or without child, Jesus Christ, or some of the Saints. Such a sculpture is a vivid example of folk art. So in 2016 the Museum of Sacred Art transferred for the conservation a white stone sculpture of the Virgin Mary with the Child. The Virgin and the Child are depicted in the crowns. The Virgin is depicted with the child, Jesus Christ sitting on Her hand and pressed his cheek to her cheeks. During the work it was found out that the sculpture comes from p. Chemeryntsi village, Peremyshlyany district, Lviv region. Old pictures were found on which the sculpture is already lying on the ground. That

is, the sculpture itself collapsed, or was scattered to the ground. Mechanical damage and loss is obviously the result of a fall.

At the time the monument was received for the conservation it was in poor condition – The figure was covered with dust and biodeteriorations, there were insignificant layers of cement mortar on the lower part of the figure. The sculpture was completely covered with several layers of oil paints. Several fingers on the arms and legs were lost (Fig. 7). During the conservation work the sculpture was completely cleared of paint. The biodeteriorations and cement layers were eliminated. Recover lost parts. Stone was strengthened. A colored unification was carried out (Fig. 8).

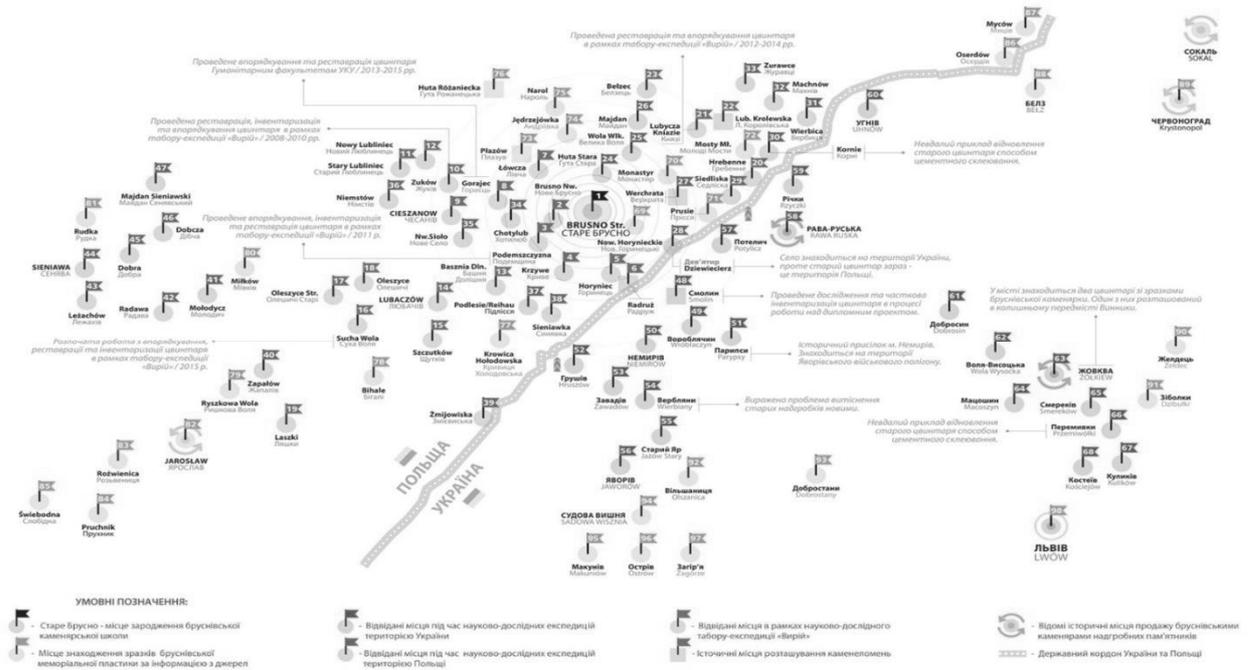
Fig. 9. A map of the distribution of the Brusno masonry school monuments

Within the framework of diploma master's works the theme of conservation of the memorial monuments of the historical cemetery was considered more widely than restoration of a separate tombstone monument. In 2016, the area of distribution of the Brusno masonry school monuments was investigated by the student Gritsiv Olga. And a map of the distribution of these monuments on both sides of the modern Ukrainian-Polish border has been completed (Fig. 9). The methodology of inventory was analyzed, and the algorithm of research and restoration of the memorial legacy of the Brusno masonry school is drawn up. The information about the cemetery in the village Smolin of Yavoriv district was worked out, its partial inventory and conservation of one tombstone was carried out. The peculiarity of this work is that the restoration itself was carried out directly at the cemetery. The object of restoration was covered with dirt, dust, marsh and very clearly visible mosses. The monument, selected for restoration, stood firmly on the ground, did not flutter, did not fall and did not have any mechanical damage. Was thoroughly cleansed and strengthened. And it stayed in its proper place.

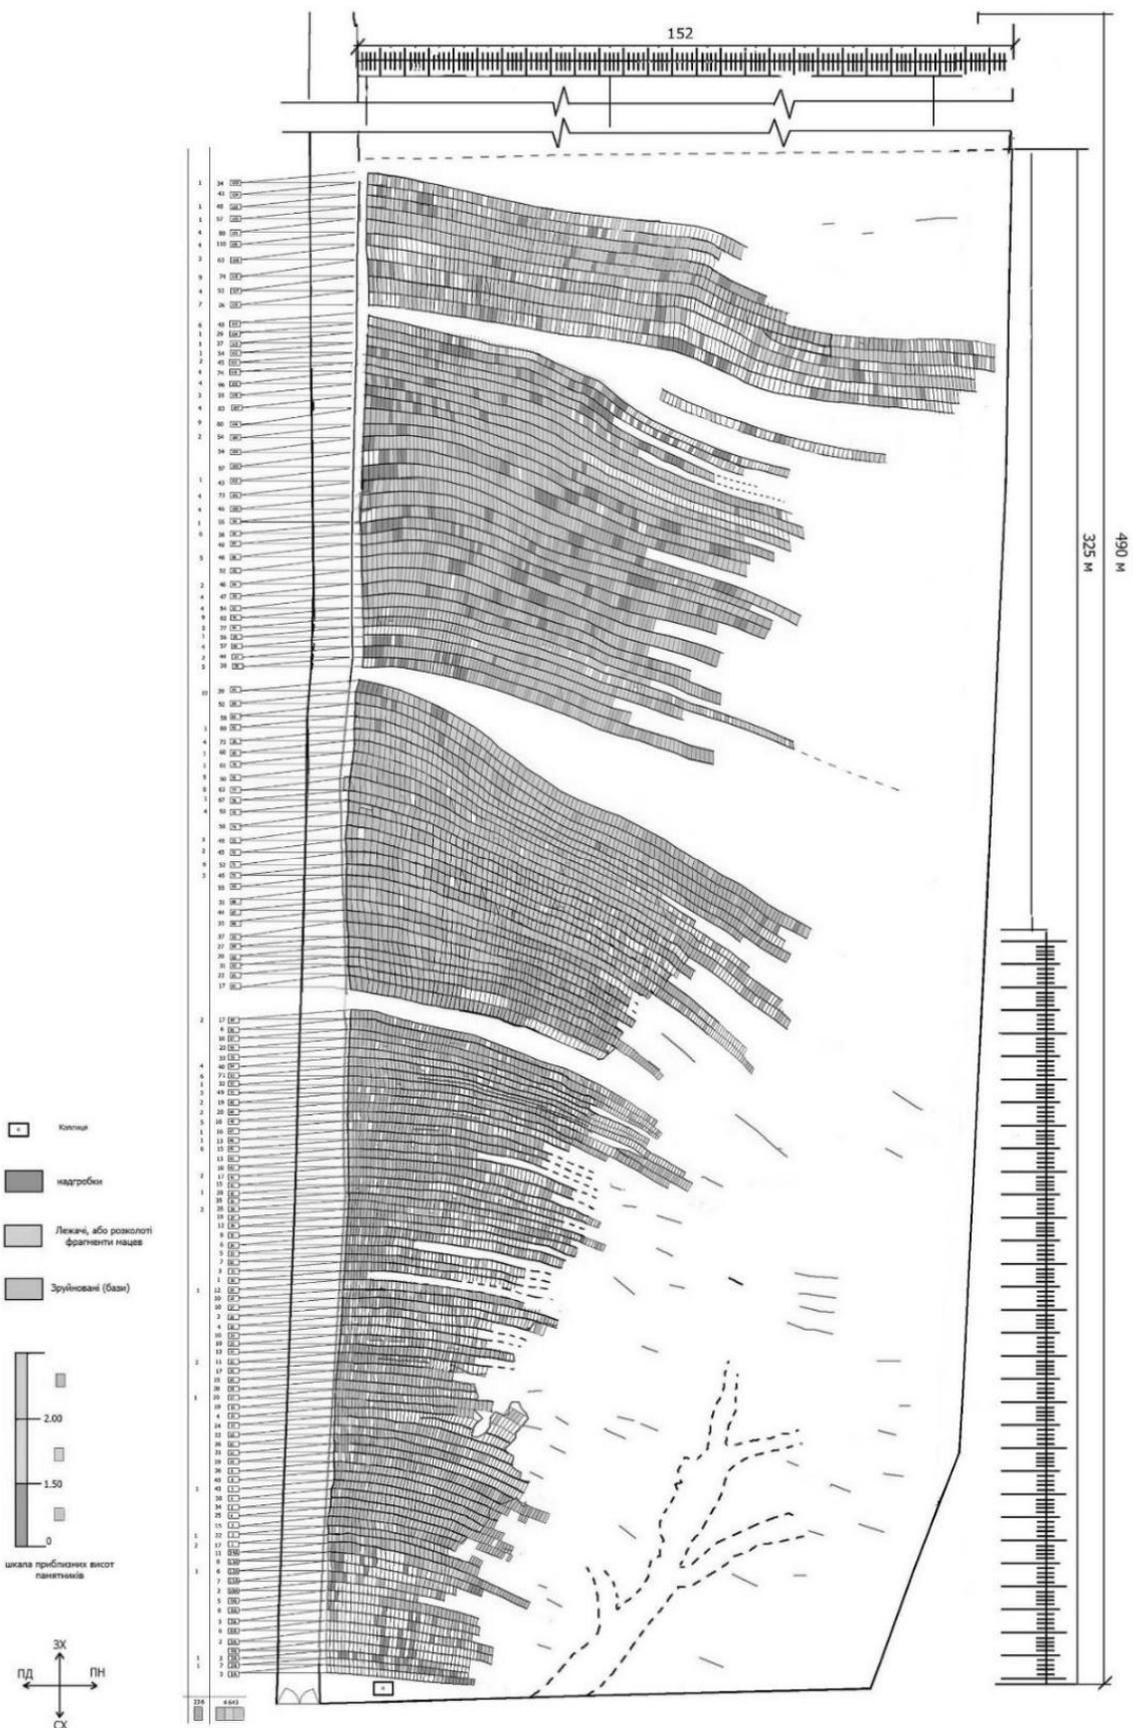
Fig. 10. Inventory the New Jewish Cemetery in Brody town

A similar work in 2015 was conducted at the New Jewish Cemetery in Brody town by students Yulia Kostetska and Zenik Shulba. In 1835 – the Austrian authorities allocated for Jewish community in the Brody the land under a new cemetery. The cemetery was also marked on cadastres and military maps. He was given the name “New Jewish Cemetery”. A detailed and complete inventory of a whole cemetery was conducted. The character and peculiarities of the memorial carving, as well as polychrome and color symbolism of the matsevs were investigated. Regarding polychromy: so it was possible to investigate it. It is clear that, initially, all mattsevs on the cemetery were colored. However, today polychromy is preserved on matsev, only in those places that were least exposed to adverse natural factors, as it were in the lower part, or part which was hidden by other mattsevs or were in the soil. That is, today we can reconstruct the color of the mattsevs. In the main graves at the cemetery belong to the 19th century and the most recent ones to the 30s of the 20th century. Two mattsev were found made in the barco style. By artistic analysis one can assume that they belong to the late 18th century. The latest graves are dated 1939. As for the inventory then really huge work was carried out (Fig. 10). I want to submit calculations. At the cemetery in Brody, the largest matsevs are more than three meters high, and the smallest are only 30 cm high. The cemetery contains approximately 8120 matsevs, but only 5477 whole matsevs have been preserved, lying and destroyed matsevs in the amount of 539 pieces, of which the undamaged lying is 356; lying split into two parts is 40; lying split into many parts is 37; lying matsevs broken near the base is 83; The split fragments of matsevs are 13, and the stone bases in the amount of 2118 and yet an unknown number of tombstones was lost. For today, the cemetery is not functioning, but we can say that it is preserved. Some of the tombstones fell, but this is obviously a natural process. There are no traces of intentional target destruction or vandalism. In addition to the research work, each student conserved to two mattsevs. At the time of receipt for conservation, the selected mattsev were in an unsatisfactory condition. The monuments were contaminated with earth, patina, mosses, lichens, the stone was partially crushed. Significant mechanical damage and loss were present. Mattsevs were cleaned, dissolved, eliminated biological contamination, made gluing and addition of lost parts, the insertion of cracks and fugging stitches, color unification and strengthening. was conducted. All problems that caused the destruction of the stone were removed. Authenticity of the object is preserved.
