*Bohdan Cherkes, Violetta Radomska*

**CURRENT STATE OF PRESERVATION  
AND PROBLEMATICS OF RESTORING POLYCHROME  
PAINTINGS BY MODEST SOSENKO IN THE STRUCTURE  
OF SACRED ARCHITECTURE**

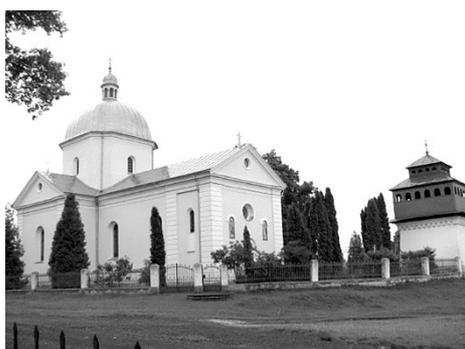
a

**Fig. 1.** Arch. Michael Church, Pidberiztsi (a); Fragment of mural by M. Sosenko (1907) on the apse top (b); photo by A. Tyrpych, 1996

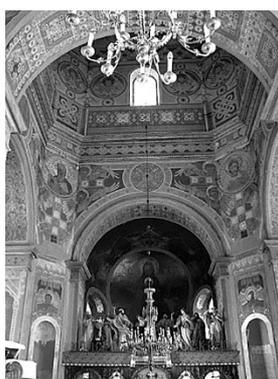
c

**Fig. 2.** Polychrome painting, central dome of transept (c); Layout of Arch. Michael Church, Pidberiztsi performed by A. Tyrpych (c1), 2015

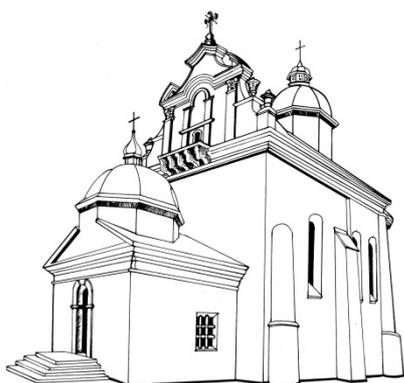
**Fig. 4.** St. Nicholas Church, Zolochiv, graphics by A. Tyrpych, 2015

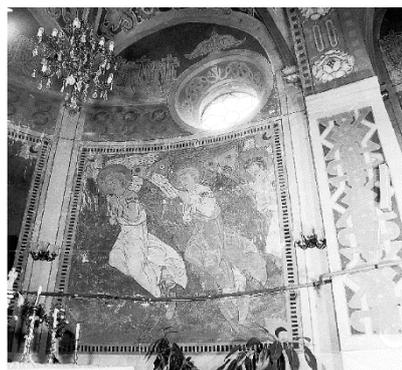
**Fig. 5.** Polychrome paintings by M. Sosenko (1911–1913), photo by V. Radomska, 1991

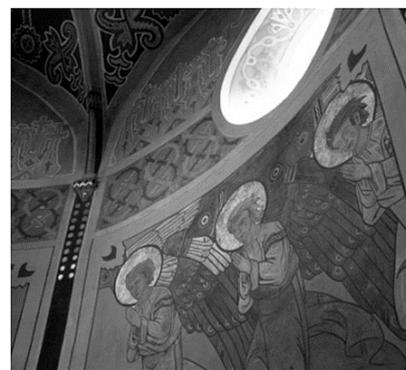
In 2013, the next expedition (restoration artist V. Radomska) was organized and it detected the following changes in the interior space of the architectural monument: – the reconstruction of iconostasis was carried out with the serious changes in stylistics and iconographic content; – the conducted restoration works caused the significant losses in the original coloristic patterns and the texture of polychrome paintings.

**Fig. 6.** Polychrome paintings by M. Sosenko (1911–1913), photo by A. Tyrpych, 2013

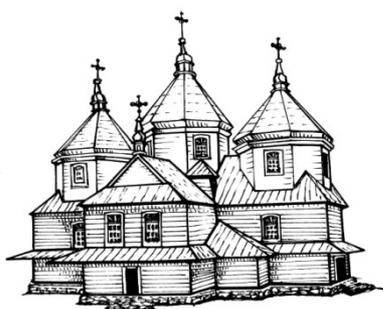
Church of Resurrection of Christ, located in Polyany village (Rykiv village till 1946), Zolochiv district, Lviv region, was designed by the architect V. Nahirnyi and dates back to 1903. In 1913–1914, Modest Sosenko created icons for the iconostasis and the two side altars and painted the central dome of the nave (Fig. 7–9).

**Fig. 7.** Church of Resurrection of Christ, Polyany, graphics by A. Tyrpych, 2015

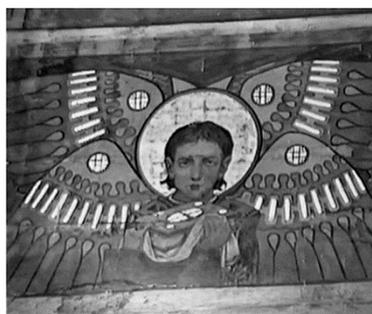
**Fig. 8.** Polychrome paintings by M. Sosenko (1913–1914), photo by A. Tyrpych, 1991

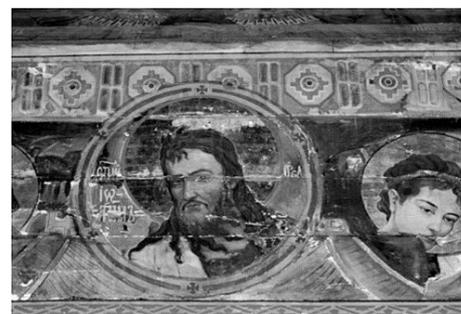
**Fig. 9.** Polychrome paintings by M. Sosenko (1913–1914), photo by A. Tyrpych, 2015

During the expeditions aimed to evaluate the preservation state of the monument of architecture (V. Radomska, 1991, 1996, 2016), we have noticed the gradual self-deterioration of Modest Sosenko polychrome paintings, located at the junctions of wooden constructions under the central dome space (Fig. 9). Partial detachment of linen canvas at the junctions of wooden boards resulted in the peeling of levkas and paint layers of the polychrome paintings. The situation was worsened by the unsatisfactory waterproof characteristics of the church roof cladding. The unstable temperature and humidity regime triggered the deterioration of joints between wooden boards and the appearance of fungi spores, etc. (Fig. 9). It should be pointed out that in 2018 the region council allocated funds to cover the central dome of the church, which could significantly influence the preservation of polychrome (elected official M. Babinska). Currently, those unique murals that are still preserved in their authentic form require urgent attention of experienced and professional restoration artists who specialize in the area of preserving decorative and monumental art objects, located in the structure of an architectural building. The program of restoration works should be based on the idea of preserving original texture, coloristic patterns, and technical and technological peculiarities. It should prevent the unprofessional approach and the “renewal” experience observed in St. Nicholas Church in Zolochiv. The
