Vol. 7, No. 2, 2021

Olena Stasyuk

**MONKS' CEMETERIES OF THE HOLY DORMITION UNIV LAVRA.
THEIR CURRENT CONDITION AND RESTORATION ISSUES**

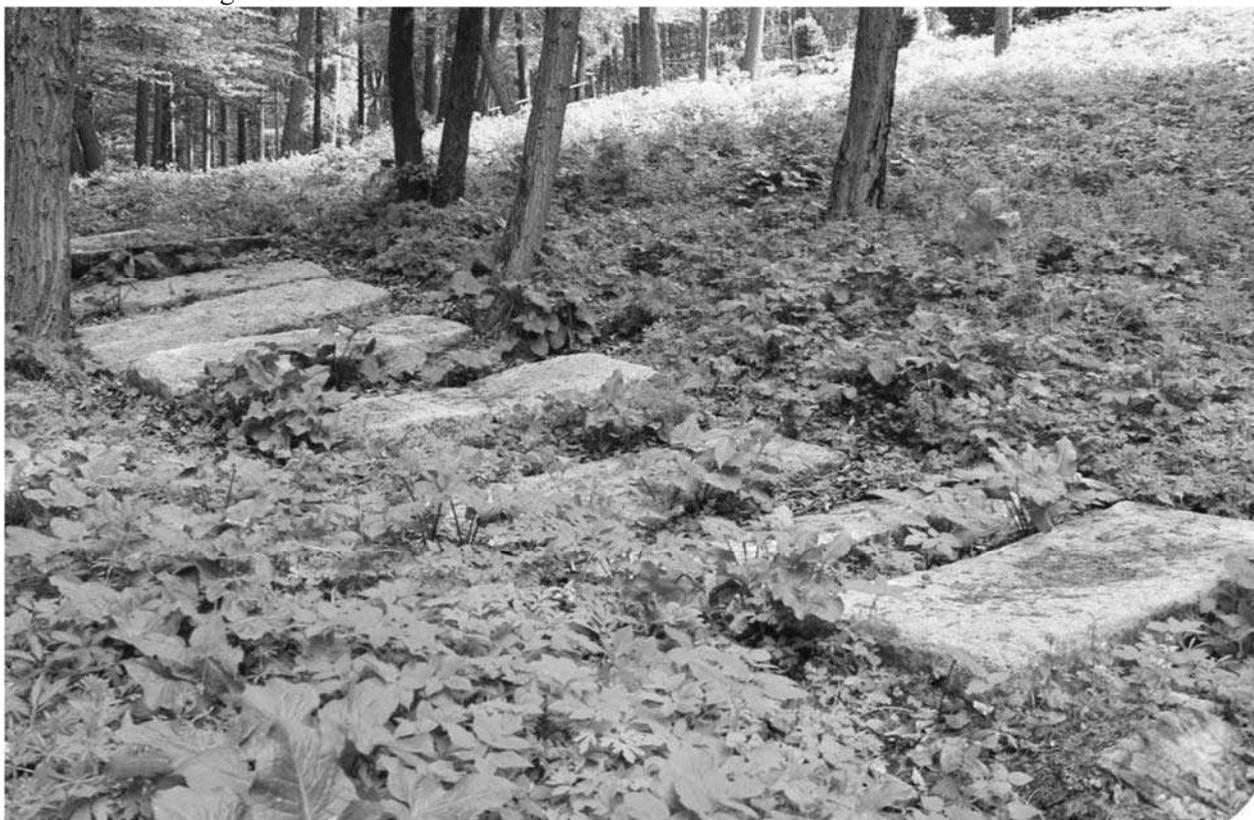
This is an example of a cemetery with sub-slab burials (Fig. 1), which is not common in our lands. The first reports of sub-slab burials in Galicia are known from the middle of the mid-nineteenth century. We find these reports in the works of archaeologists. Participants of the expeditions, who investigated the mounds on the Halych-Volyn border, in addition to the descriptions of the excavated mounds, noted the presence of large displaced slabs in the area. There were no inscriptions on their surfaces. Gradually, such sub-slab burials were discovered and studied more, and archaeologists are inclined to believe that there is a widespread practice in Galicia of sub-slab burials within various necropolises of the medieval city (Lutsyk, 2019). The cemetery is not fenced and it is difficult to understand where it begins and where it ends. This cemetery is dissolved in the surrounding landscape. Judging by the number of tombstones we can see in the cemetery today, it is very likely that some of the crosses and slabs are hidden underground. To finally determine the parameters of the cemetery, the number of burials and preserved tombstones, it is necessary to conduct detailed archaeological research.

Fig. 1. The old monks' cemetery with sub-slab burials in Univ

The surviving sub-slab burials are arranged in rows from north to south, and the burials themselves are oriented east-west. This can be judged from the inscriptions and images that are stored on separate plates. All plates are approximately the same size. That is, the difference in width and length between the plates varies within 10 cm. Of the 28 slabs in the cemetery, 18 slabs are empty. That is, without inscriptions or drawings. Some of these plates are not quite the right rectangular shape. In some, the surface of the stone is very destroyed – damaged by biology, weathered. And here it is difficult to say whether these images never existed, or whether they simply have not survived to our time. It is also worth mentioning

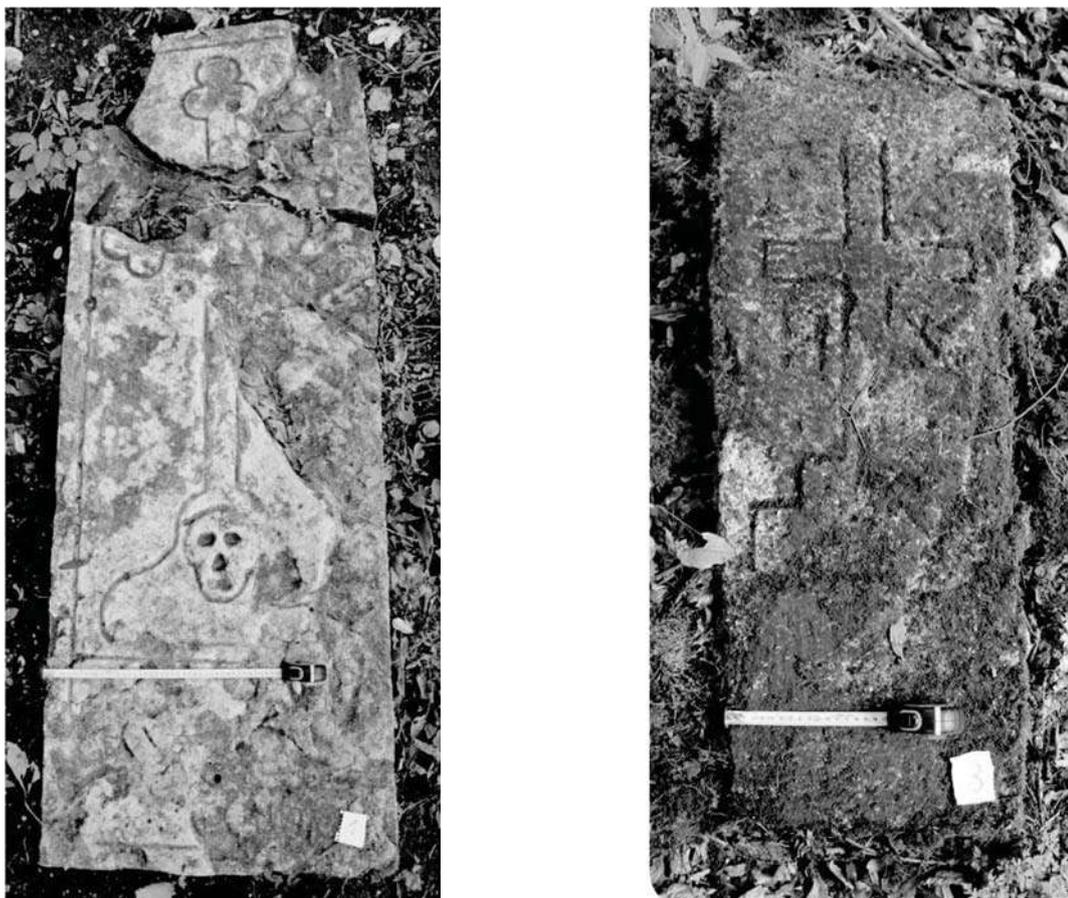
The two slabs in the cemetery are decorated with images (Fig. 2). These are linearly executed images by erasing a line. On one of the slabs is a large cross with three-leafed ends of the arms. The cross stands on a pyramid similar to the image of the mountain of the so-called “Golgotha”. The image of the mountain is with rounded corners. The image of Adam's skull is placed on the mountain. Probably below, there was still an inscription, but it is very poorly preserved. You can guess about it rather than read it. The second plate also depicts a cross. It is a Latin cross with simple rectangular arms. This cross also stands on a mountain in the form of a stepped pyramid. The lower part of the plate is very destroyed and it is not clear whether there were any drawings or text. At the top right and left of the cross you can see the traditional letters - the abbreviation of the name of Jesus Christ. Traditional, such as is usually painted on icons.

Fig. 2. Slabs decorated with images

All the objects in the ancient monastic cemetery are made of limestone. The stones are mostly the same colour, but with different types of granularity and sometimes with shells. The condition of the tombstones is unsatisfactory. Since the cemetery is located in the forest, the stone is under the constant influence of all natural factors. Biology is especially destructive here. Both crosses and slabs are quickly overgrown with moss, fungi, and so on. 9 of the 28 plates are divided, mainly into two parts. In several reflected and lost corners. In particular, one of the two plates decorated with carvings is broken. She also lost her upper left corner.

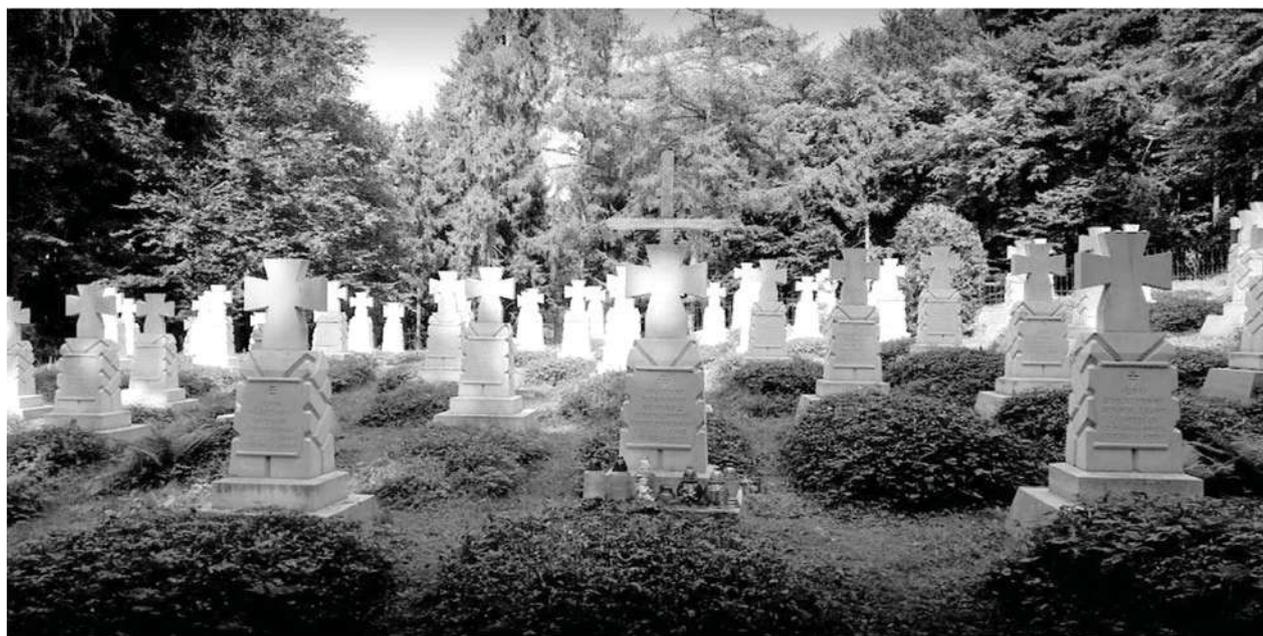
The second, newer and currently operating monks' cemetery is also located on the Chernecha Mountain in Univ (Fig. 3). Chernecha Mountain is a special holy place east of the Univ Lavra. It is on the top of this mountain that the current monastic cemetery is located, which is a place of pilgrimage for pilgrims arriving at the Univ Lavra. It should be noted that this cemetery is in good condition. The cemetery consists of identical tombstones. The graves themselves are earthenware overgrown with periwinkle.

Fig. 3. Newer and currently operating monks cemetery located on the top of Chernecha Mountain

At the head of each of the graves is a stone monument. A monument in the shape of a truncated pyramid stylized as “Golgotha”. The pyramid is crowned with a cross of the Kozak (or Maltese) type. On the pyramid, i.e. on the mountain, there is a cartouche for the inscription. The inscriptions are engraved. The monuments are arranged in straight rows from west to east. In the middle of the cemetery is a wooden cross with a round metal plate. Along the perimeter of the plate is a wreath of leaves, and in the centre of a short philosophical text about the value and meaning of life. The cemetery is fenced with a delicate metal fence. It is tidy and well-groomed. The stone tombstones are in very good condition. The stone is light with a warm shade of the so-called “ivory”. There are no traces of dirt, moisture or biology. Even though this cemetery is a place of pilgrimage and is visited by a large number of people, it is clear that the pilgrims follow cleanliness and order. The fact that the cemetery is often visited is indicated only by the presence of candles or lamps on the monuments.

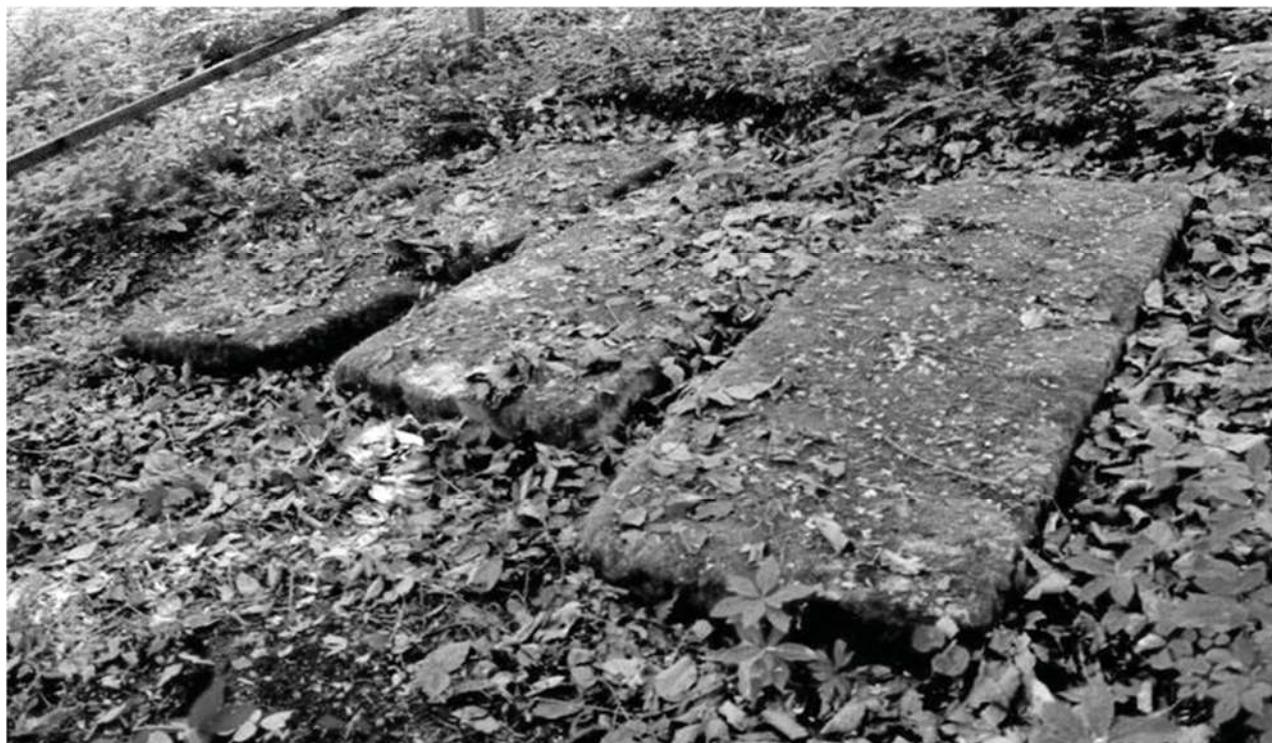
Examining the current state of the cemeteries, it became clear that the two monks' cemeteries are in a completely different state. The existing, newer cemetery on the top of the hill is well-groomed and tidy. The ancient monks' cemetery on the hillside is forgotten and abandoned (Fig. 4). This cemetery, as well as individual monuments of this cemetery, need to be restored. The territory of this cemetery is neglected. The grass is not mown, the trees grow randomly, that is, they are not pruned, do not watch how they grow, obviously many of the trees are self-seeding. There are no paved paths in the cemetery – only paths trodden in the grass. In the new cemetery on the top of the mountain, the grass is always mown, and there are no trees in this cemetery at all.

Fig. 4. The result of inaction at the old monk's cemetery in Univ

The first challenge is to tidy up the territory of the ancient cemetery. Perhaps we should take as an example the existing newer cemetery, which is perfectly arranged. The next challenge is the restoration of individual monuments. This applies again to the ancient cemetery. Restoration should be done by specialists. As for the stone crosses, they should first of all be stabilized statically – raised, levelled, strengthened accordingly, that is, do everything necessary to make the monument stand flat and strong. Next, you need to clear the crosses and slabs, respectively, if necessary, strengthen the stone material, glueing and bonding the broken parts of the tombstones. Accordingly, if necessary, the addition of lost parts. In both cemeteries there is a need for constant care, cleaning, clearing (such as snow removal in winter, fallen leaves in autumn, mowing in summer), continuous monitoring of the condition of monuments, and immediate removal or repair of minor damage. These seemingly simple steps can significantly extend the life of cemetery monuments, and hence the cemetery as a whole.
