EXPERIMENTAL RESULTS OF DAMAGED RC BEAMS

*Lviv Polytechnic National University,
Department of highways and bridges
yaroslav.z.blikharsky@lpnu.ua*

This article presents the results of an experimental study of damaged reinforced concrete beams. Corrosion of reinforcement in concrete is one of the main problems of durability faced in practice by civil engineers. Particular attention should be paid to the action of an aggressive environment as one of the most common causes of the introduction of elements into an emergency. The aim of the work is to determine the strength and deformability of reinforced concrete structures without damaging the reinforcement and in case of damage. According to the research program 4 beams were tested. Among them were undamaged control samples with single reinforcement of $\varnothing 20$ mm diameter and samples with $\varnothing 20$ mm reinforcement with damages about 40 %. The reinforcement was damaged before concreting the samples. The test specimens were tested for bending under short-term load. At the result impact of damage to reinforcement in RC beams reduces the load-bearing capacity. The results are given in the article.

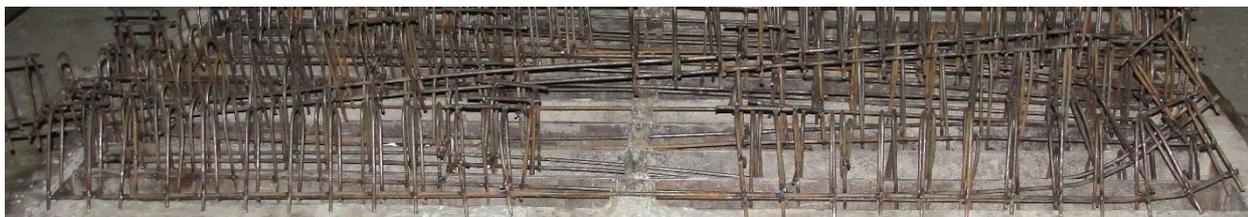
The reinforcement of samples: A500C steel bars, the diameter was $\varnothing 20$ mm. Reinforcement of compressed zone and transverse reinforcement are made of $\varnothing 5$ B 500 bars. Transverse reinforcement $\varnothing 5$ B500C has 75 mm spacing (Fig. 1).

Fig. 1. The general view of reinforcement

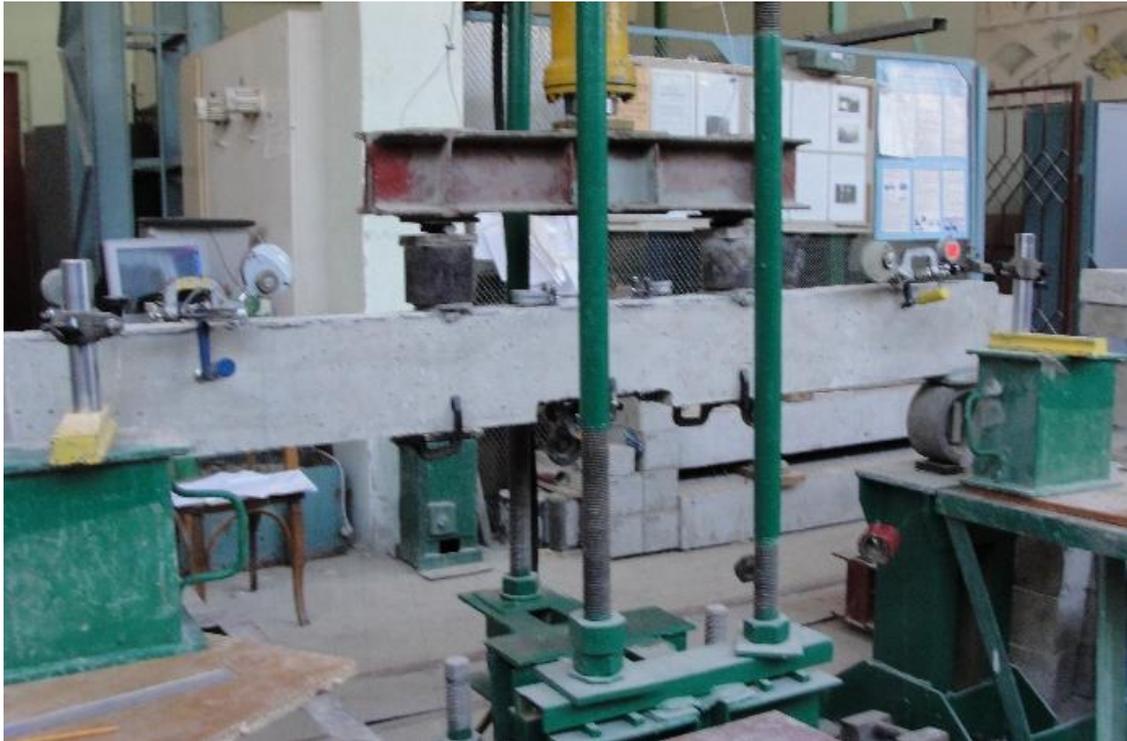
The test specimens were tested for bending under short-term load. The load level was monitored by means of annular dynamometers, which simultaneously served as a hinged support on one side and a fixed support on the other side of the beam with a run of 1900 mm. The load was applied in the form of two concentrated forces in the thirds of the span of the beam by means of a hydraulic jack and a distribution traverse (Fig. 2).

Fig. 2. The graphs of the strains` calculated values of the stretched main steel rebar's (stretched reinforcement) and the compressed concrete (compressed concrete) for beam BD-2

Deformations of reinforcement and compressed concrete were measured using clock-type micro indicators with a division price of 0.001 mm. Five deflection gauges were installed on the beam to measure the deflections.
