Analysis of Eddy-Current Testing and Metallographic Examinations for Corrosion Damages of Heat Exchanging Tubes in NPP Steam Generators

Tetiana Kovalenko, Stepan Lys*, Volodymyr Vostres

Lviv Polytechnic National University, 12 S. Bandera St., Lviv, 79013, Ukraine

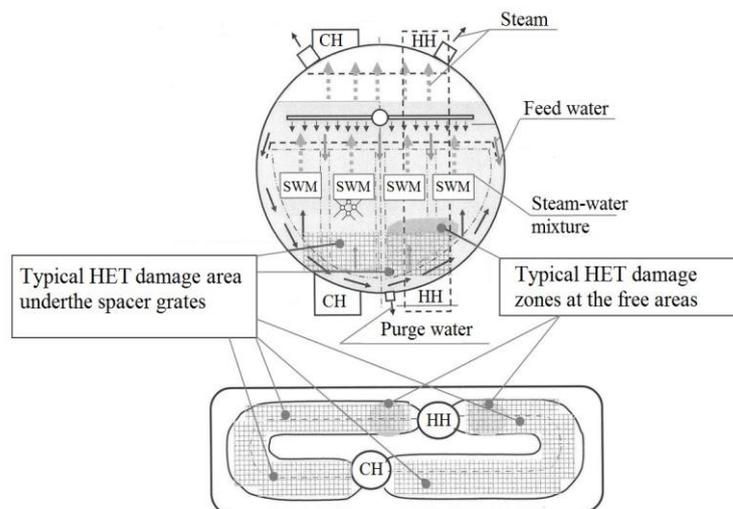
Fig.1. The steam generator in cross section and plan.

The results based on the analysis of HET corrosive defects of the NPP SG with WWER at Ukrainian and foreign NPP are cited in papers [1], [3]-[7]. It was determined that the corrosion defects on free areas and under spacing elements tend to appear mainly at a bottom of SG tube bundles (Fig.1).

Whereupon the defects on free areas localize mainly near hot header (HH). The defects under spacing grates are also situated at the SG bottom but distributed more evenly along with the tube bundle.
