APPLICATION OF CFD FOR INTERIOR FLOW ANALYSIS INFLUENCED BY EXTERIOR CONDITIONS

The aim of the paper is the presentation of application CFD analysis for interior flows in chimneys and flats in a building. It is a summary of a case study of fatal intoxication by carbon monoxide coming from a gas heater of flowing water at a bathroom. That kind of accidents mostly happens due to problems with ventilation and very popular old construction gas water heaters. Closed, airtight windows are the main causes of the production of carbon monoxide but sometimes wrong construction of the chimney outlets versus the roof shape causes the backdraught of combustion products. The paper deals with an accident which took place in one of Polish cities. Gas heater of flowing water installed in a bathroom at the first floor was connected to the vent pipe with a low outlet. During windy weather conditions, at the end of October, so in a cold season, one of the inhabitants of the apartment died in bathroom due to carbon monoxide intoxication.

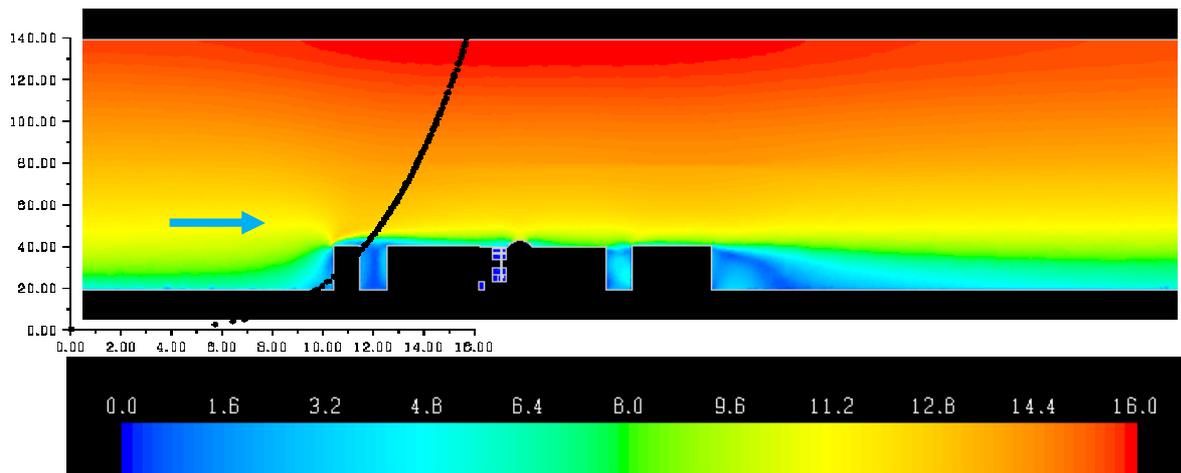
The initial conditions, the wind speed and direction at the time of the accident were retrieved from the measurements from the nearest weather station that was located at the airport. The 10-minute mean wind speed at a height of 13 m above the ground was 11 m/s, gusting up to 19 m/s and ambient air temperature was 9 °C (Krajewski and Zuranski, 2009).

The wind speed has been modeled according to the power law with an exponent of 0.19 for wooded terrain at the meteorological station windward of the anemometer for the wind direction that was taken into consideration, that is a category B according to (PN-77/B-02011) and 0.24 for a city (category C). Gradient heights were assumed at 400 m and 500 m, respectively.

Based on mentioned assumptions the wind speed profile was estimated. Only 10-minute mean wind speed were used in the calculations. It was app 10 m/s at the height of chimney outlets.

Fig. 3. The area included in the analysis. Underneath, the wind speed scale and left the mean wind speed profile are presented

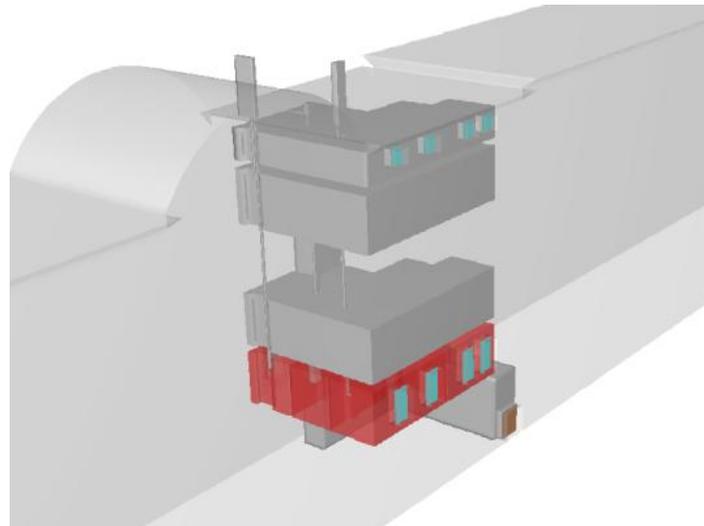
The three-dimensional model of the analyzed domain was based on the architectural plans of the building, including chimneys, and a testimony of eye-witnesses. Based on information from on-site inspection and prosecution files, an assumption was derived that all the windows were closed apart from the one in the kitchen that was slightly repealed. This assumption could not be verified.

Several other flats, connected with the one previously taken into consideration, have also been modeled. All modeled flats form a complex of buildings are enclosed by three streets and a courtyard.

Fig. 5. Three-dimensional model of the analyzed building

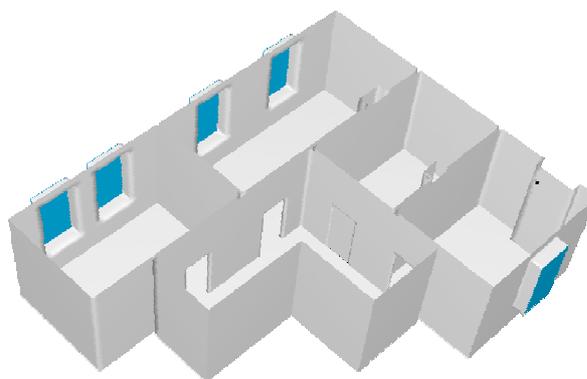
The simulation also takes into account the leakage through the door to the staircase and to other apartments, as well as leaks through the attic windows.

The calculations were conducted using the turbulence model Realizable k- ϵ . Additionally, in order to recreate the conditions in the apartment, as accurately as possible, heat sources imitating the burner in the gas water heater were implemented into the model.

Fig. 6. Digital model of the analyzed flat
