CONSERVATION OF ARCHITECTURAL AND ARTISTIC HERITAGE

**CAUSES OF DESTRUCTION  
OF ARCHITECTURAL DETAILS MADE OF ALABASTER STONE.  
(FOR EXAMPLE, THE GOTHIC CHURCH IN DROHOBYCH)**

**The aim of this study is** to define the reasons and the consequences of the deterioration of the gothic alabaster portal of the parish church of St. Bartholomew in Drohobych.

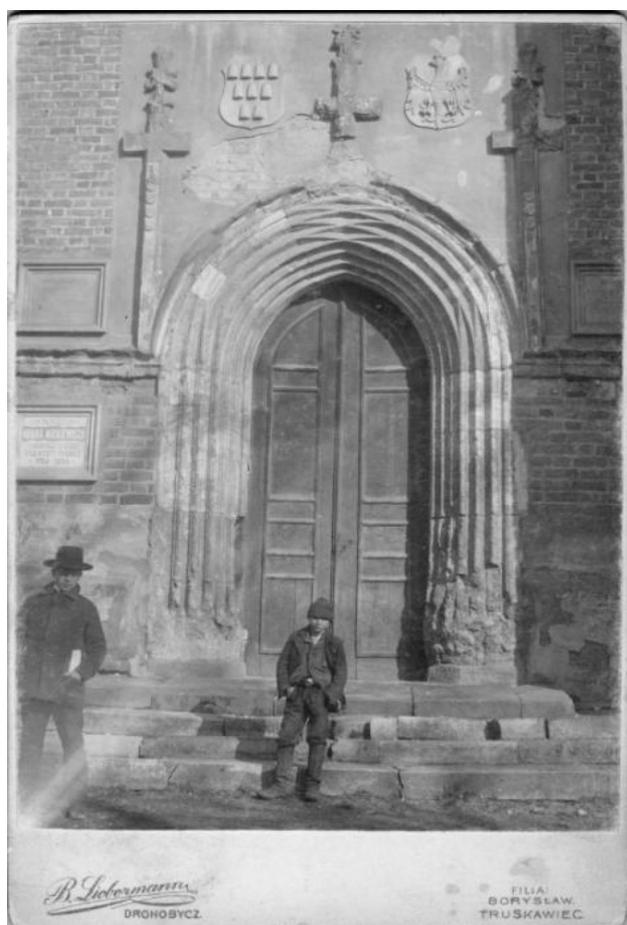
The gothic alabaster portal is one of the unique architectural features of the church. Its foundation M. Mściwujewski credits with Jan Mężyk (chief – starost – of Drohobych), who supported the building of other entrance portals on the south and north sides of the church. The research of Felix Gątkiewicz gives some facts about the once oak double leaf doors and the poor state of the portal, which was literally falling apart into pieces (Gątkiewicz, F. Z., 1906, p. 9). Today the oak doors are replaced with the metal doors. The photograph taken by B. Lieberman in 1906 before the reconstruction is the visual confirmation of Gątkiewicz's words (Walczak, W., Lopatecki, K., 2013, p. 318] (Fig. 3). In the picture, you can clearly see the damaged lower part of the portal,

now reconstructed from sandstone. Unfortunately, it is impossible to define the authenticity of the reconstruction. You may as well see the elements of the alabaster panels made before 1906. The staircase was laid out of stone and was considerably narrower than nowadays. Information plaques were relocated to the buttresses. There is the surface of plaster with two crosses and coats of arms of Drohobych and Poland above the alabaster portal. M. Mściwujewski poetically unfolds the history of these two crosses origin, which is related to the name of Jan Mężyk (chief – starost – of Drohobych). In the eighteenth century, swords were replaced with crosses; in the center, one more cross, smaller in size, was hewn; the coat of arms of Drohobych substituted the J. Mężyk’s one. According to M. Mściwujewski, Jan Mężyk commemorated the most significant day in his life – the participation in the Battle of Grunwald (July 15, 1410), which the two swords along the edges of the portal symbolize. “Therefore, he decided to tell the descendants about the triumph of the Polish and Lithuanian troops and his own participation in it, and ordered the architect to hew out of stone two huge Teutonic swords over the doors, the coat of arms of Poland and his own, and the inscription: “Hoc templum ineuntes Deus benedict – memento animi” – “Bless God all those who enter this shrine – remember the soul” (Mściwujewski, M. V., 2018, p. 4).

**Fig. 3.** Drohobych, parish church, south portal.

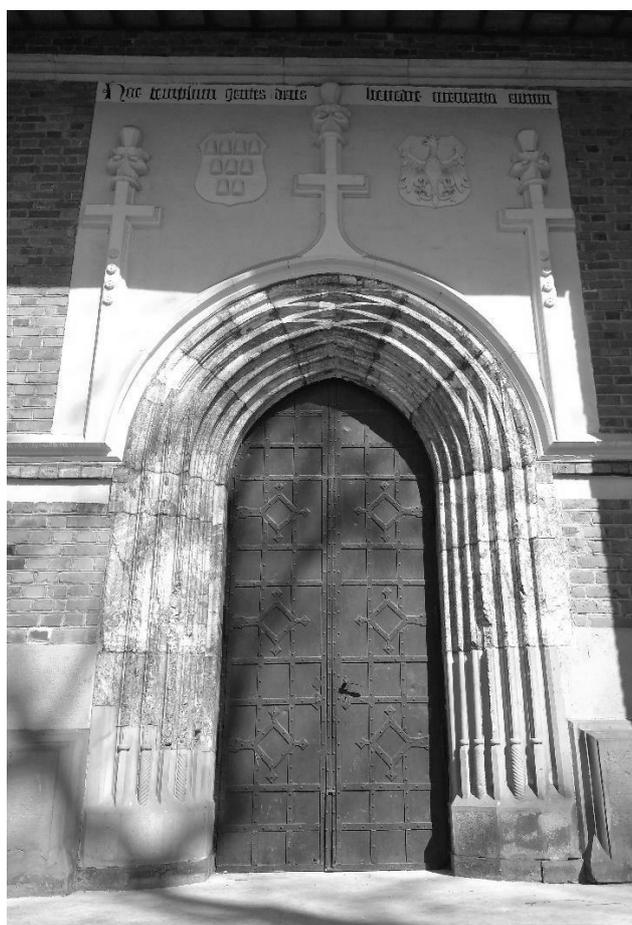
**Fig. 4.** Drohobych, parish church, south portal, 2018

The gothic alabaster portal of the Church of St. Bartholomew in Drohobych is in the extremely unsatisfactory condition. Internal, small, large, deep cracks are visible all over the alabaster surface. Mechanical loading causes an increase in their size, depth and quantity. Rain, water, humidity, abrupt air temperature change leads to the formation of furrows, cavities, splits, weathering and stratification of the alabaster. Stratification can be mostly observed on the masonry wall of the church. The stone surface is uneven and loose, covered with black patina. There are also yellow, white and red-orange spots. Cracks, cavities, additions, masonry joints between the blocks, gaps are filled with cement mortar. The additions belong to different periods. A big gap across the plane between the portal jamb and the metal door is also filled with cement mortar. It indicates the fact that the entrance door was much closer. The additions of the jamb are partly green and black. There are also spots of red paint. Cement mortars used during the additions differ from each other by the ratio of binding agent and component composition: brick, sand, gypsum, lime. There are gypsum additions on the portal (gypsum without fillers, gypsum mixed with fibers, found between 7–8 blocks) and gauged mortar (the filler of which is crushed brick) in the joints between the blocks.

Numerous alabaster panels of different size, colour, structure and period of mounting, which were the results of the previous restoration work, are on the portal. The alabaster panels are fixed on the cement mortar. Most of the panels are in the unsatisfactory condition. The keystone of the portal is in a particularly critical condition, as the biggest amount of mechanical loading falls on it.
