¹Esmeralda Paupério, ²António Arêde, ³Rui Silva, ⁴Susana Moreira
CONSTRUCT-LESE, Faculty of Engineering, University of Porto, Porto, Portugal

CROSS-BORDER FORTRESSES IN PORTUGAL; INSPECTION AND DIAGNOSIS

Keywords: *Structural inspection, structures, defensive walls, forts.*

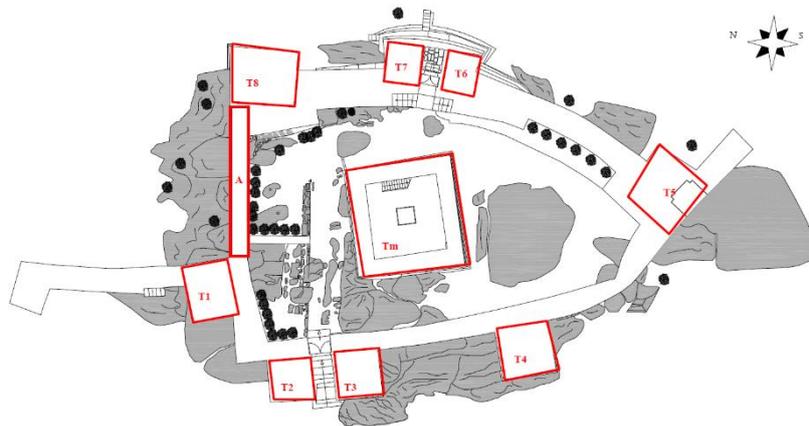
Fig. 7. Identification of the elements of the Castle of Guimarães.

Structurally, the Guimarães Castle has load-bearing walls in granite stonework, generally with good arrangement. It has 8 towers integrated in the walls and a central keep with much larger section and height than the other towers. As shown in Fig. 7, the wall towers are designated from T1 to T8, with Tm being the keep. The main entrance to the castle is located between the T2 and T3 towers and the “betrayal” gate is between the T6 and T7 towers. The area of the wall marked by A in Fig. 7 refers to what remains of the fortress wall. This identification was used in the inspection procedures, allowing for a more targeted and, consequently, more effective registration of damages. Thus, in a first phase, the damages were identified and located in maps by type of damage; in a second phase, a form per element was made for the most affected elements in order to compile all kinds of damage that occur simultaneously on the same element. This recording approach allows to describe each damage, to identify its occurrence location and additionally, for each element, to associate the record of all its damages thus providing the information of its overall structural state.

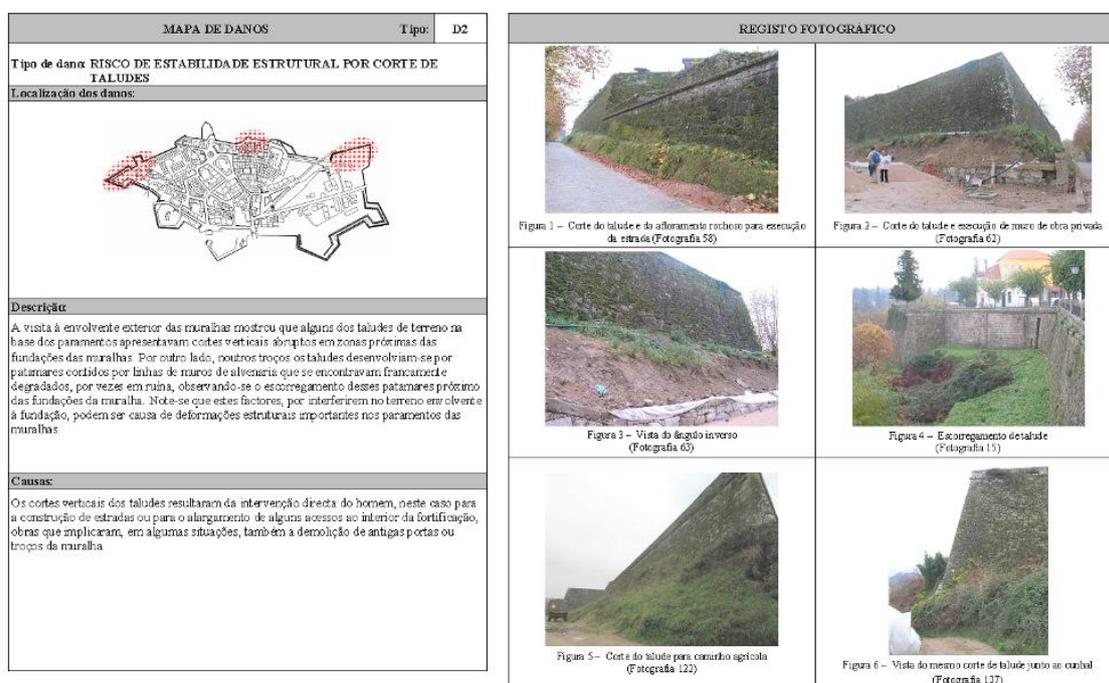
Fig. 13. Example of a damage form.

In these fortresses, characterized by several lines of defense developing along more or less high walls in granite, visual inspections with a structural scope were carried. For each fortress, after the identification and description of the load-carrying structure, those considered most relevant were recorded in damage forms (Costa, Guedes and Paupério, 2005). In these forms, Fig. 13, in addition to the in plan location of the damage, there is also a brief description associated with the identification of its probable cause. Also, the interconnection between different types of walls (crossing or extension of medieval walls with bastions) were identified and marked as additional and fundamental information to the inspection process.

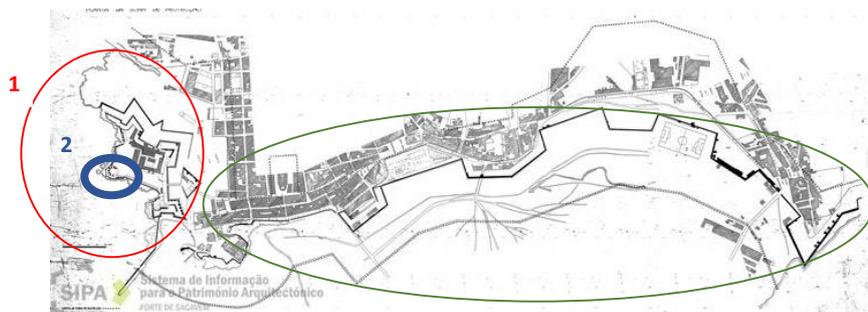
Fig. 16. Implantation plan of the fort and walls with bastions of Peniche, with indication of zones 1, 2, and 3 (retrieved from: www.monumentos.pt).

In the fort (Zone 1), a total of 48 sections of the different walls were identified in plan, which were inspected from the outside and the interior, having identified for each face the existing damage, as well as the corresponding evidenced intensity. In Zone 2, the different buildings within the fortress were marked from A to K, and the different associated construction processes were recorded, as well as the damage and occurrence intensities, Fig. 17. The same methodology was applied to the city wall line, Fig. 18. The inspection procedures were similar to those mentioned above, with this fortress having the particularity of housing constructions from different periods, to be preserved due to its importance for the collective memory.
