GREEN ROOF AS A SAVING TECHNOLOGY AND CREATOR OF MICROCLIMATE

This paper highlights the importance of energy savings in terms of the best choice of vegetation used on green roofs.

Ecopoint building in Kosice has a green roof on one top of the building. Aim of this article is to present three different measurements of temperatures under three different types of foliage of this green roof. The fact that different choice of vegetation has an effect on lowering the temperature of green roof might be very interesting in terms of microubanism and microclimate. Reducing temperature may cause also other savings like energy or water retention, what is the main idea of this article.

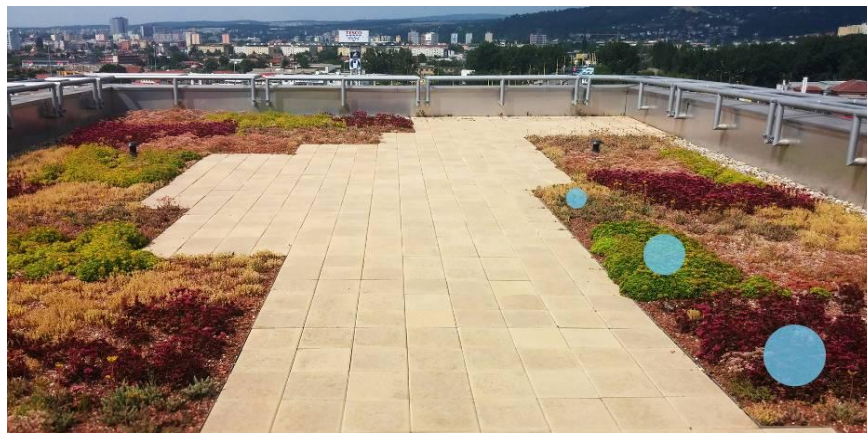
Fig. 1. Places for sensors under three different sedums

The roof construction and all its layers are described in Table 1. Spots, where the sensors are placed under the sedums are pictured on Fig. 1. As can be easily notable from the pictures, main idea of this article is explained here, the sensors are placed under three different plants.
