## ANALYSIS OF THE BACOR REFRACTORIES AFTER THEIR SERVICE IN GLASS FURNACE

**Abstract.** The degree of the baddeleyite-corundum refractories erosion depending on the areas of their location in the glass-making furnace in the float glass production was established. With the use of petrographic analysis the influence of chemical and mineral composition and also temperature and gas environment on corrosion of bacor linings was studied. Due to obtained results the recommendations in relation to the increase of glass-attack resistance of the furnace and its service life length were formulated.

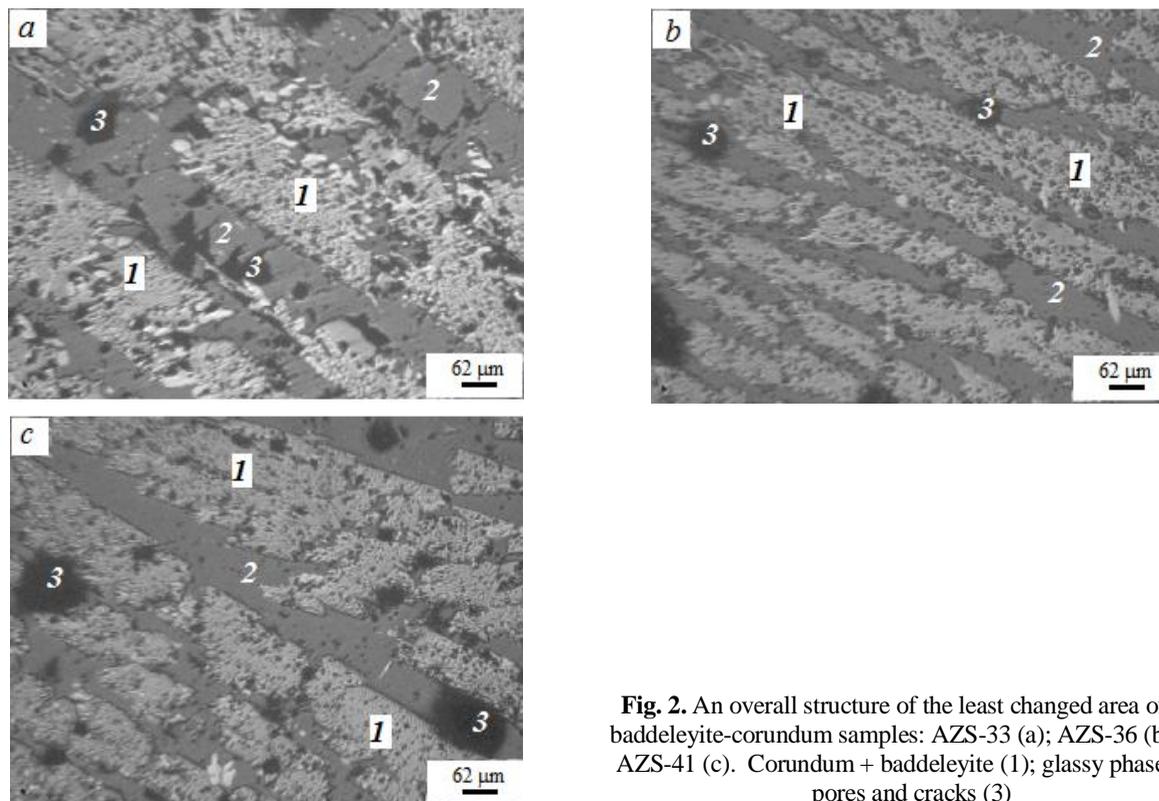
The structure of the investigated samples is shown in Fig. 2.

**Fig. 2.** An overall structure of the least changed area of the baddeleyite-corundum samples: AZS-33 (a); AZS-36 (b) and AZS-41 (c). Corundum + baddeleyite (1); glassy phase (2); pores and cracks (3)

The results of petrographic studies have shown that in the samples of baddeleyite-corundum refractories during their service the following areas were formed: the least changed area, working (reaction) area and the area with the crust of glass on the samples surface (Table 3). The least changed area of the AZS-33 (I) sample consists of the tabular, ribbon-shaped, frequently parallel inclusions of the corundum and baddeleyite cocrystallization (solidified eutectic melt) with different lengths and widths, and also contains the glassy phase between the baddeleyite-corundum inclusions.

Baddeleyite is observed in the form of grains (crystals) with isometric (rounded), elongated (oval) and irregular shapes, distributed among the short-prismatic and isometric crystals of corundum. Colourless glassy phase with an index of refraction  $N \approx 1.500$ – $1.510$  has also the form of the elongated ribbon-shaped inclusions.

In the glassy phase and inclusions of cocrystallization (in a smaller amount) the pores of the least changed area are isometric and irregularly shaped. Contacts of all phases are dense, only occasionally at the contact “glassy phase – baddeleyite + corundum” the cracks are observed.

Samples AZS-36 (II) and AZS-41 (III) at the least changed area have finer crystallization of both the inclusions of cocrystallization, and the crystals of corundum and baddeleyite in these inclusions themselves, and also glassy phase (Table 4). In the sample AZS-41 (III) the baddeleyite is occasionally observed in the form of separate grains and aggregations, and in the glassy phase at the contact area with corundum the needle crystals of mullite ( $3\text{Al}_2\text{O}_3 \cdot 2\text{SiO}_2$ ) are found, which are up to 0.02–0.04 mm in length.

The sample AZS-36 (II) is indicated with a slightly smaller number of pores and cracks, and in the sample AZS-41 (III) the rounded pores predominate, and their sizes are considerably bigger ones (Table 4).

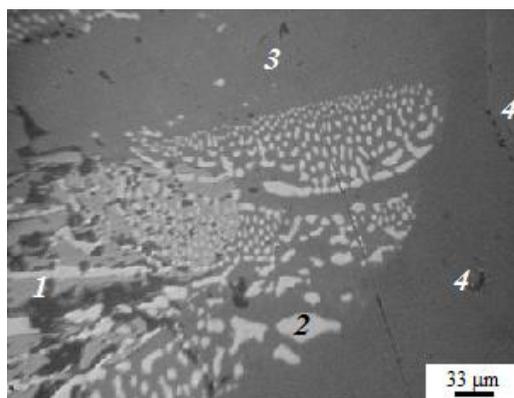
In the working (reaction) area of the AZS-33 (I) sample the similar structure is observed. But in the aggregations (inclusions) of cocrystallization only the baddeleyite is kept (Fig. 3), which is freely immersed in the colourless glassy phase with an index of refraction  $N \approx 1.510 \pm 0.005$  and with crystallizing in it the prismatic crystals of nepheline ( $\beta\text{-Na}_2\text{O} \cdot \text{Al}_2\text{O}_3 \cdot 2\text{SiO}_2$ ) and, quite seldom, – of the carnegieite ( $\text{Na}_2\text{O} \cdot \text{Al}_2\text{O}_3 \cdot 2\text{SiO}_2$ ), with the length up to 0.03 mm and sometimes subparallel oriented.

**Fig. 3.** Structure of the working (reaction) area of the baddeleyite-corundum sample AZS-33 (I): corundum (1); baddeleyite (2); glassy phase (3); pores and cracks (4)

The sample from the working area practically has no pores.

In the samples AZS-36 (II) and AZS-41 (III) the corundum in inclusions of cocrystallization is kept, although in the smaller amount (Table 4), and in its place the glassy phase with nepheline crystals with sizes of 0.004–0.008 mm is marked.

Different capacities crust is observed in the working surface of all samples and represented by the colourless glassy phase with an index of refraction  $N \approx 1.520$ – $1.525$ , which is close to the float glass index.

Contacts of the working area with the refractory and glassy crust are rough, winding, with penetration of glass in pores and cracks.

Thus, it was found that the glass melt, penetrating through pores and cracks into the refractory, reacts with components of refractory, primarily with glassy phase of bacor and corundum. As a result of this interaction the glass melt is formed similar to the composition of the nepheline according to the index of refraction ( $N \approx 1.510$ ). Also nepheline or carnegieite are crystallised. The gradual substitution of the refractory components for low-melting compounds and slopping and/or washing-off of the intensively changed layer occur.
