ОЦІНКА УМОВ НАВКОЛИШНЬОГО СЕРЕДОВИЩА В МЕЖАХ ПРИБЕРЕЖНИХ ЗОН ОХОРОНИ ВОДИ З ВИКОРИСТАННЯМ ТЕХНОЛОГІЇ WEBGIS

VASILE GRAMA, ANDREI IACOVLEV

Faculty of Constructions, Geodesy and Cadastre, Technical University of Moldova, bd. Dacia 41, Chisinau, MD2060, Republic of Moldova

ASSESSMENT OF ENVIRONMENTAL CONDITIONS WITHIN THE LIMIT
OF THE RIPARIAN WATER PROTECTION STRIPS USING THE WEBGIS TECHNOLOGY

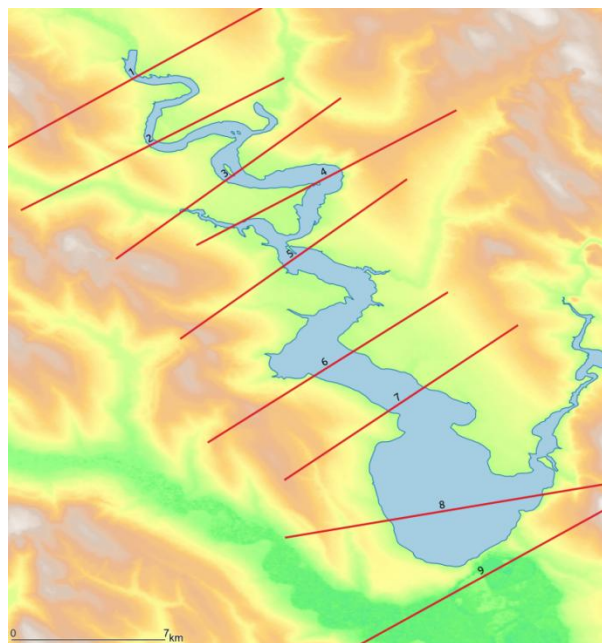
Fig. 1. Reservoir Costești-Stâncă

The reservoir Costești-Stâncă (Fig. 1) was arranged in 1978 on the Prut River, the filling of the lake took place from April 1978 until April 1979. The lake dam is 576 km from the mouth of

Prut river. The length of the lake is 60–90 km, the average width – 1 km, the average depth – 12.5 m (near the dam – 41.5 m), the volume – 735 mln. m³ – 1.1 billion. m³, with the area of the aquarium of 5–9 thousand ha, and the water catchment area – 12000 km². It ensures the seasonal regulation of Prut river run, especially in the mitigation of the floods, the river waters being used for the production of electric energy, for irrigation of land, for industry and for fish farming.

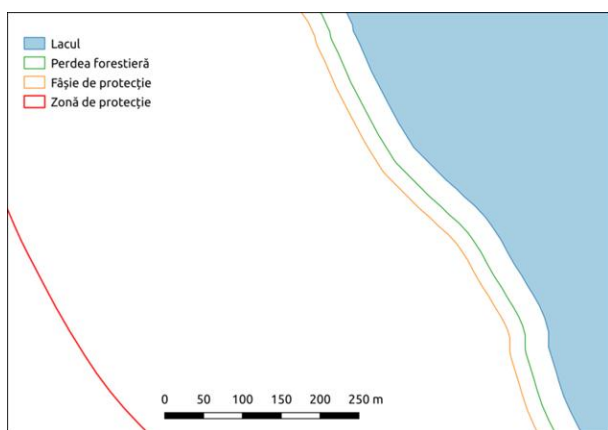
The subject of this study is represented by riparian strips of water protection of rivers and water basins as defined by Law no. 440 of 27.04.1995 (Fig. 2).

Fig. 2. Scheme for the delimitation of protection zones, windbreaks

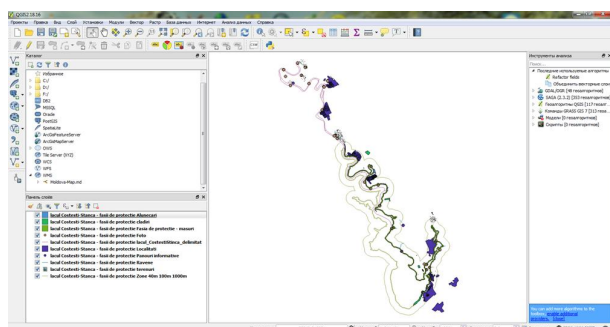
The data mapping was performed using QuantumGIS software (Fig. 4), Mapinfo, ArcGIS, etc. These software allow advanced analysis of collected and existing data.

Fig. 4. QGIS software interface, Lake Costesti-Stanca

created as well. . Thus, by accessing the blog you can view the lake, the deck of interest, with the necessary attributes (Fig. 4).

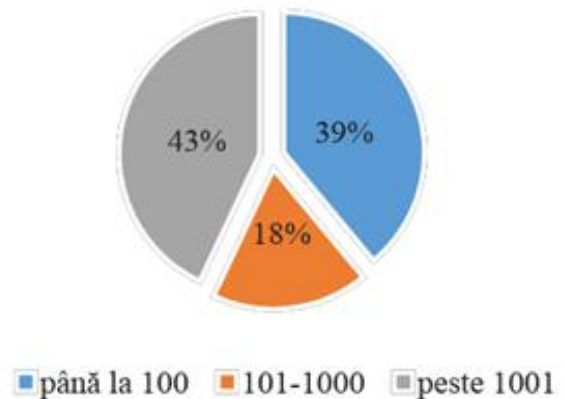
Fig. 5. Distribution of forest land according to the protection zone

In order to evaluate the environmental conditions of the water protection strips along the Costesti-Left reservoir, the study is being focused on the analysis of the forest lands on a distance of 100 m, 101–1000 m, and over 1000 m from the surface of the water (Fig. 5).

In the case of the Costești-Stânca reservoir, 39 % of the forest lands are located 100 m from the water, 18 % – 101–1000 m and 43 % over 1000 m.

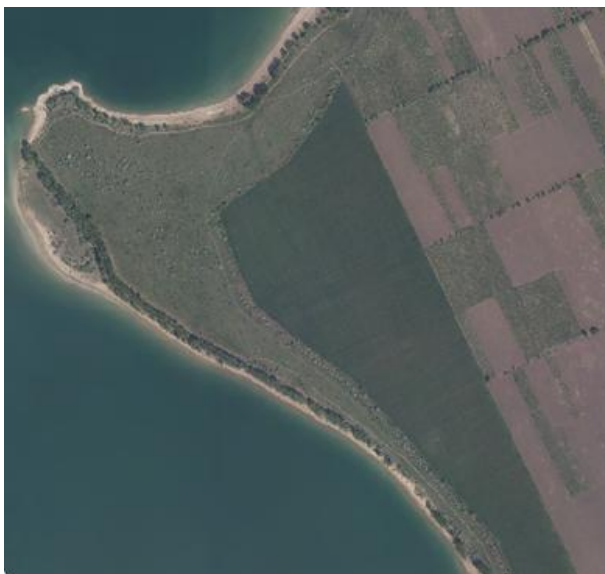
As a result of the site review of existing riparian protection strip, the length of about 11.5 km is located on the territory of Duruitoarea Nouă and Dumeni commune. The strip was created with the creation of the Costești-Stânca reservoir and is currently discontinuous in its length (Fig. 6). The species that constitute the protection strip are the Euro-American poplar, the willow and the sail. The willow have regenerated naturally over time. Natural grassland regenerations are also found in the meadows in the immediate vicinity of the coastal protection strip.

Fig. 6. Protected coastline in the Duruitoarea Noua village

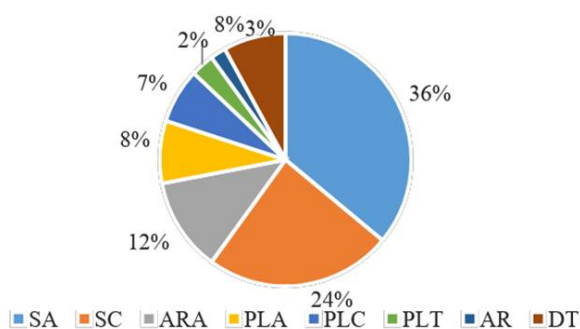
The water catchment area and the forests near the Costești-Stâncă reservoir are composed of the following species: willow (SA – 36 %), acacia (SC – 24 %), American maple (ARA – 12% white poplar (PLA – 8 %), gray poplar (PLC – 7 %), tremulous poplar (PLT – 3 %), tartar maple (AR – 2%) and various hardwoods – 8 %). The distribution of the occupied area of the species is shown in Fig. 7. Of the above, it is noted that predominantly the following species predominate in the composition of the arboretums: the willow, the acacia and the American maple. The other species are in a smaller proportion.

Fig. 7. Composition of river protection strips

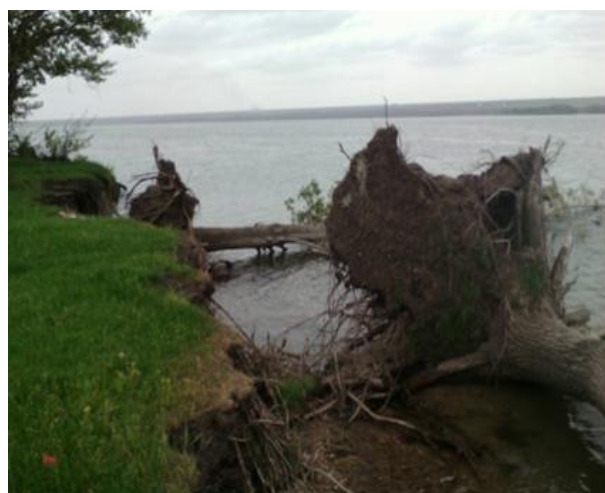
The age of Euro-American poplar is advanced in comparison with the age of technical exploitation. Thus, interventions are needed to regenerate coastal protection strips. The acceleration of the regeneration works of the riparian protection strip is also due to the shores of the banks due to the erosion caused by the waves and the weight of the trees (Fig. 8).

Fig. 8. Degradation of shores due to wave erosion and tree weight

Describing the coastal protection strip as it is currently being constructed, there is a lack of consolidation band. Here it is necessary to intervene with bank consolidation works and, if necessary, to create the consolidation band.

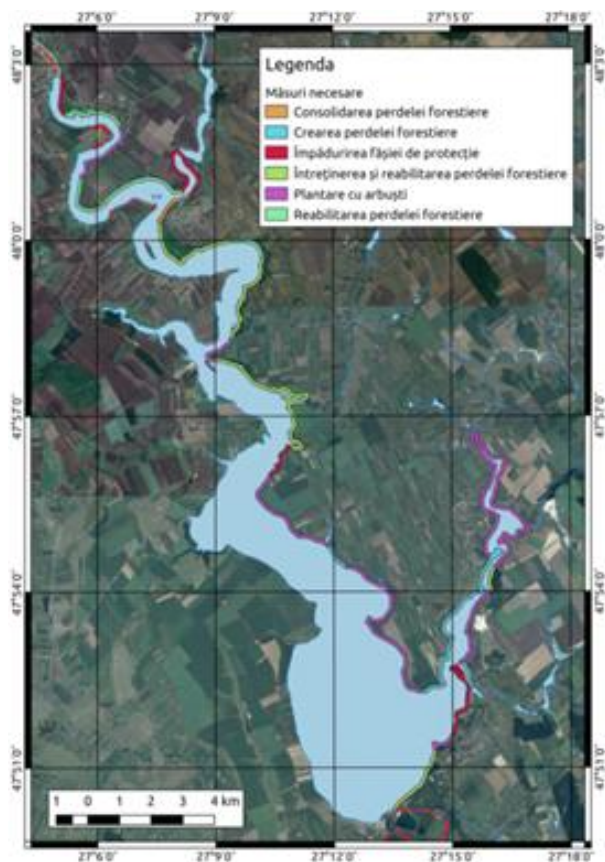
Fig. 9. Localization of measures to improve the state of protection strips of Lake

Using the GIS mapping [References of Law number, ..., 2016; Geoportal NSDI of Moldova, http://www.indes.gov.md/geoportal_inde] the localization of the actions on rehabilitation creation of protection strips was made (Fig. 9, Fig. 10) and location of solid waste landfills requiring action (Fig. 11).

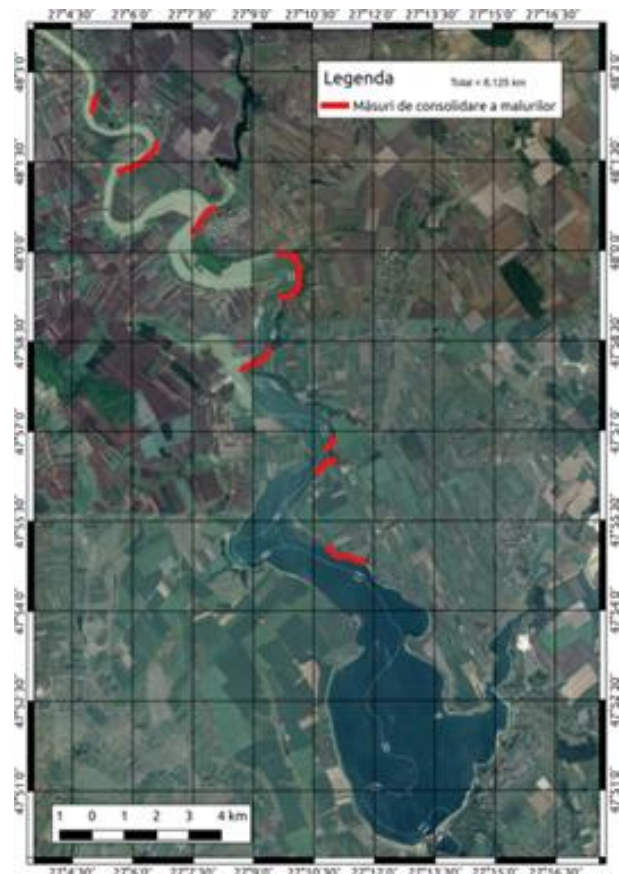
Fig. 10. Localization of measures to strengthen the shores of reservoir

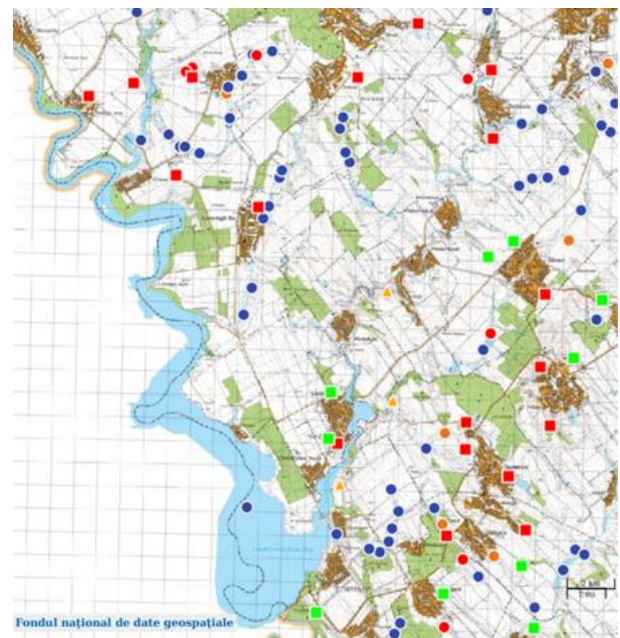
Fig. 11. Localization of solid landfills in the vicinity of Costesti-Stânca Lake (green squares – authorized warehouses, red squares – unauthorized landfills)

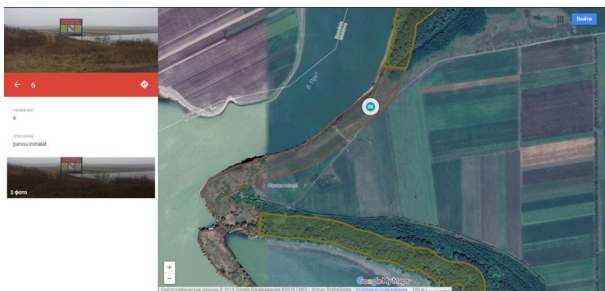
Figure 12 shows the location and picture (photos) of the information panel on the protection zone of Lake Costesti-Stinca.

Fig. 12. Viewing the information panel for the protection zone of Lake Costesti-Stinca
